RESERVE STUDY

**City Walk Condominium Association
66 9th Street East
St Paul, MN**

Date of Inspection: December 3, 2024

Revision #2: September 3, 2025

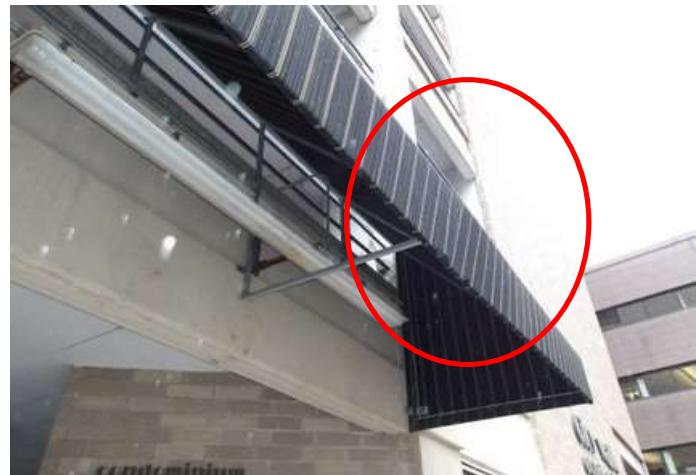
Dented metal frame

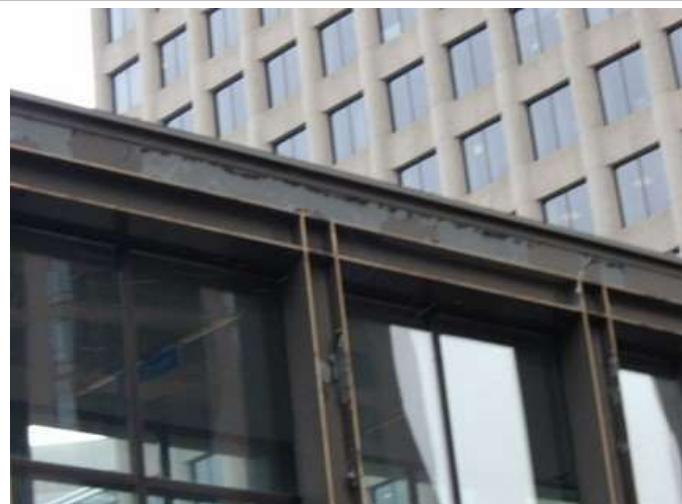
Rust at metal frame

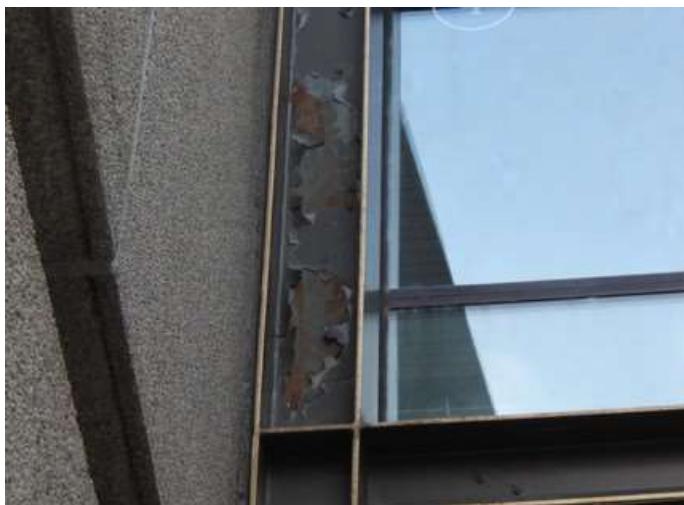
Rust ant peeling paint

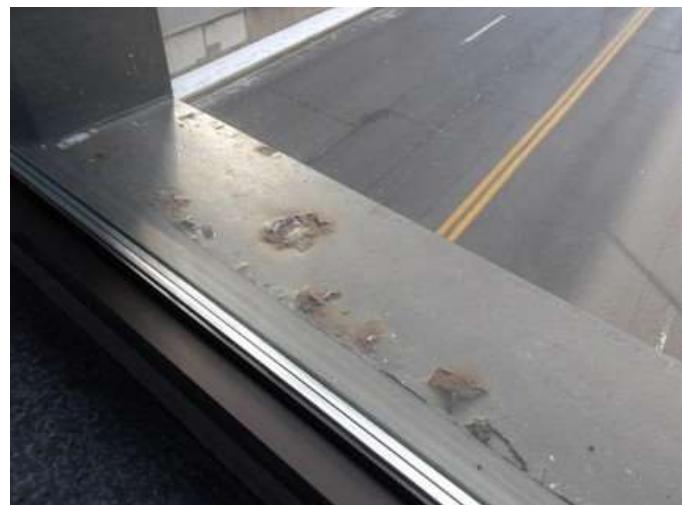
Rust as viewed from inside skyway

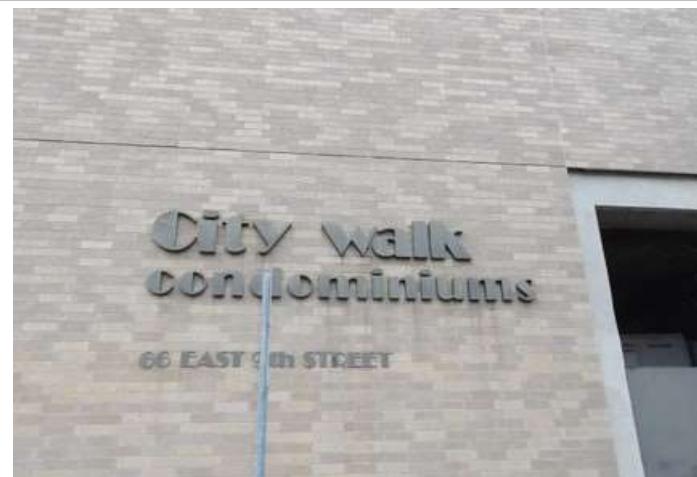
Metal lettering with staining

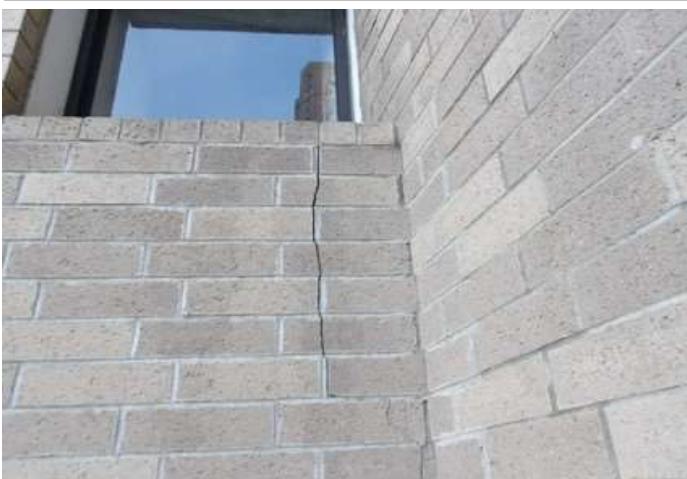
Brick and mortar crack

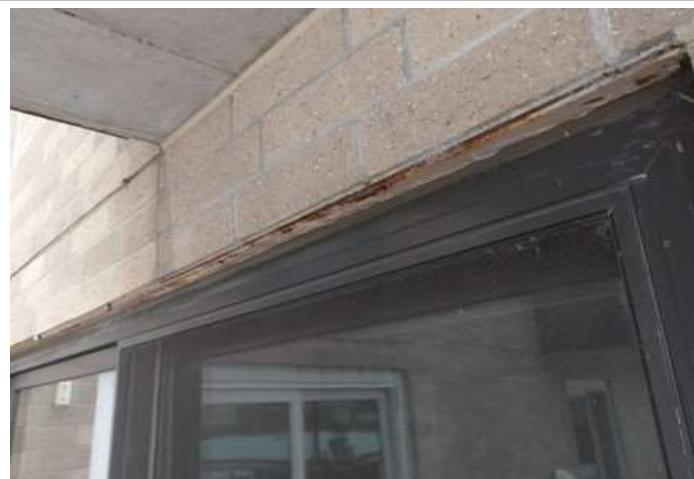
Rust at metal lintel

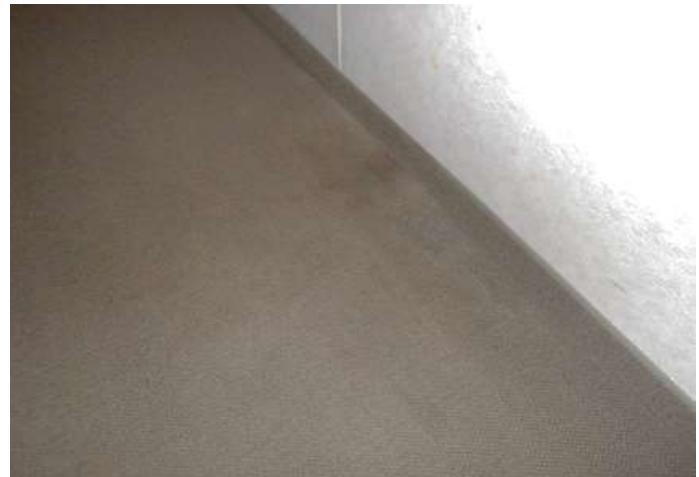
Carpet stain

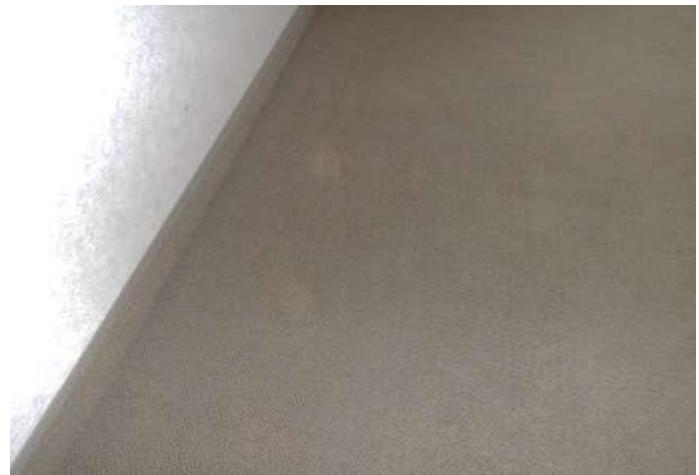
Carpet stain

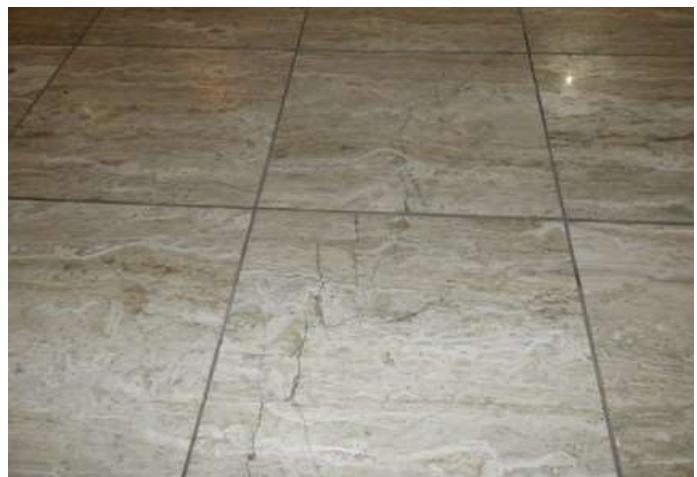
Cracked floor tile

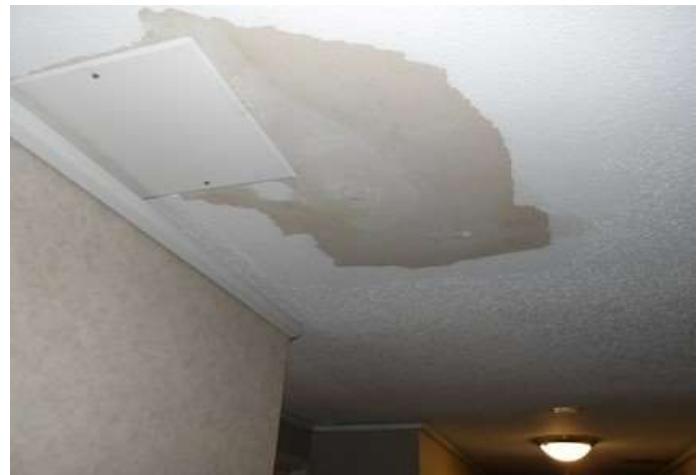
Isolated damaged finish

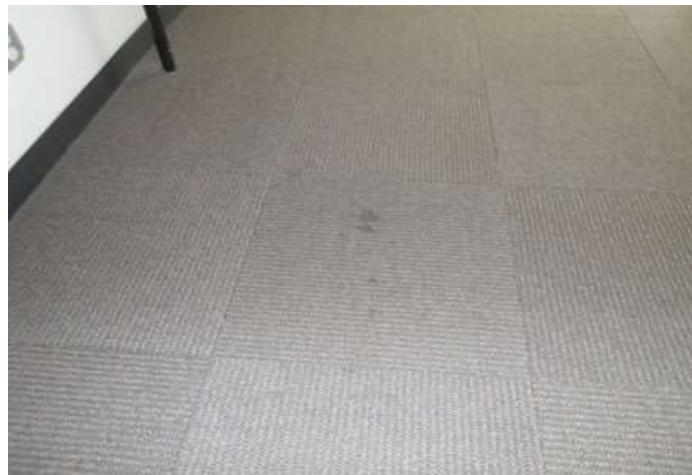
Shared skybridge atrium stained carpet tile

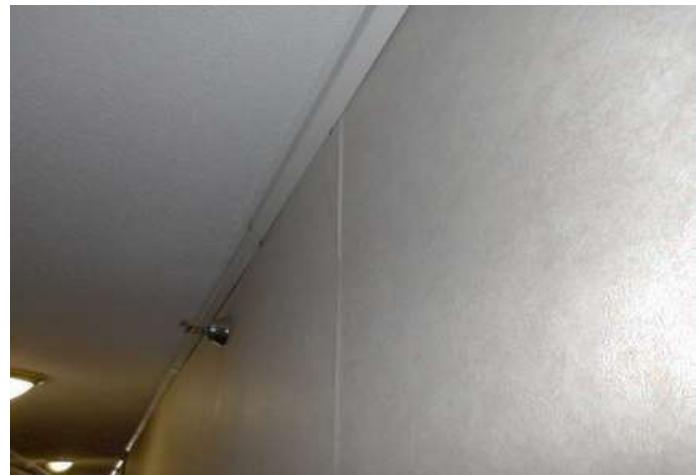
Stains at wall covering

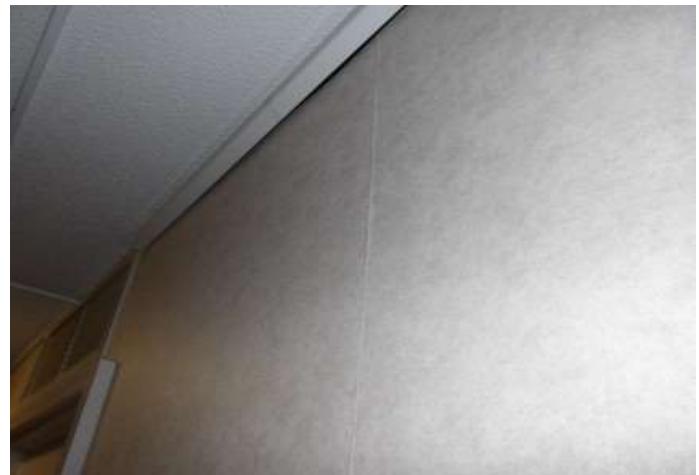
Loose seam near corner

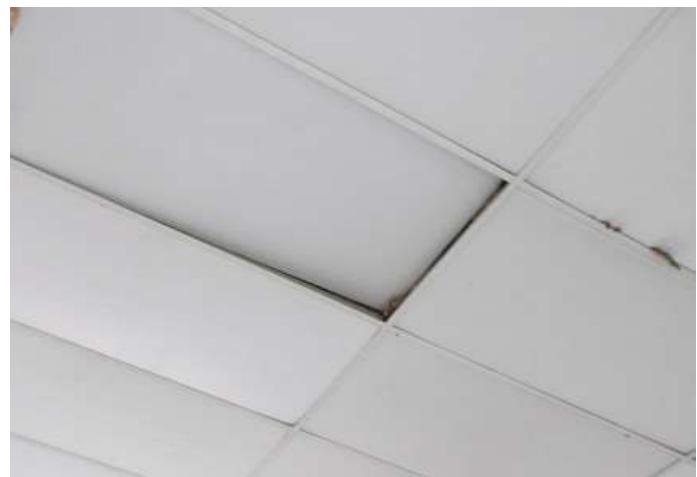
Loose ceiling tile

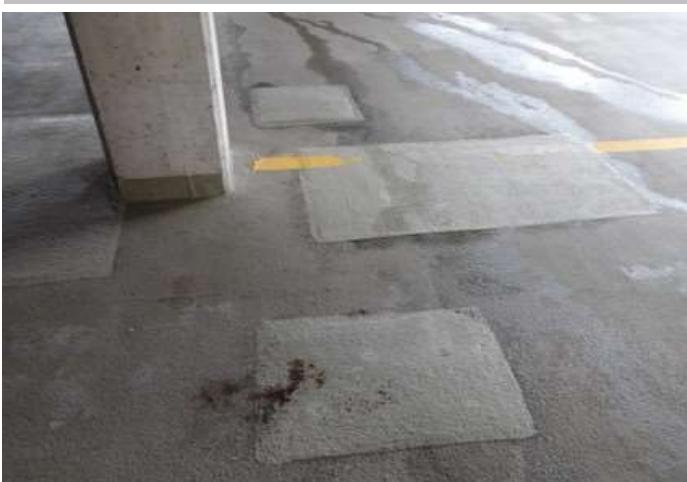
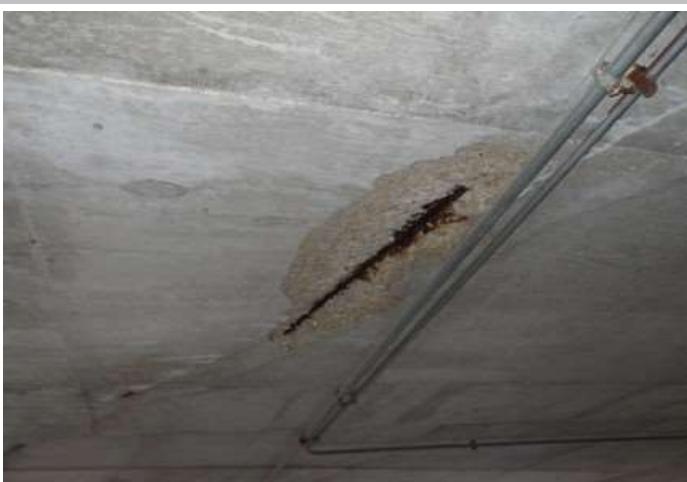
Previous concrete patches

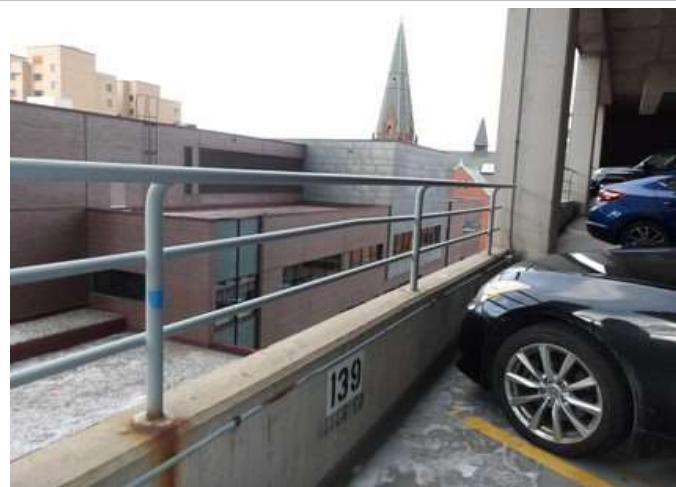
Rust at railing posts
