RESERVE STUDY

**City Walk Condominium Association
66 9th Street East
St Paul, MN**

Date of Inspection: December 3, 2024

Revision #2: September 3, 2025

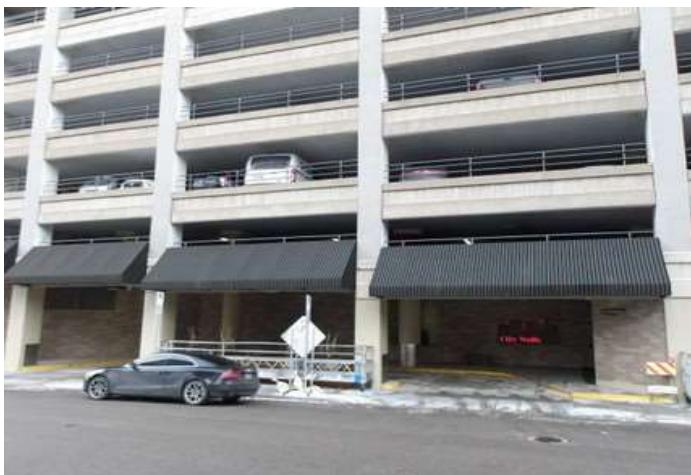
Awnings at main entrance

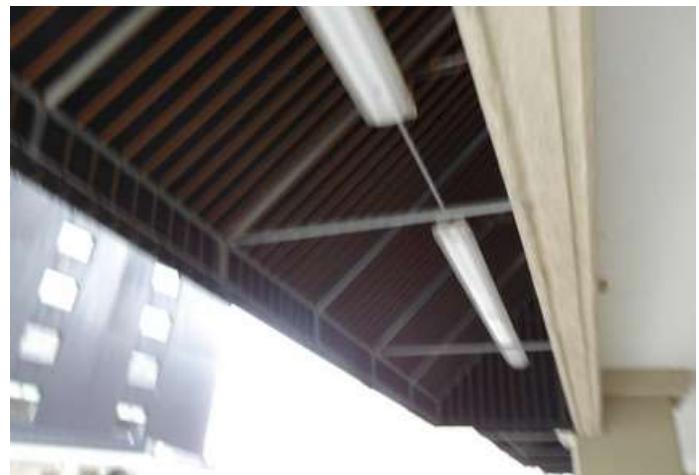
Awning and frame with lighting

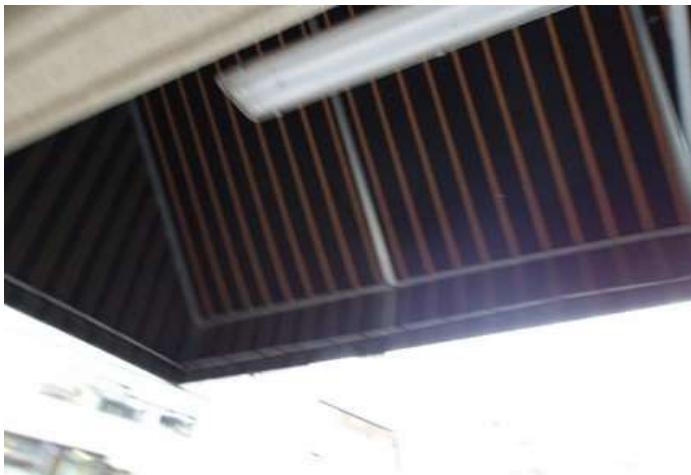
Metal frame detail

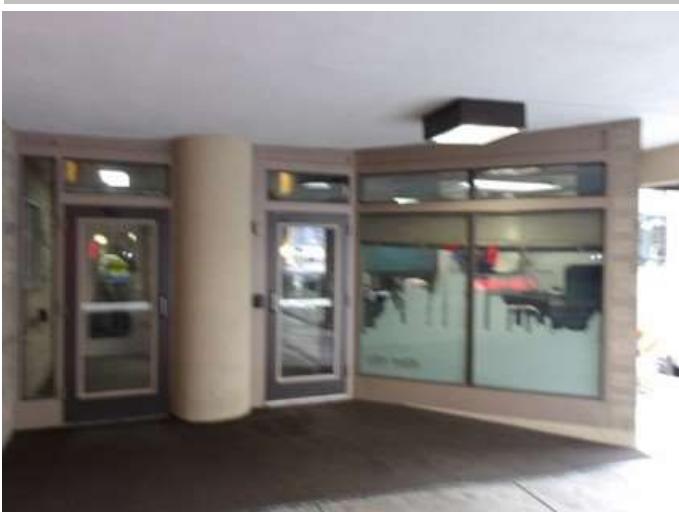
Main entrance doors

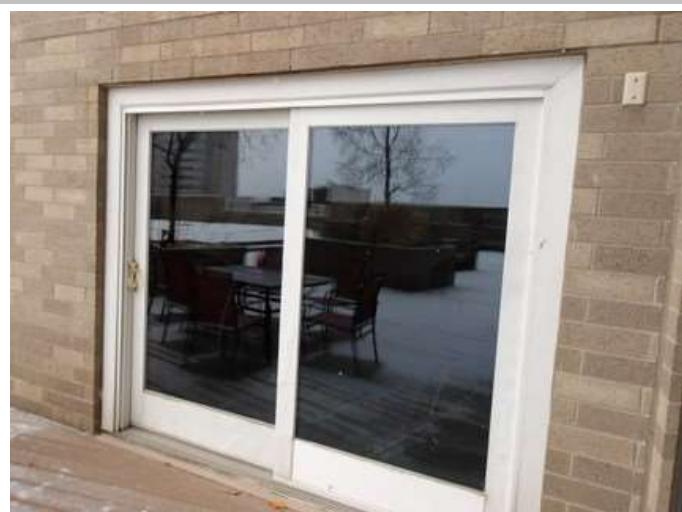
Patio door at 12th floor

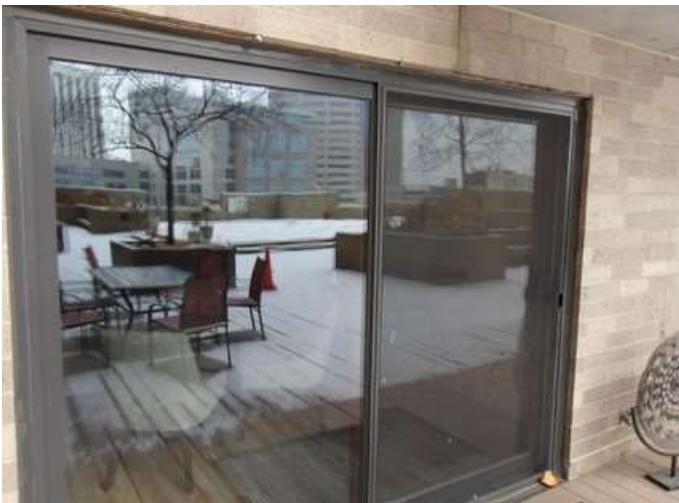
Common 12th floor glass door

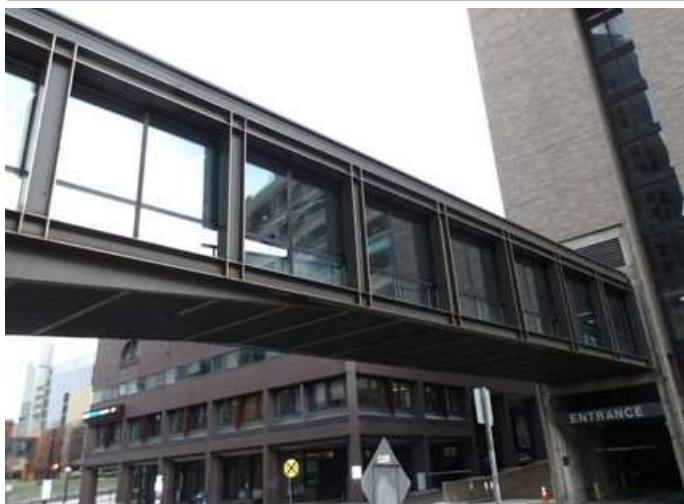
7th Street skyway

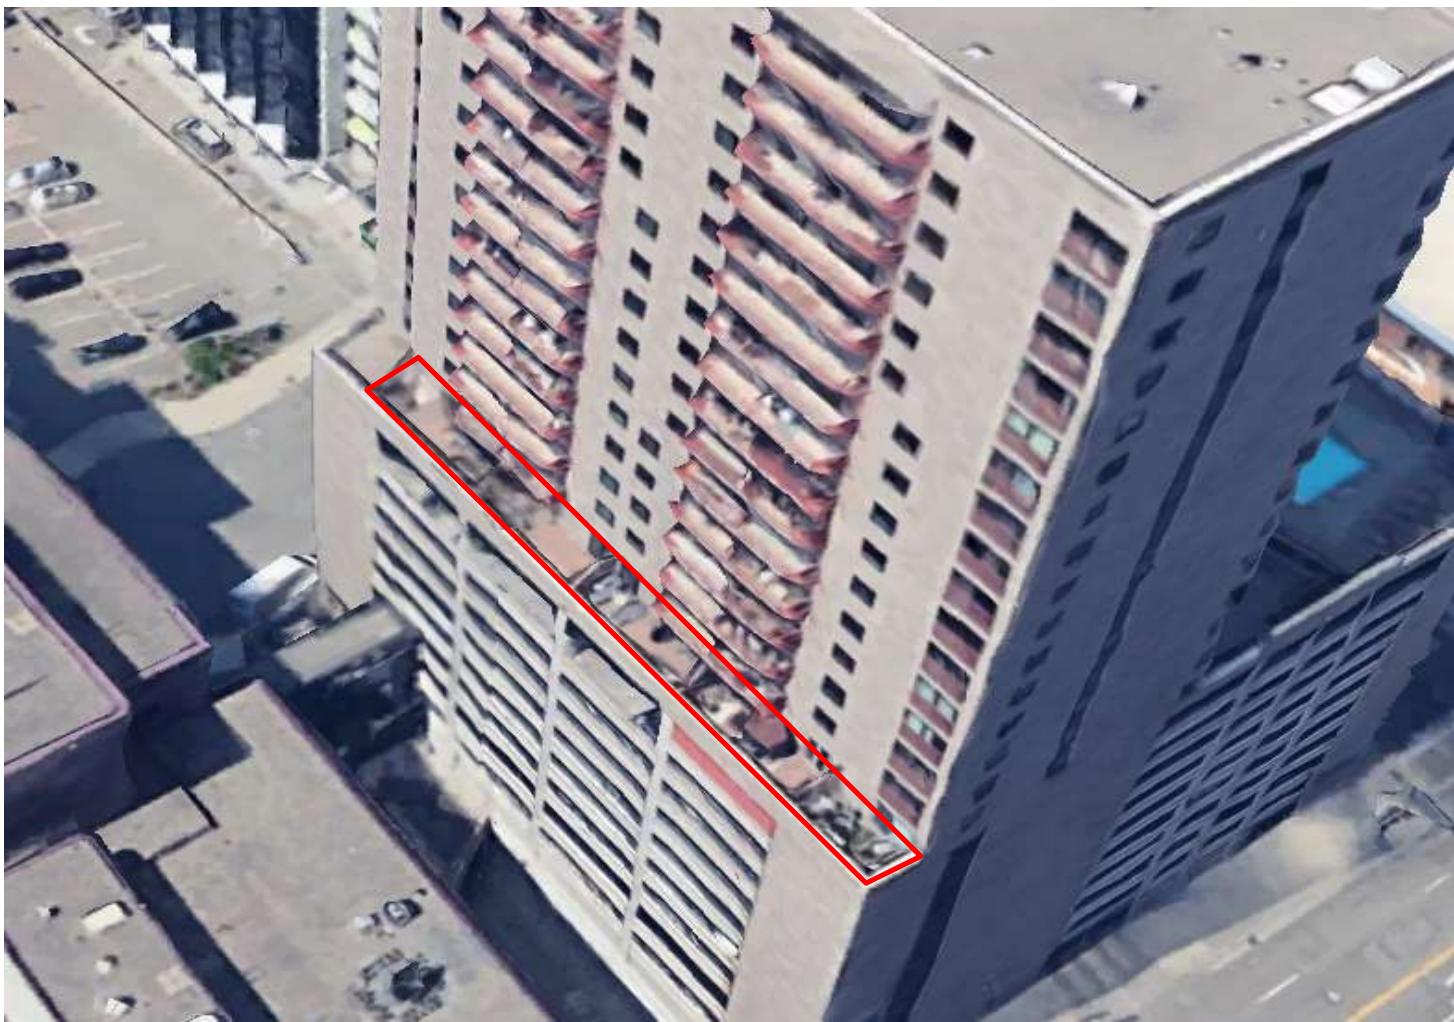
Location of 12th floor patios

Engineering Narrative	
The client informs us that the association is responsible for the flat roof membranes underneath the west unit patios at the 12th floor. Inspection of the membranes is beyond the scope of this report. The client reports that the underlying membranes may be original and does not report any leaks. We conservatively include an allowance to replace the underlying membranes, floor drains, insulation and flashing by 2028. Unit owners are responsible for any patio improvements located over the membrane.

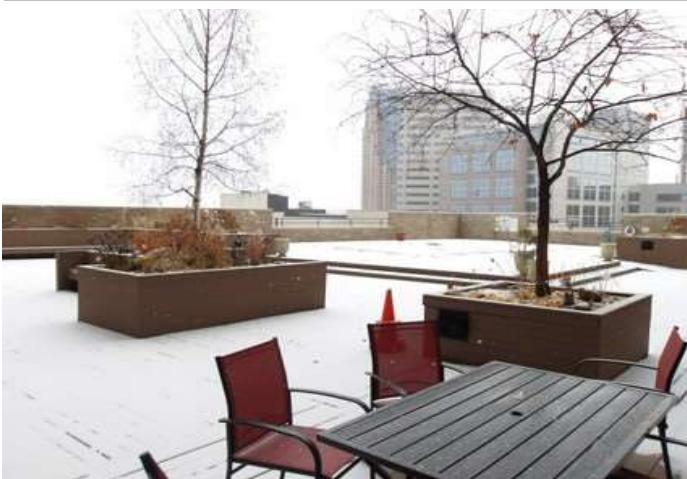
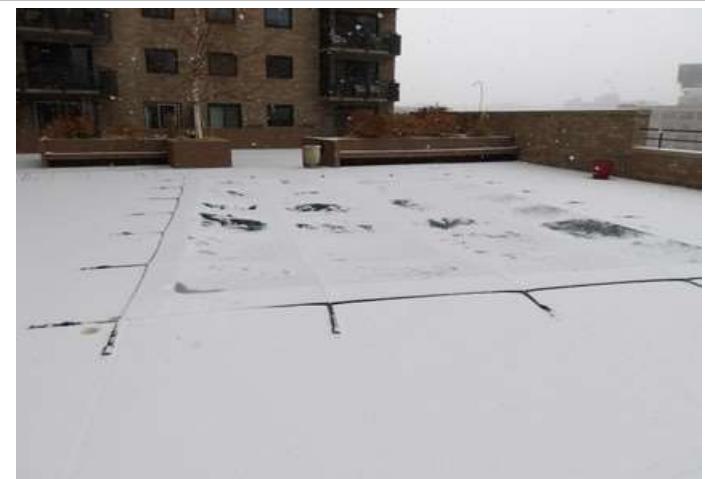
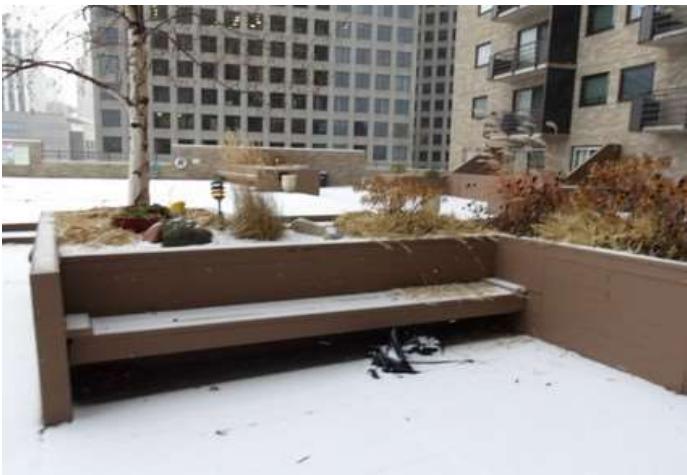
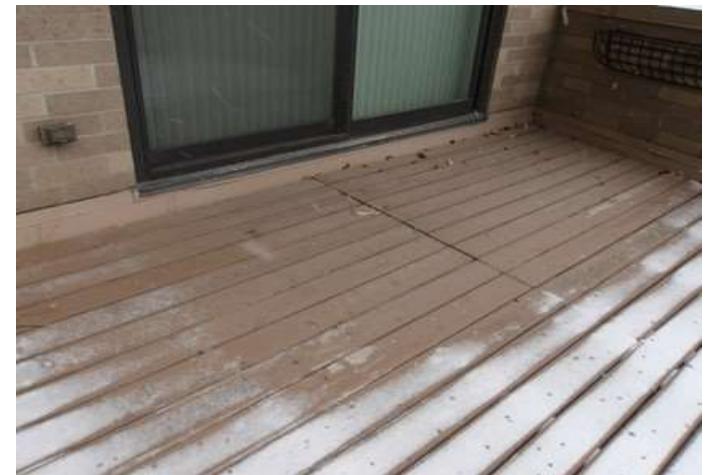
12 floor common deck overview

Pool area

Planters at 12th floor terrace

Wood decking over roof membrane

An elevated plaza is located above the garage spaces at the 12th floor terrace. We surmise the system comprises the concrete structure, an underlying waterproof membrane, insulation and drainage provisions, as well as surface concrete, landscape planters and wood decking. The client reports a history of leaks, possibly originating at floor drain penetrations. Inspection of the membrane is beyond the scope of our non-invasive inspection. We include an allowance for capital repairs to the deck by 2026 and again by 2041. At the direction of the board, we exclude complete replacement of the underlying membrane from this report.

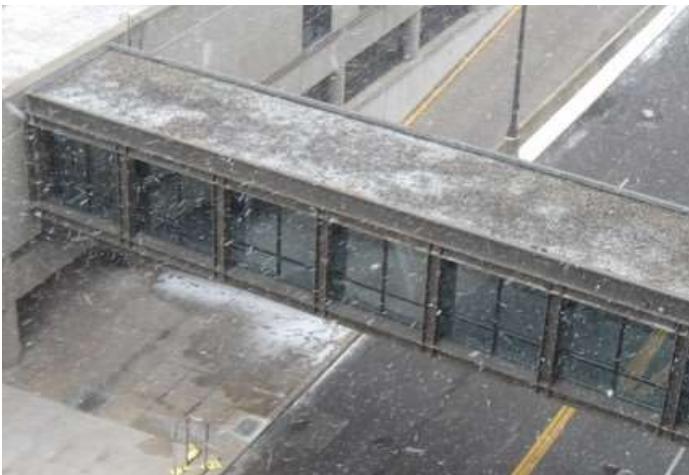
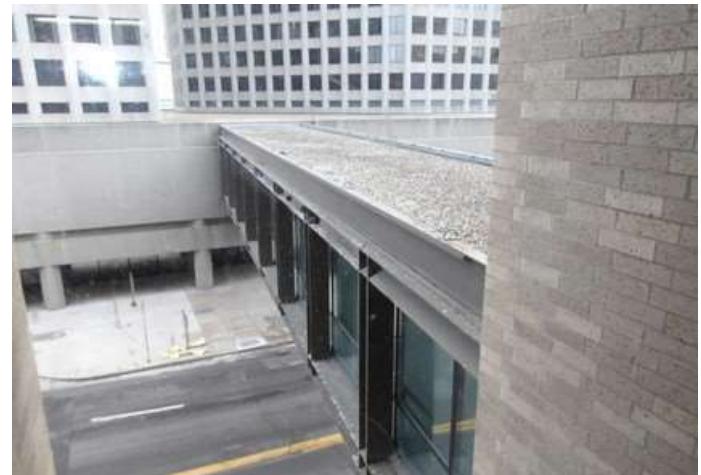
7th Street skyway

The flat skyway roof is reported in satisfactory condition, with no known active leaks. We recommend the association budget for replacement of the roof by 2033, in coordination with the tower roofs.

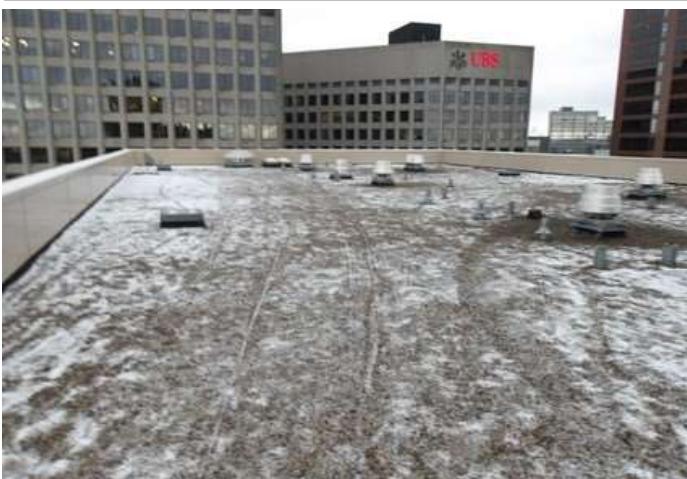
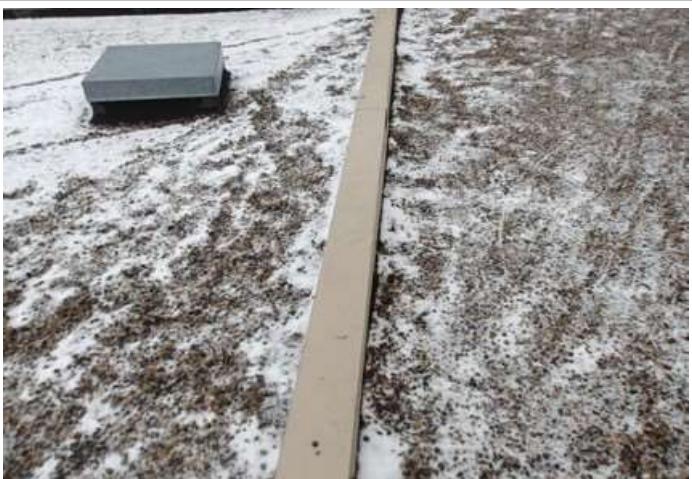
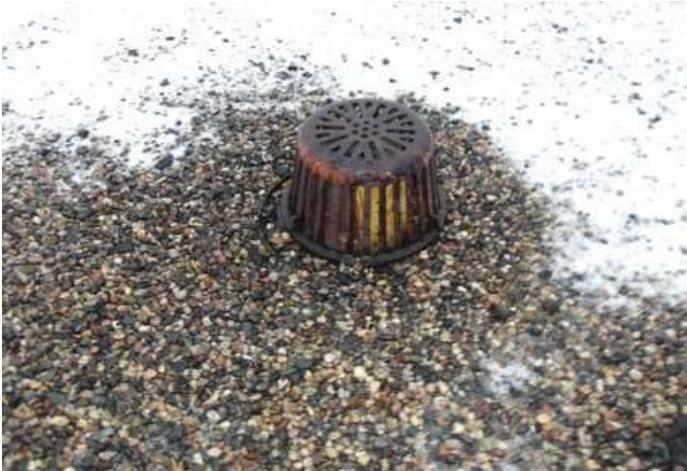
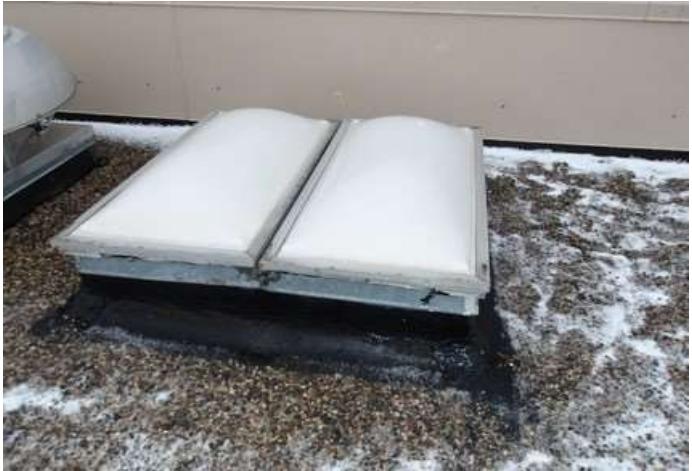
Main tower roof

Metal coping between roof sections

Roof drain penetration

Stairwell skylights

The built-up tower roofs (including mechanical penthouse and stairwell) appear in fair condition and date to 2002. We recommend the association fund annual repairs and inspections to maximize the remaining useful life of the roofs. Built-up roofs are sometimes referred to "self-healing" roofs and have long useful lives. Our quantity includes the small section of common flat roof at the 12th floor near the elevator lobby. At the direction of the client, we show deferred roof replacement by 2055.

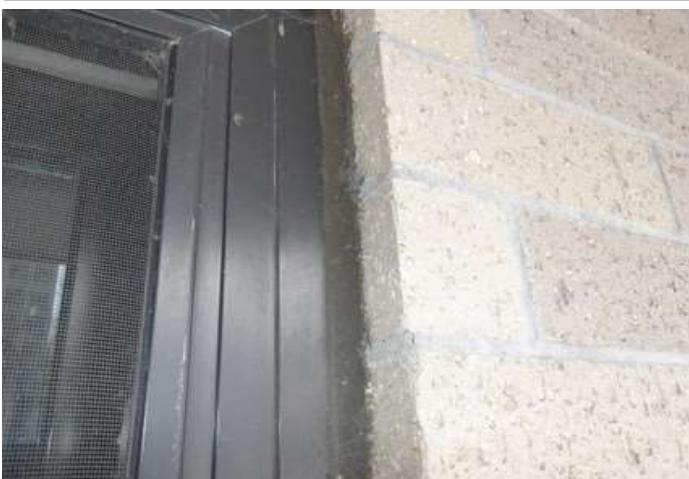
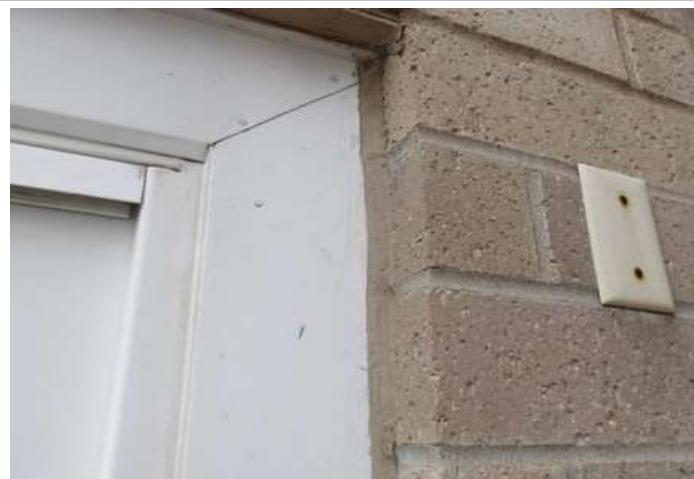
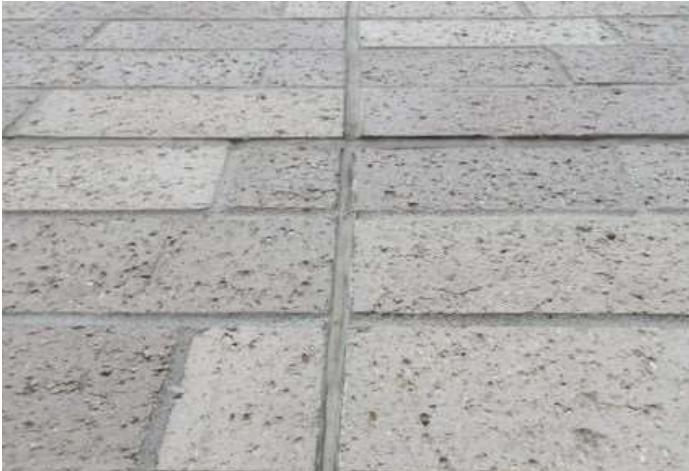
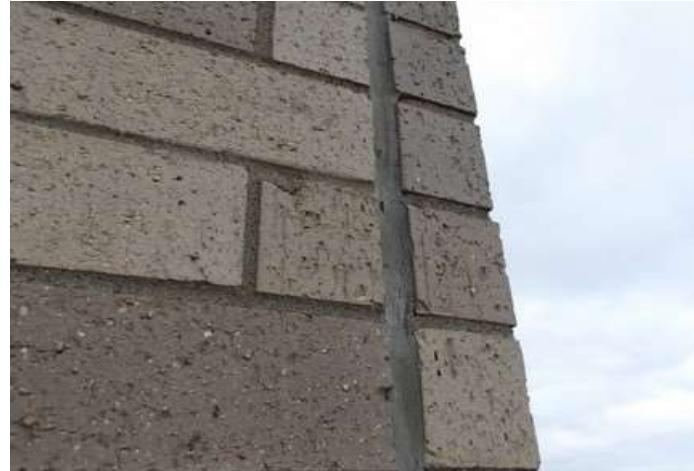
Window sealant detail

Control joint sealant detail

Engineering Narrative				
Flexible sealants are located between dissimilar materials and at control joints to allow for differential movement while preventing moisture and air infiltration into the building. The sealants are in good condition and were addressed as part of a 2019 facade renovation project. Failure to maintain the sealants will lead to deterioration of the masonry, windows and doors. We recommend replacement by 2031 and every 12 years after, in coordination with masonry repairs.

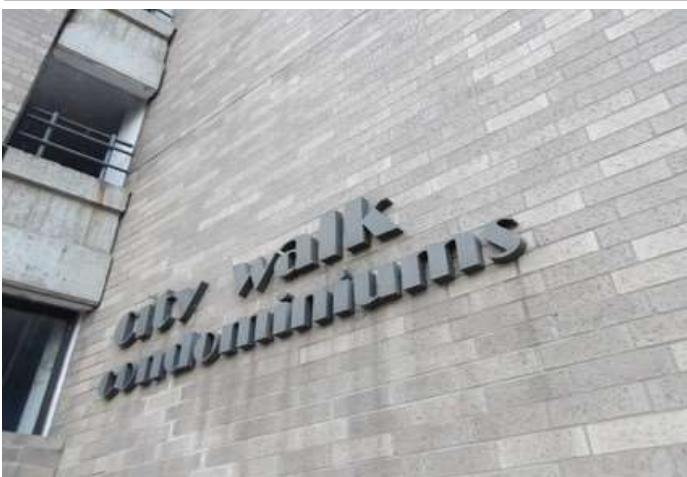
Metal lettering with staining

The association maintains 3 sets of metal lettering and 1 illuminate sign around the building. The signage provides a good first impression to guests and potential owners and replacement is usually driven by aesthetic concerns. Based on condition, we recommend the association budget for replacement of the signage by 2031 and again by 2051..

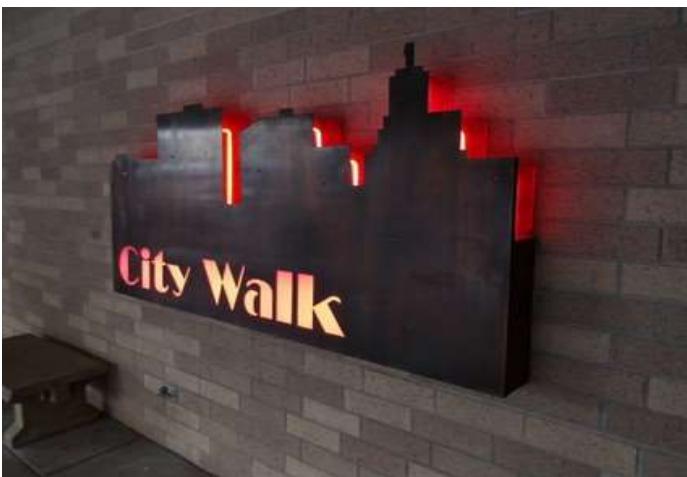
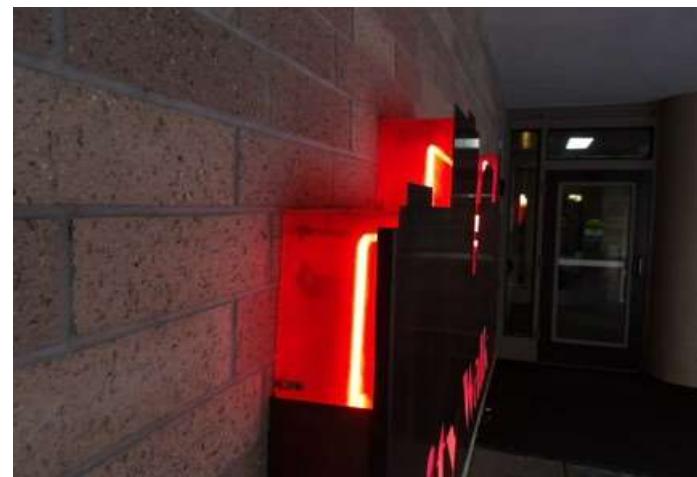
Illuminated sign at main entrance

Lighting detail

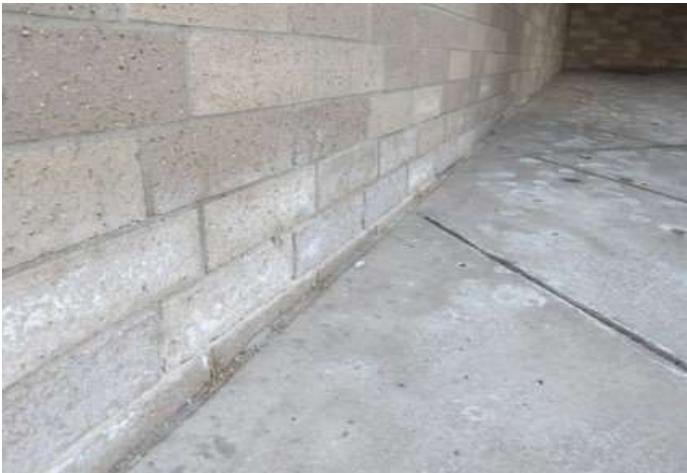
Evidence of water damage at porte cochere

Brick masonry is the primary cladding of the building. The masonry is in good overall condition and was last repaired in 2019. However, we still note isolated locations of cracks and deterioration. The masonry has a long useful life and should not require complete replacement. However, we include an allowance for partial repointing, isolated brick replacements, and isolated lintel replacements by 2031 and every 12 years after. Other entities are responsible for the concrete and masonry serving the commercial parking garage.

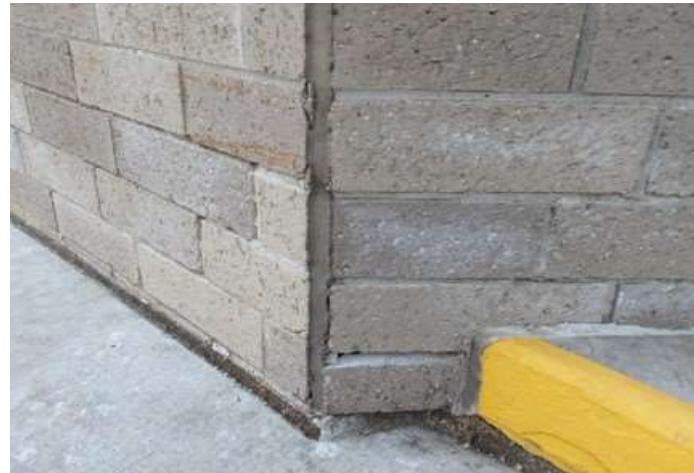
Mortar loss

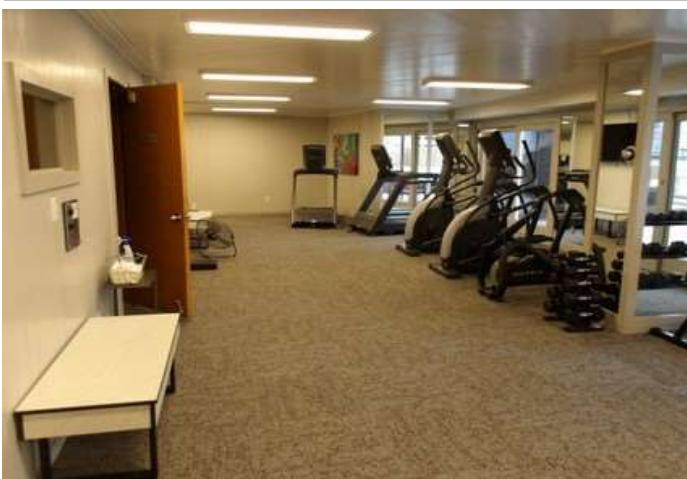
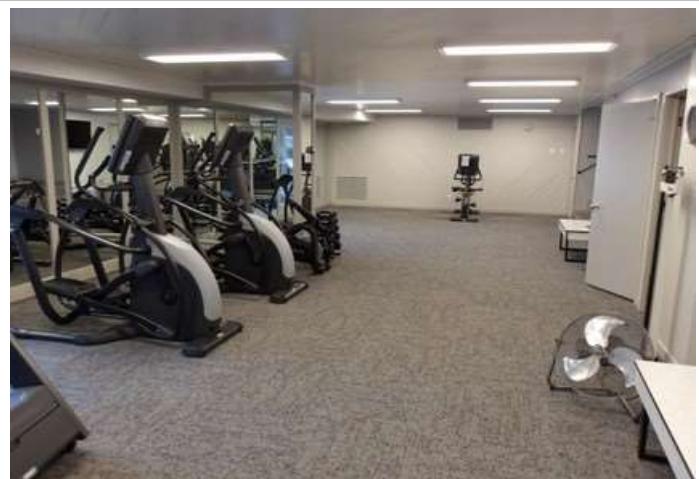
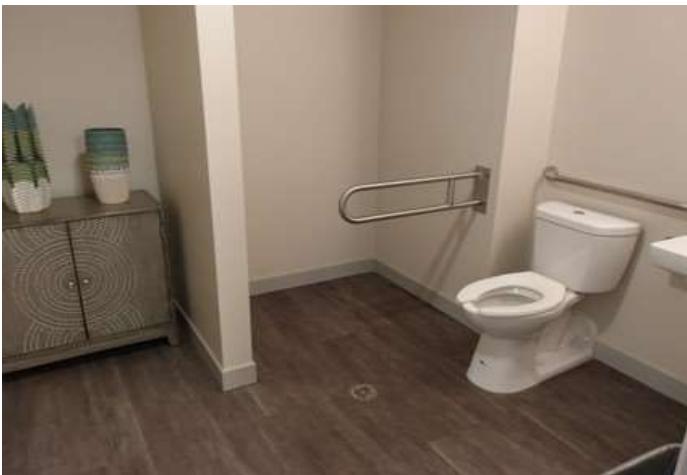
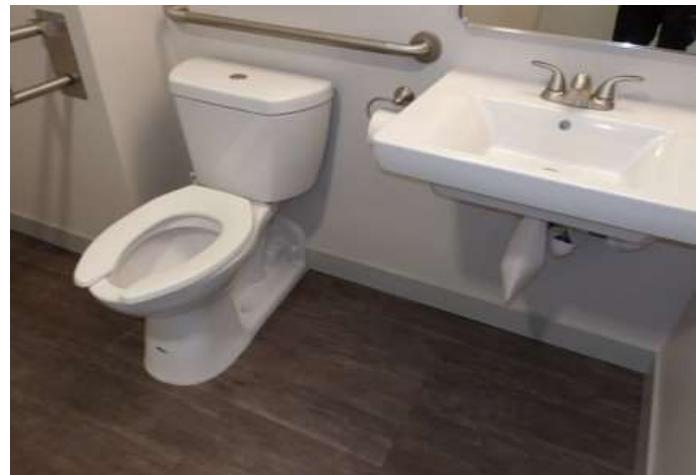
Fitness room overview

Fitness room finishes and lighting

Fitness room restroom

Plumbing fixtures detail

The association renovated the 12th floor fitness room and 2 adjacent restrooms in 2024. The finishes and fixtures appear in very good condition. We include an allowance for future renovations by 2044. Our cost is partially based on the association's historic cost. We discuss the exercise equipment previously in this report.

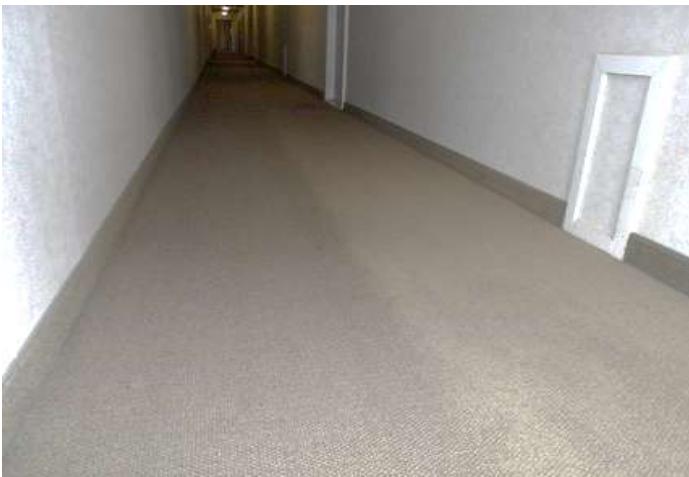
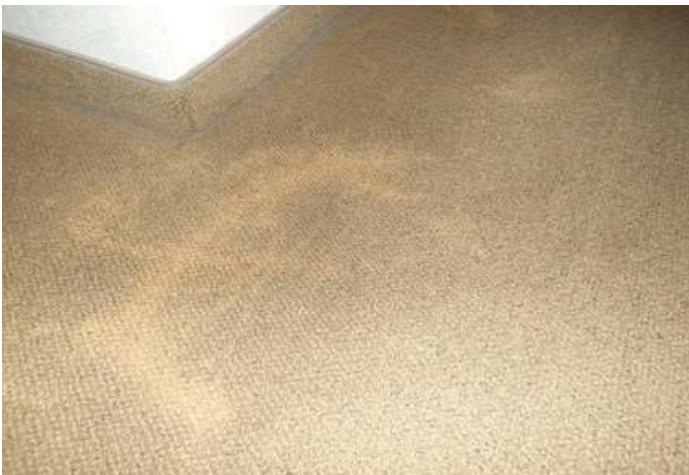
Carpet detail

Carpet stain

Engineering Narrative	
The carpet in the hallways dates to 2011 and appears in fair overall condition. We note locations of stains. At the direction of the board, we include an allowance to replace the hallway carpeting by 2026 and every 12 years after.

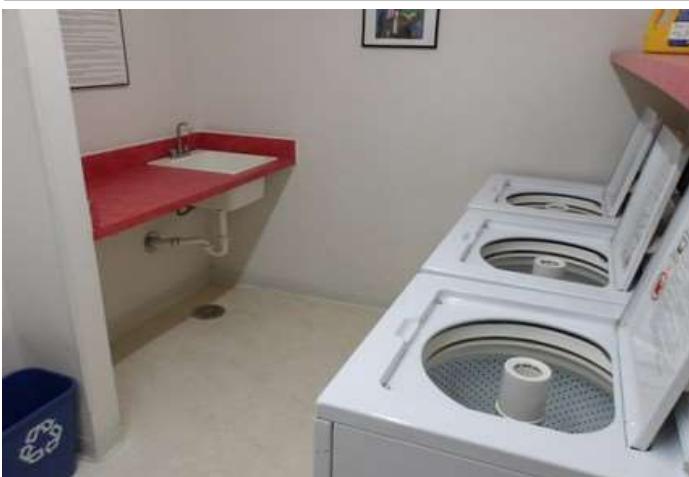
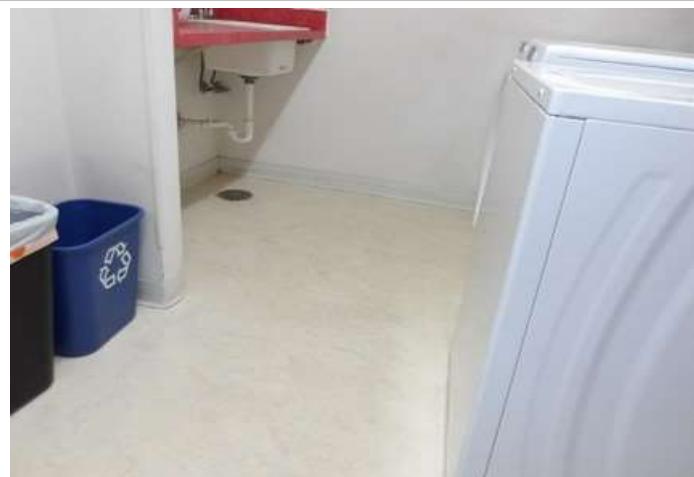
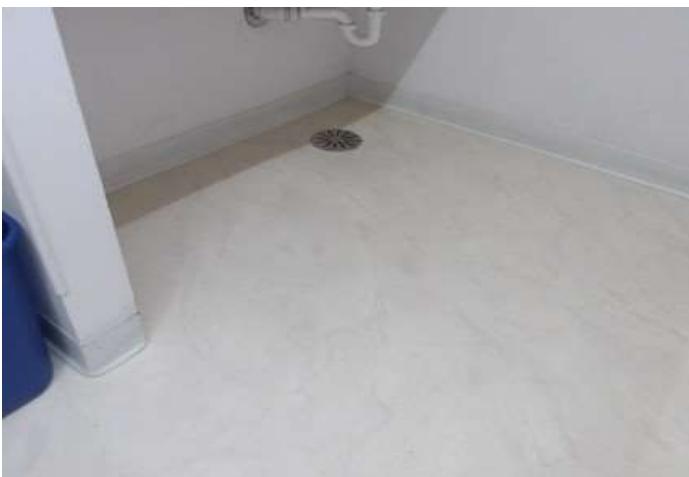
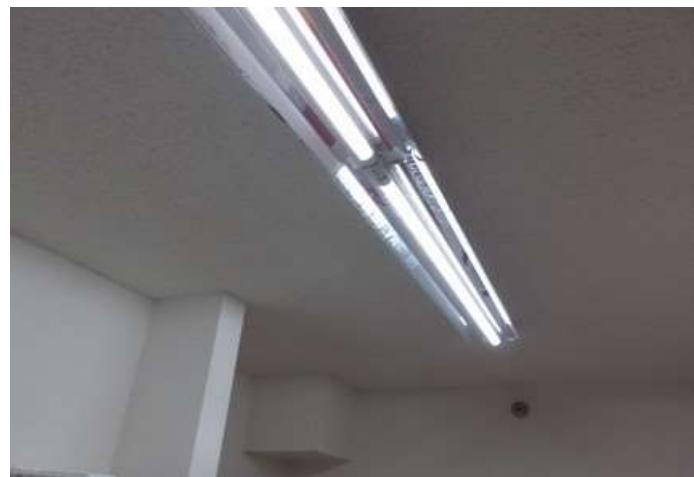
Laundry room overview

Resilient flooring

Flooring with drain

Laundry room lighting

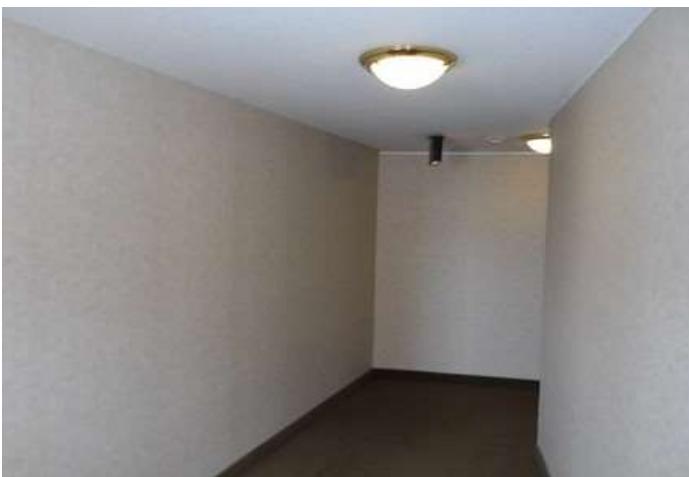
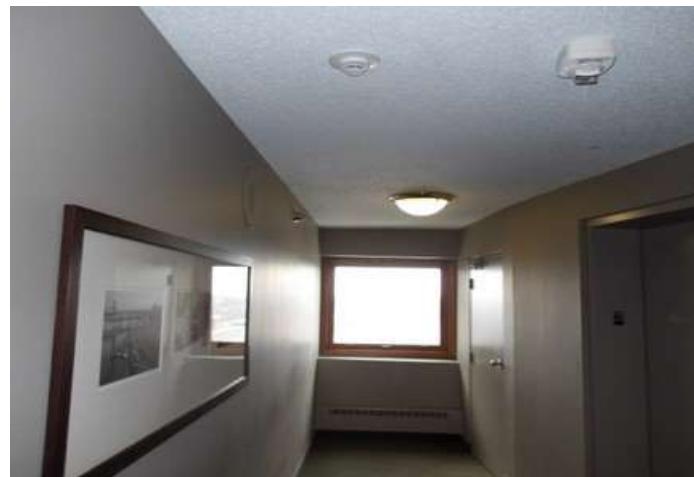
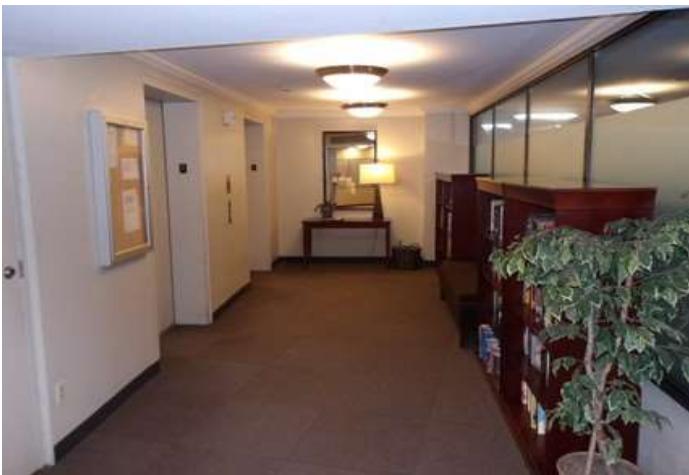
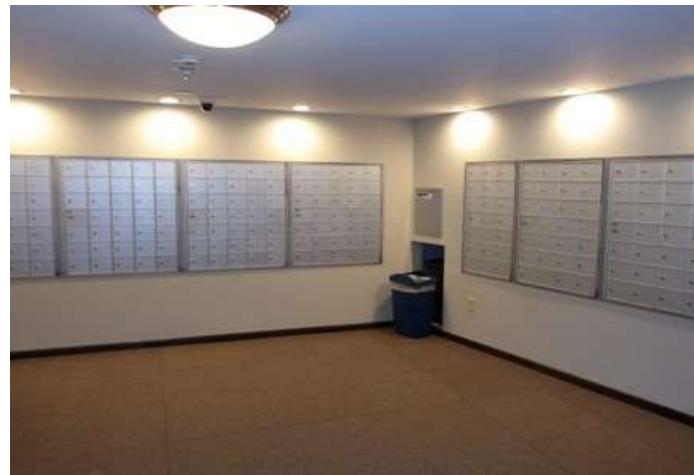
Hallway ceiling mounted light fixtures

Elevator lobby lighting

Recessed lighting at mail area

The light fixtures in the hallways and stairs are in fair overall condition. The ages of the light fixtures were not available at the time of inspection. We include an allowance for coordinated aggregate replacement of all the interior light fixtures next by 2038, in coordination with a hallway renovation project.

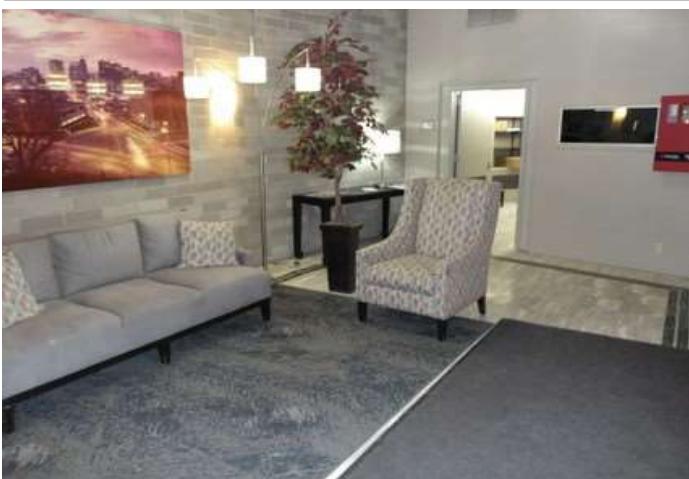
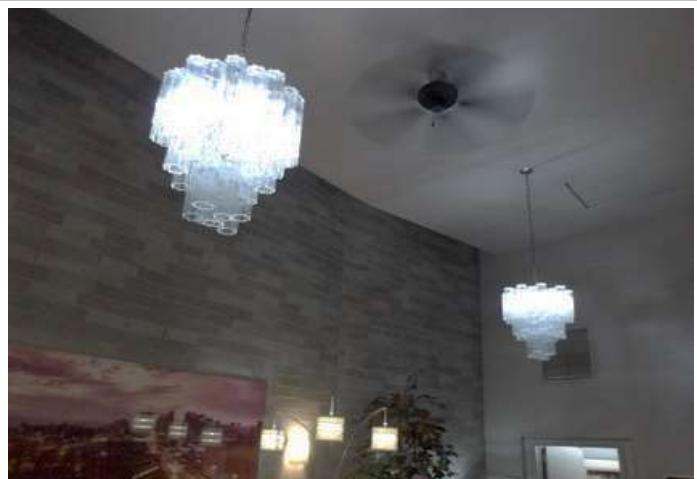
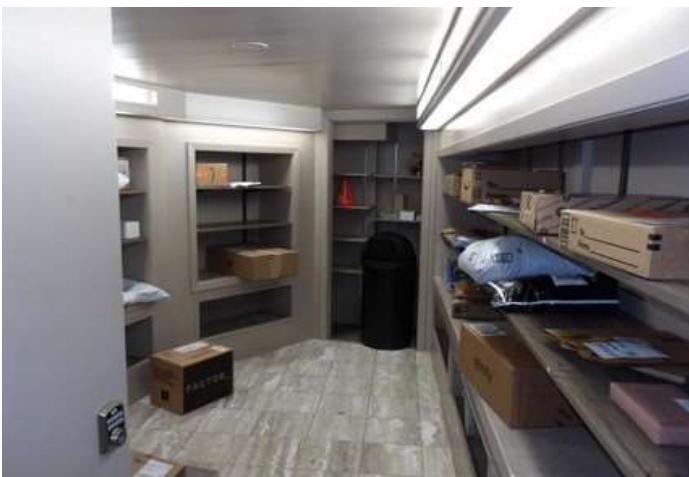
Lobby overview

Lobby lighting

Package room at lobby level

The lobby, package room and foyer appear in good overall condition. The association conducted a larger renovation project in 2018 and replaced the rug in 2024. The timing and cost of lobby renovations can vary dramatically based on the desires of the board. We recommend the association budget for a coordinated renovation project by 2040.

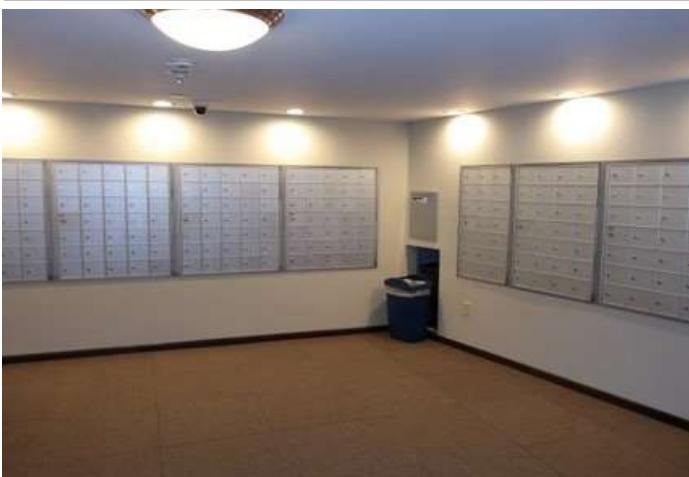
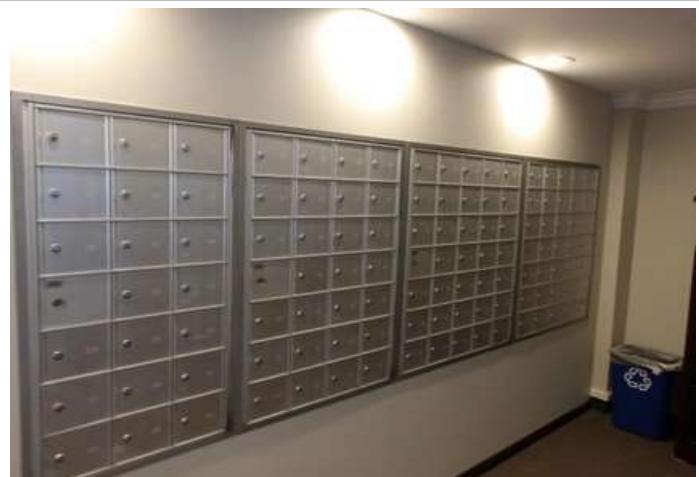
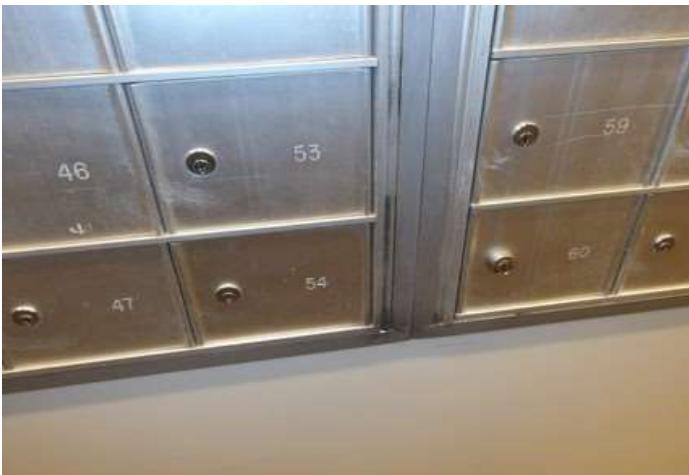
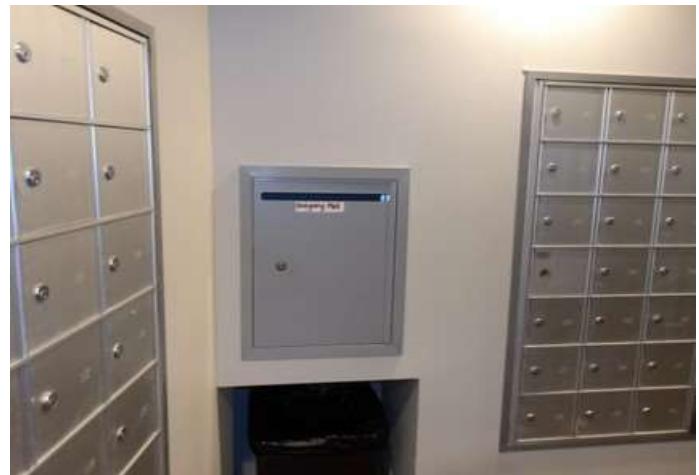
Mailbox overview

Unit mailboxes

Metal mailbox detail

Outgoing mailbox

Engineering Narrative	
The unit mailboxes are located in the skyway lobby at the 3rd floor. The mailboxes appear in fair condition. We include an allowance to replace the mailboxes by 2038.

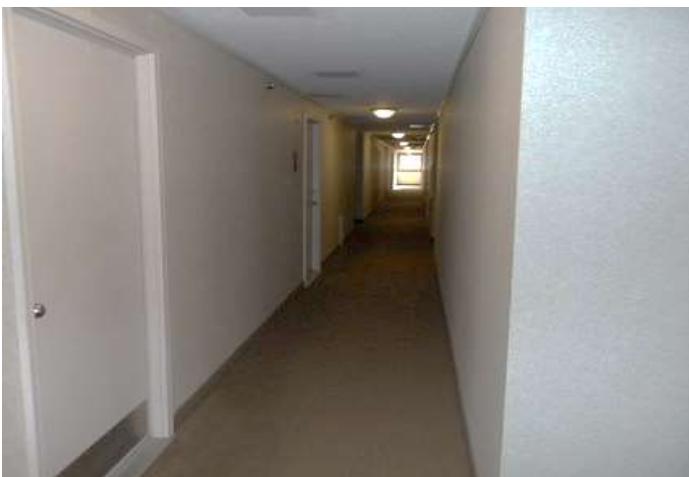
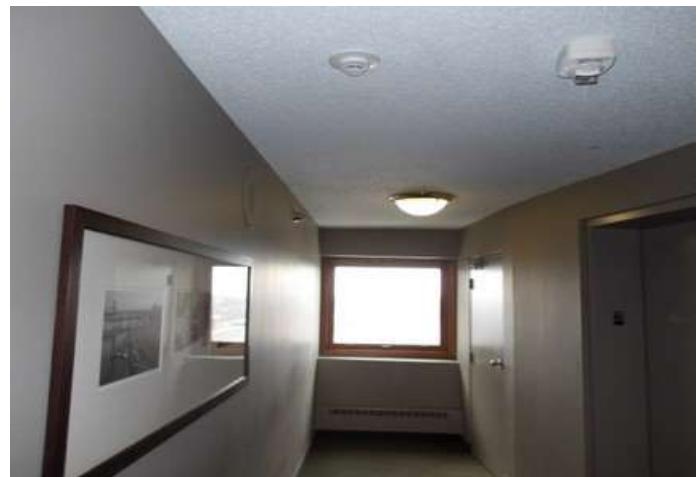
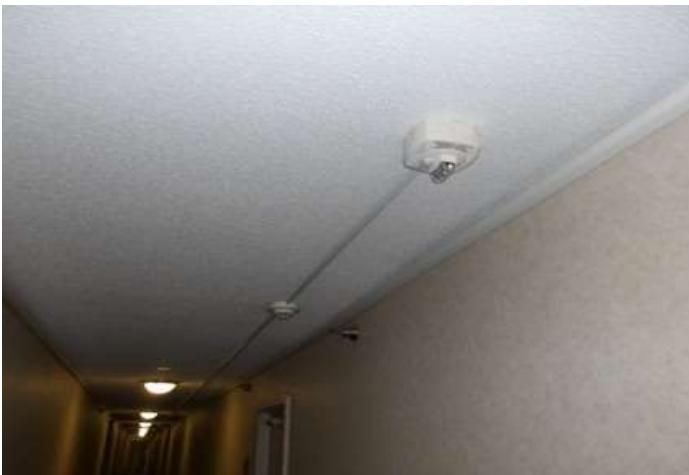
Typical hallway finishes

Painted ceiling

Engineering Narrative	
The paint finishes in the hallways are primarily located at the ceilings. The finishes may be original to construction. The finishes are in good to fair overall condition. We include paint finishes next by 2038.

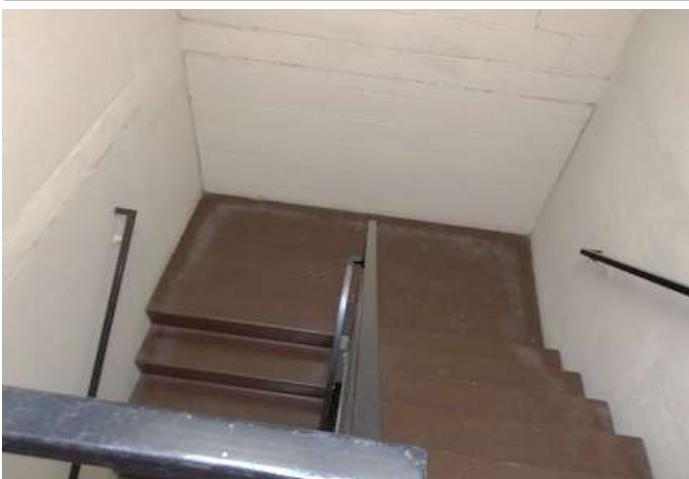
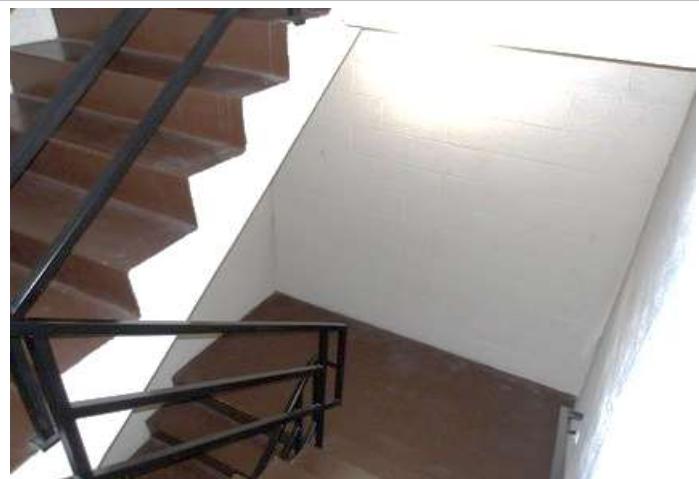
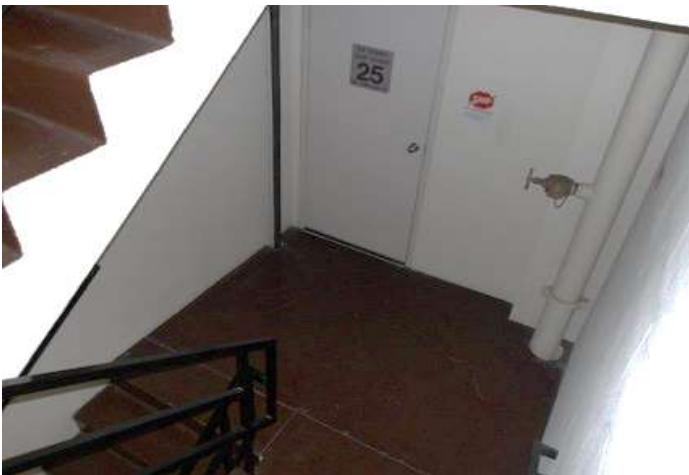
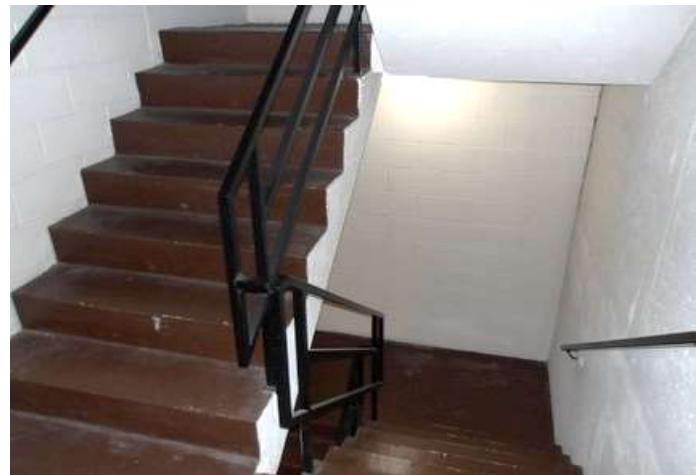
Typical stairwell finishes

Painted walls, floors and railings

Painted walls, floors, railings and ceilings

Engineering Narrative					
The paint finishes in the stairwells appear in fair condition. The useful life of paint finishes in these lesser-used areas is from 15-20 years. We include allowances for paint applications by 2028 and again by 2048. The association should fund touch up paint applications through the operating budget as needed.

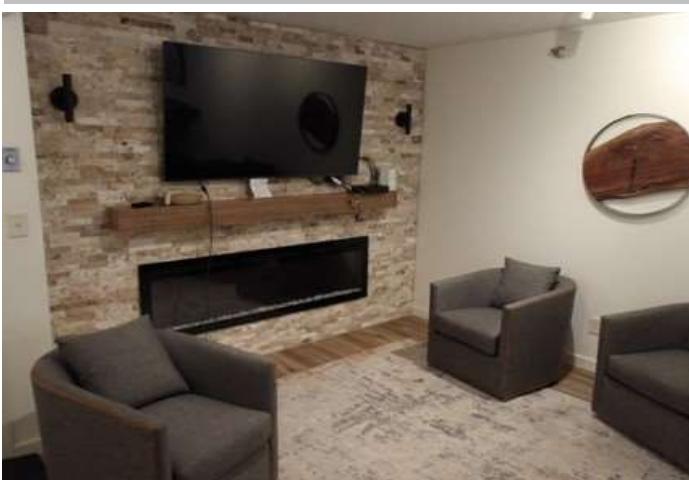
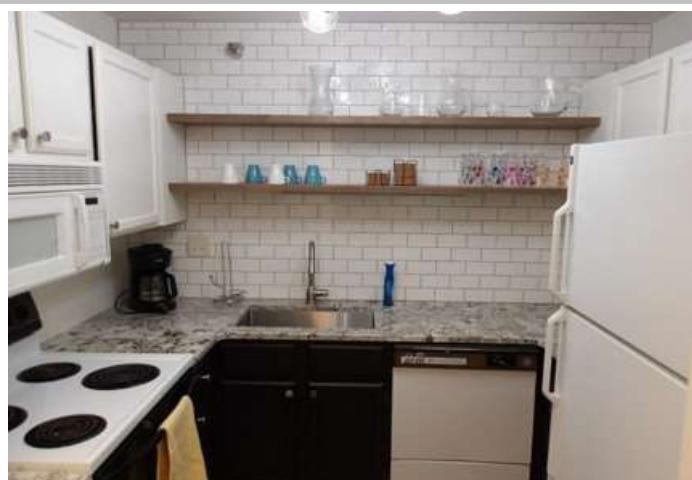
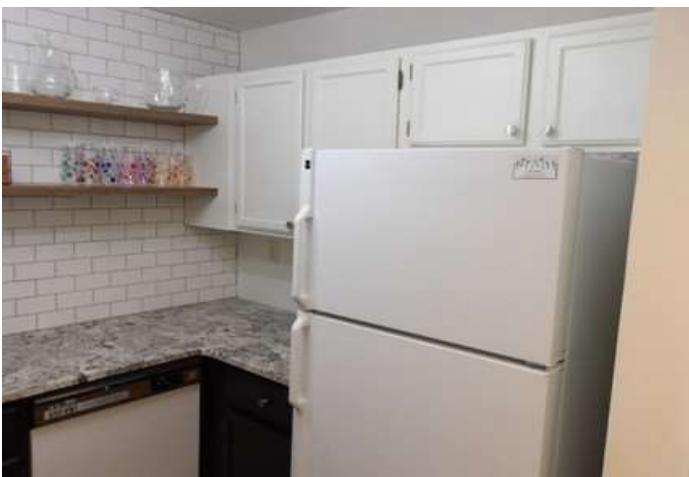
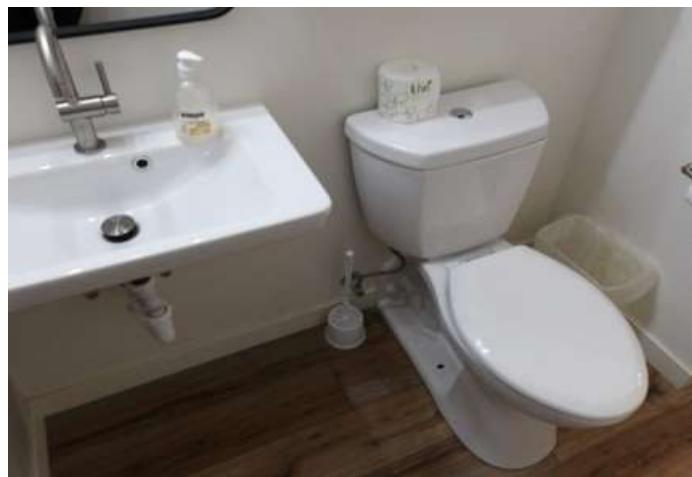
Party room furniture

Party room kitchen

Kitchen appliances and casework

Party room restroom plumbing fixtures

A common party room is located on the 12th floor adjacent to the pool plaza. The finishes, fixtures and furnishings partially vary in age, though many date to 2022 and appear in good condition. Renovation of the party room (restroom and kitchen) is largely driven by aesthetic concerns. At this time, we include an allowance for renovations by 2042. Updates to this study will consider the timing and costs of these expenditures.
