RESERVE STUDY

**City Walk Condominium Association
66 9th Street East
St Paul, MN**

Date of Inspection: December 3, 2024

Revision #2: September 3, 2025

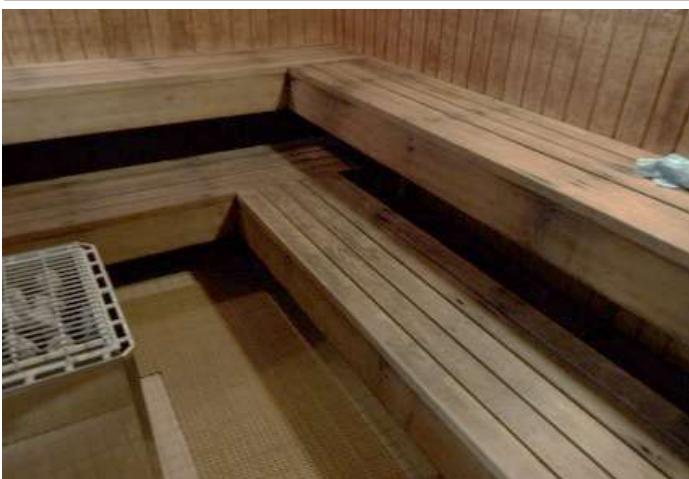
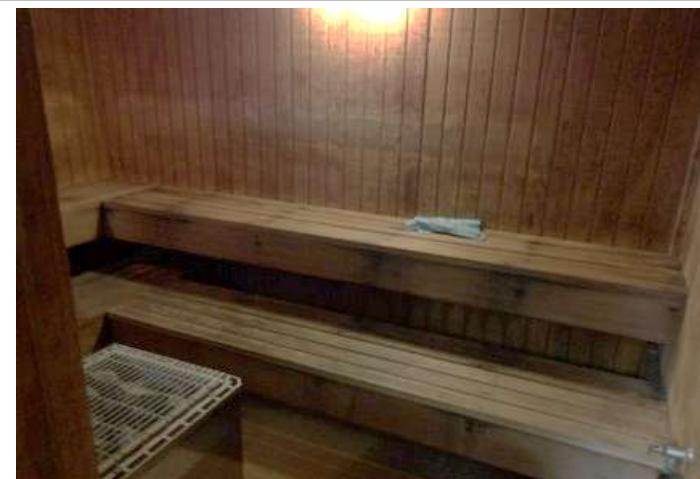
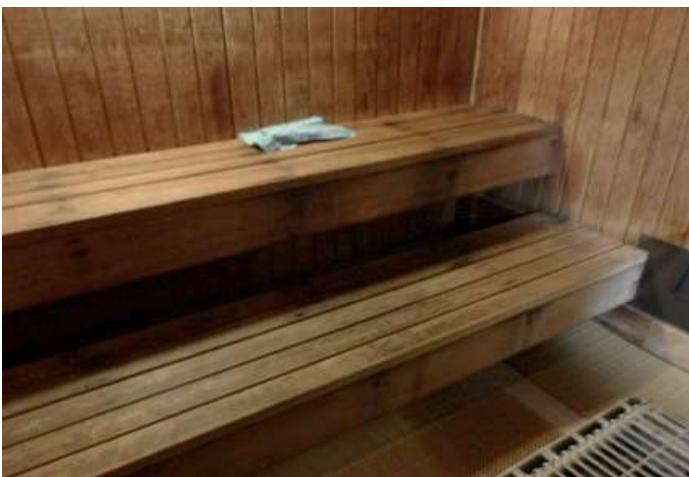
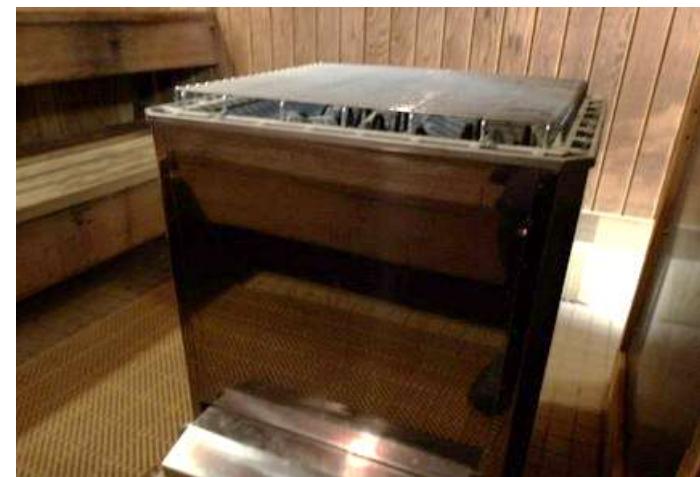
Sauna benches

Sauna

Wood seating

Sauna heater

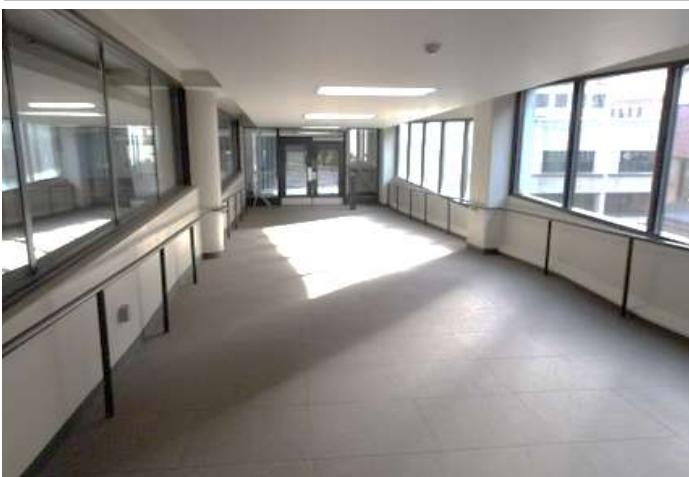
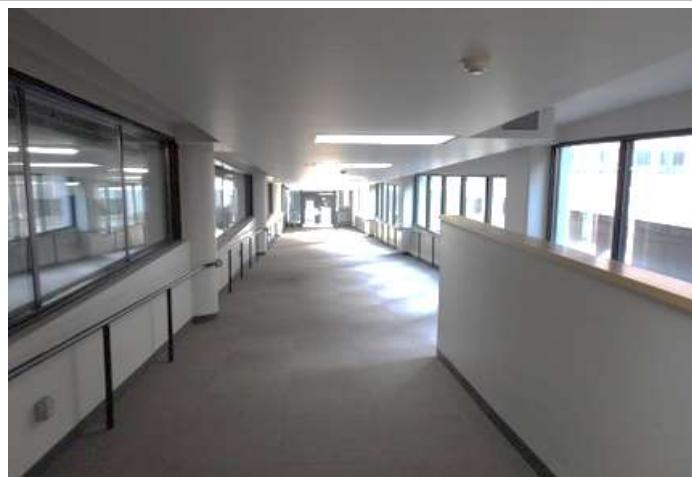
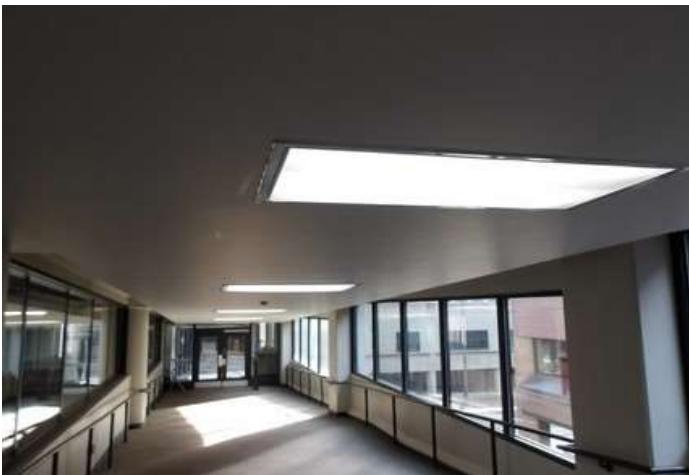
Shared skybridge atrium

Skybridge atrium finishes

Shared skybridge atrium lighting

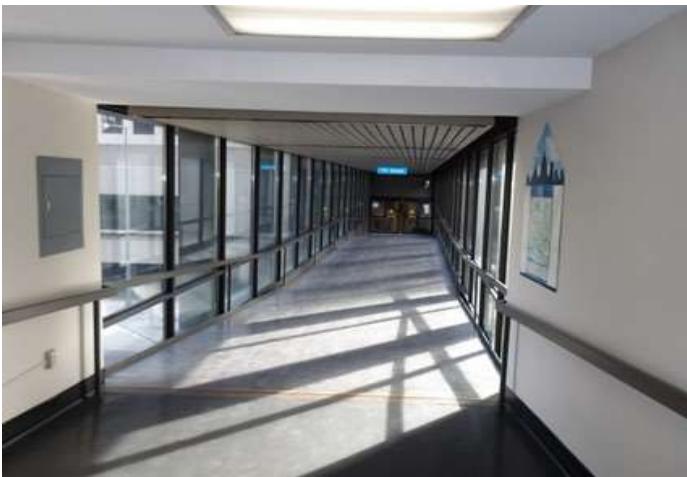
Skyway overview

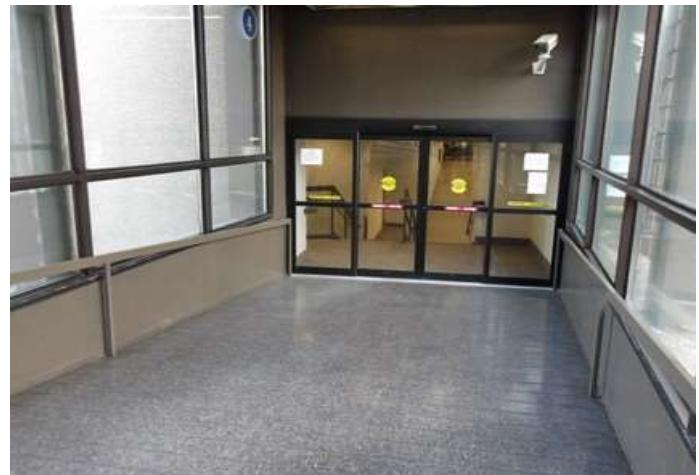
Terrazzo flooring

The finishes and fixtures in the 7th Street skyway include terrazzo and resilient floor coverings, paint finishes and strip light fixtures. These components appear in good to fair condition. We include an allowance to replace the resilient floor coverings, paint finishes and light fixtures by 2032 and again by 2052. We do not anticipate the need to replace the terrazzo flooring during the next 30 years.

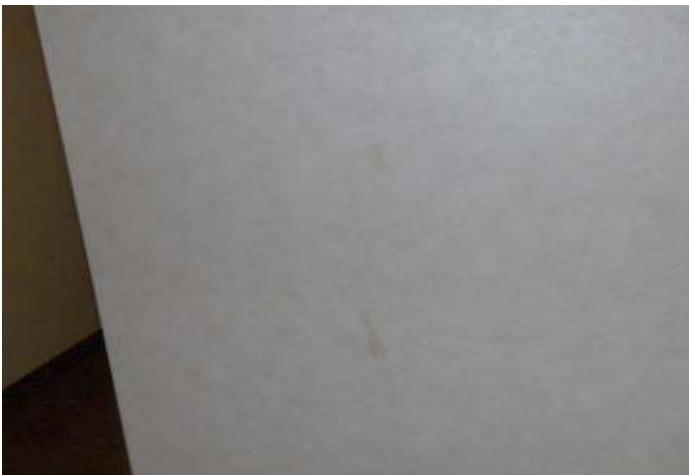
Stains at wall covering

Engineering Narrative				
The wall paper in the hallways appears in fair to poor condition and reportedly was replaced over 20 years ago. We include an allowance to replace the wall coverings by 2028 and again by 2052, in coordination with other hallway renovation projects.

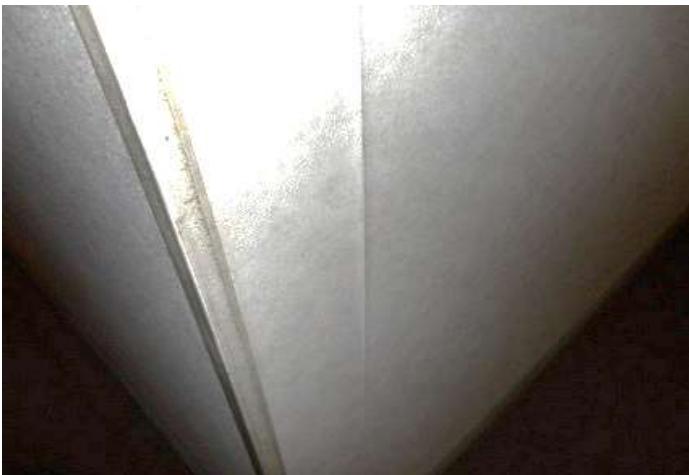
Loose seam near corner

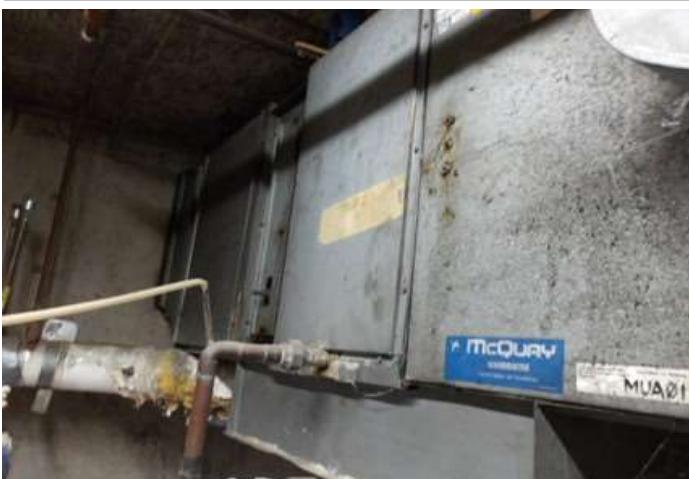
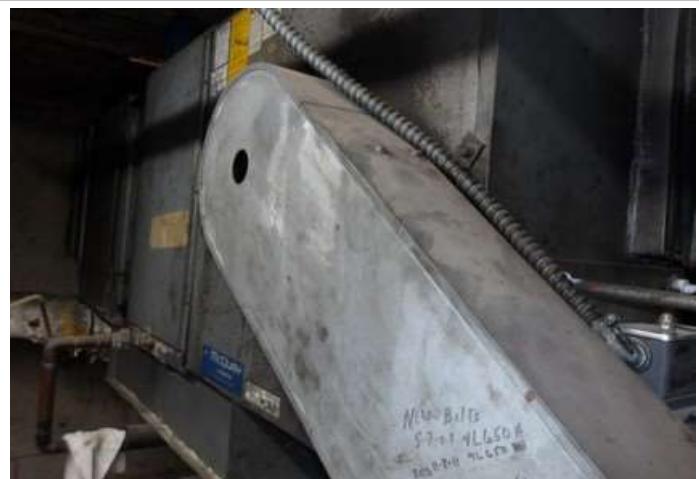
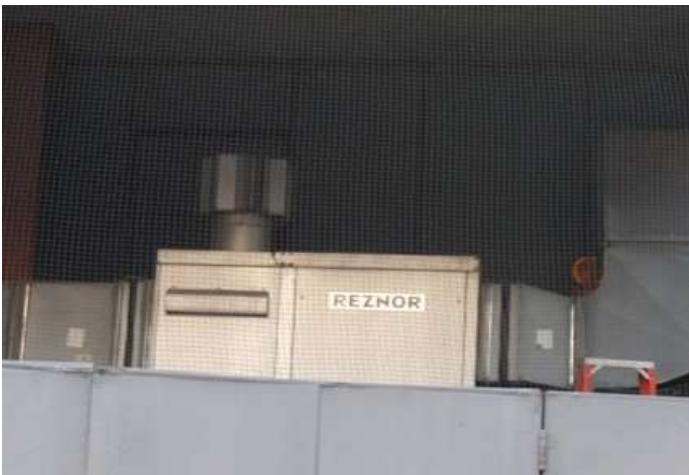
Hallway air handling unit

Lobby make up air unit

1 make up air handling unit is mounted to the ceiling in the mechanical penthouse and serves the hallways. This unit is original to construction. A separate air handling unit serves just the lobby and was added in 2021. The units bring in outside fresh air, and tempers it by passing over pipe coils with either hot or cold water. We include an allowance to replace the hallway unit by 2029 and the lobby unit by 2047.

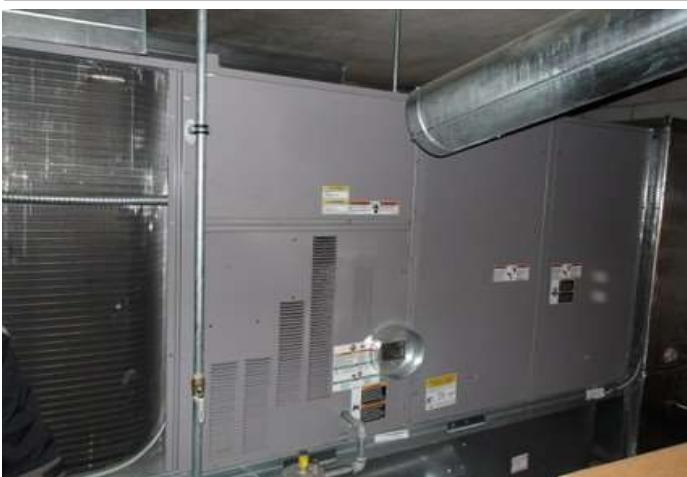
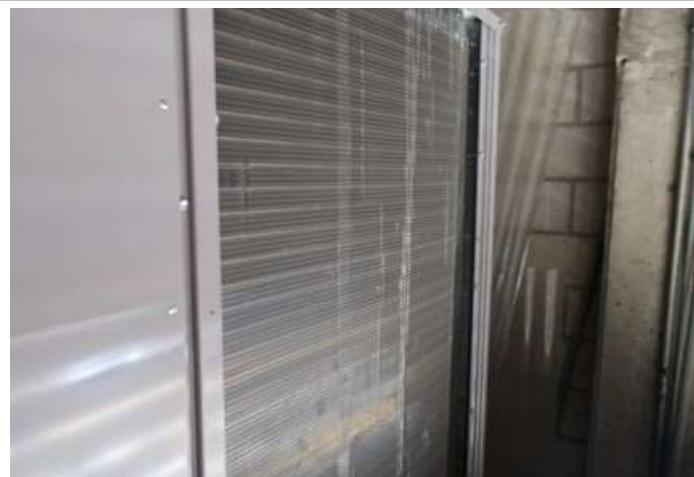
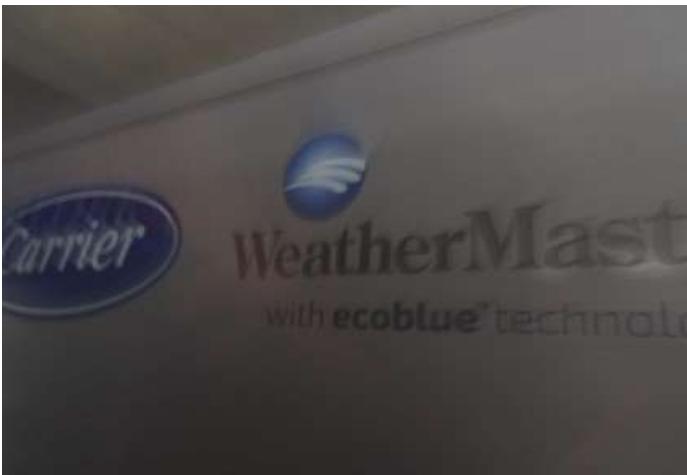
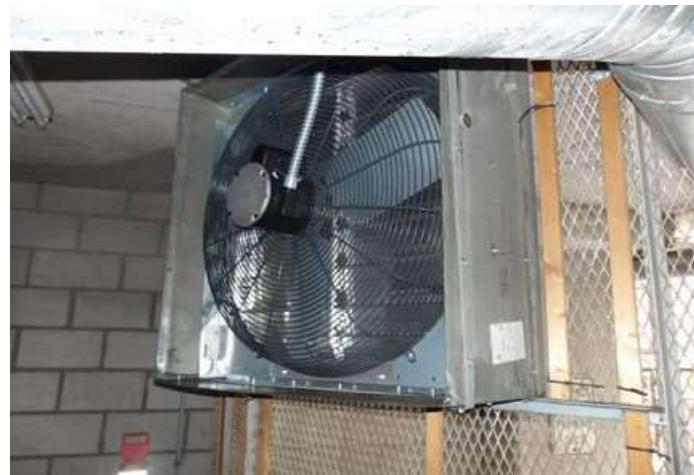
Packaged heating and cooling unit

Fins at packaged unit

Engineering Narrative	
A packaged air handling unit (RTU) provides heated and conditioned air to the skyway and skybridge atrium. The RTU has a cooling capacity of 12.5-tons. The RTU is in very good condition and dates to 2024. We include an allowance for replacement of the RTU next by 2046. Our unit cost reflects the shared nature of this component. We base our cost of replacement on the association's historic cost.

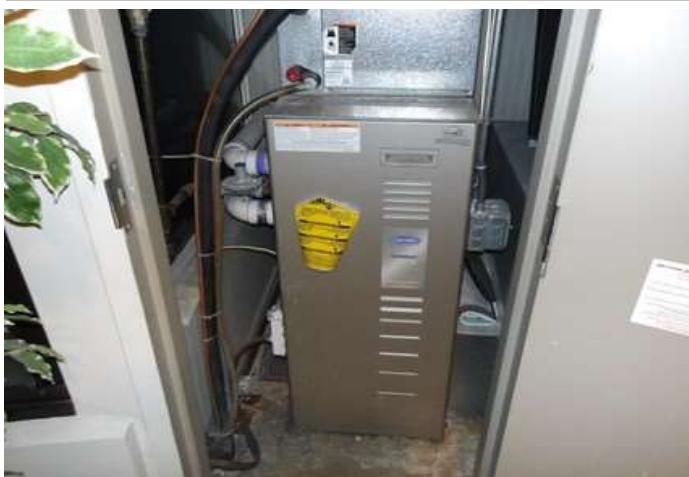
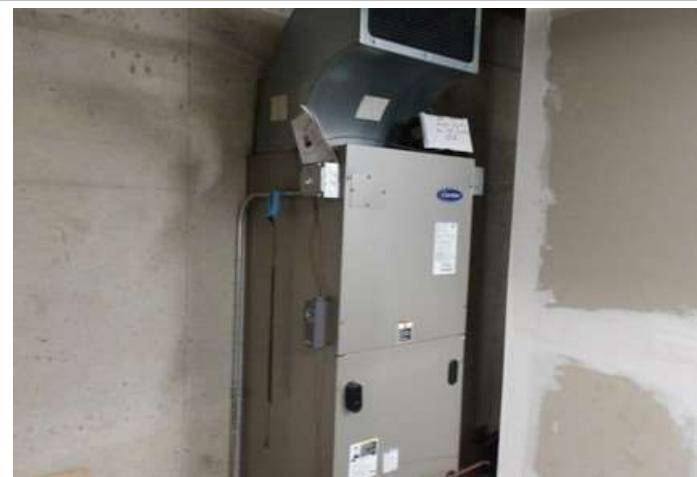
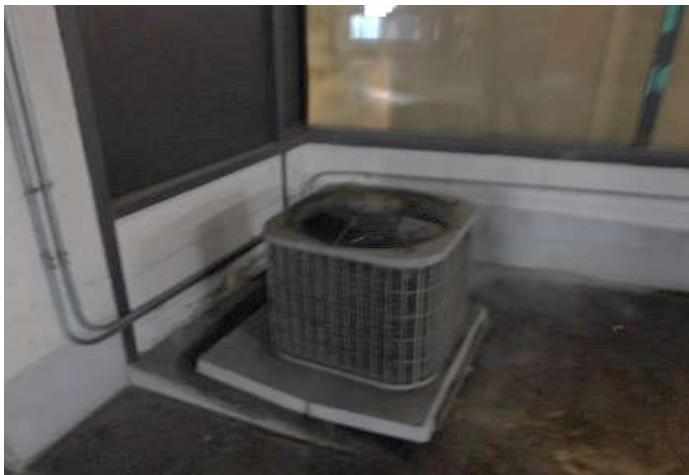
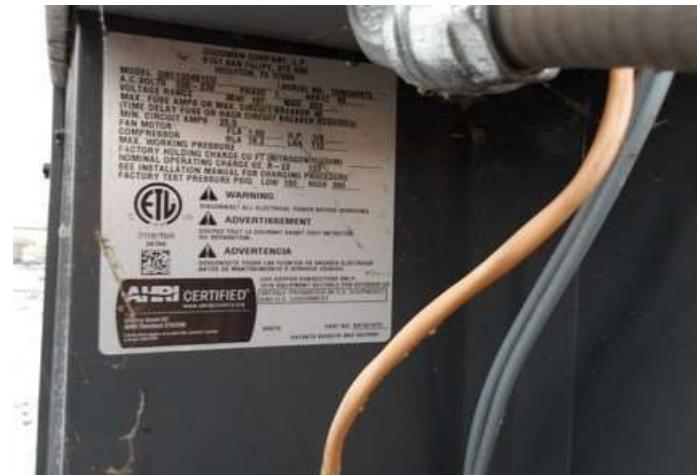
3rd floor lobby air handling unit

Elevator control room air handling unit

3rd floor lobby condensing unit

Engineering Narrative					
1 split system with a cooling capacity of 2.5 tons serves the mailroom and dates to 2021. Another split system with a cooling capacity of 4 tons serves the elevator control room and dates to 2009. A split system includes an exterior condensing unit and an interior air handling unit/furnace. We recommend replacement of the elevator control room system by 2028 and again by 2048. We recommend replacement of the mailroom system by 2041.

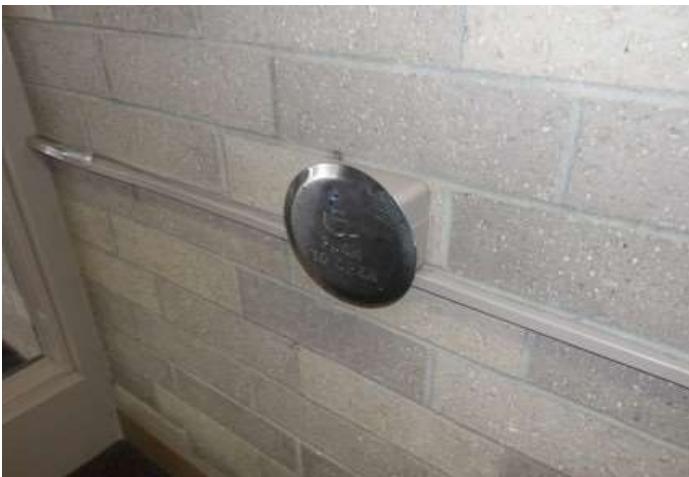
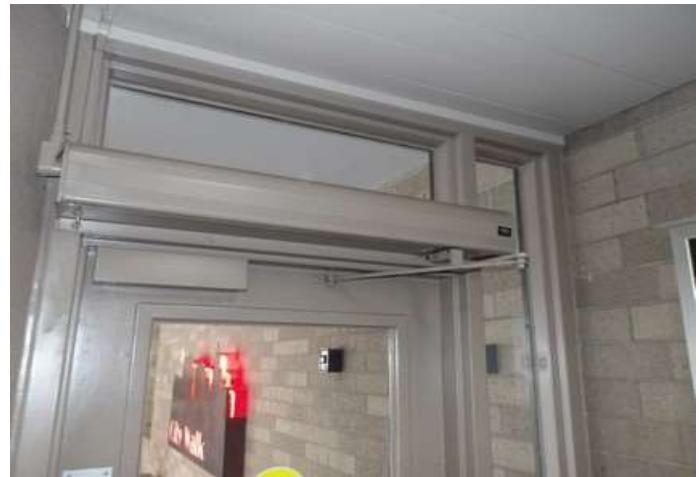
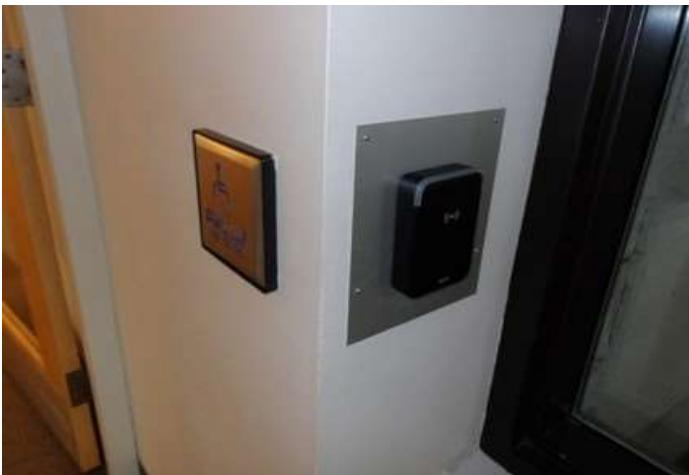
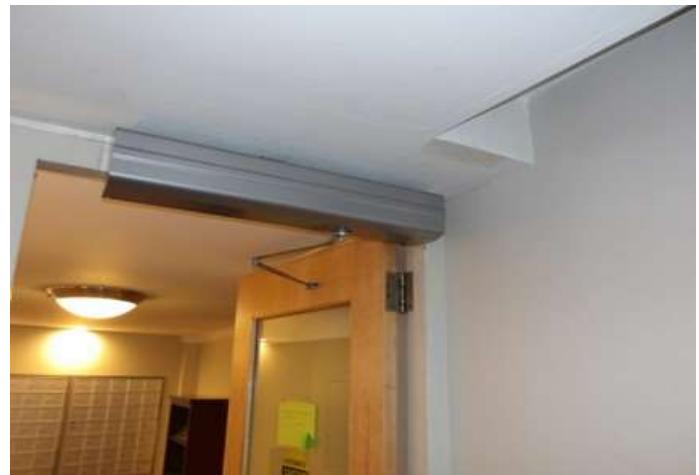
Door switch

Lobby door operator

Engineering Narrative					
The association owns 2 automatic door openers at the lobby, 1 at the mailroom and they share ownership of 1 at the skybridge shared atrium (shared with MPR). The ages of these components were not available at the time of inspection; they appear in satisfactory operational condition. We recommend replacement of the operators and switches by 2036. Our unit cost reflects the shared nature of 1 of the openers.

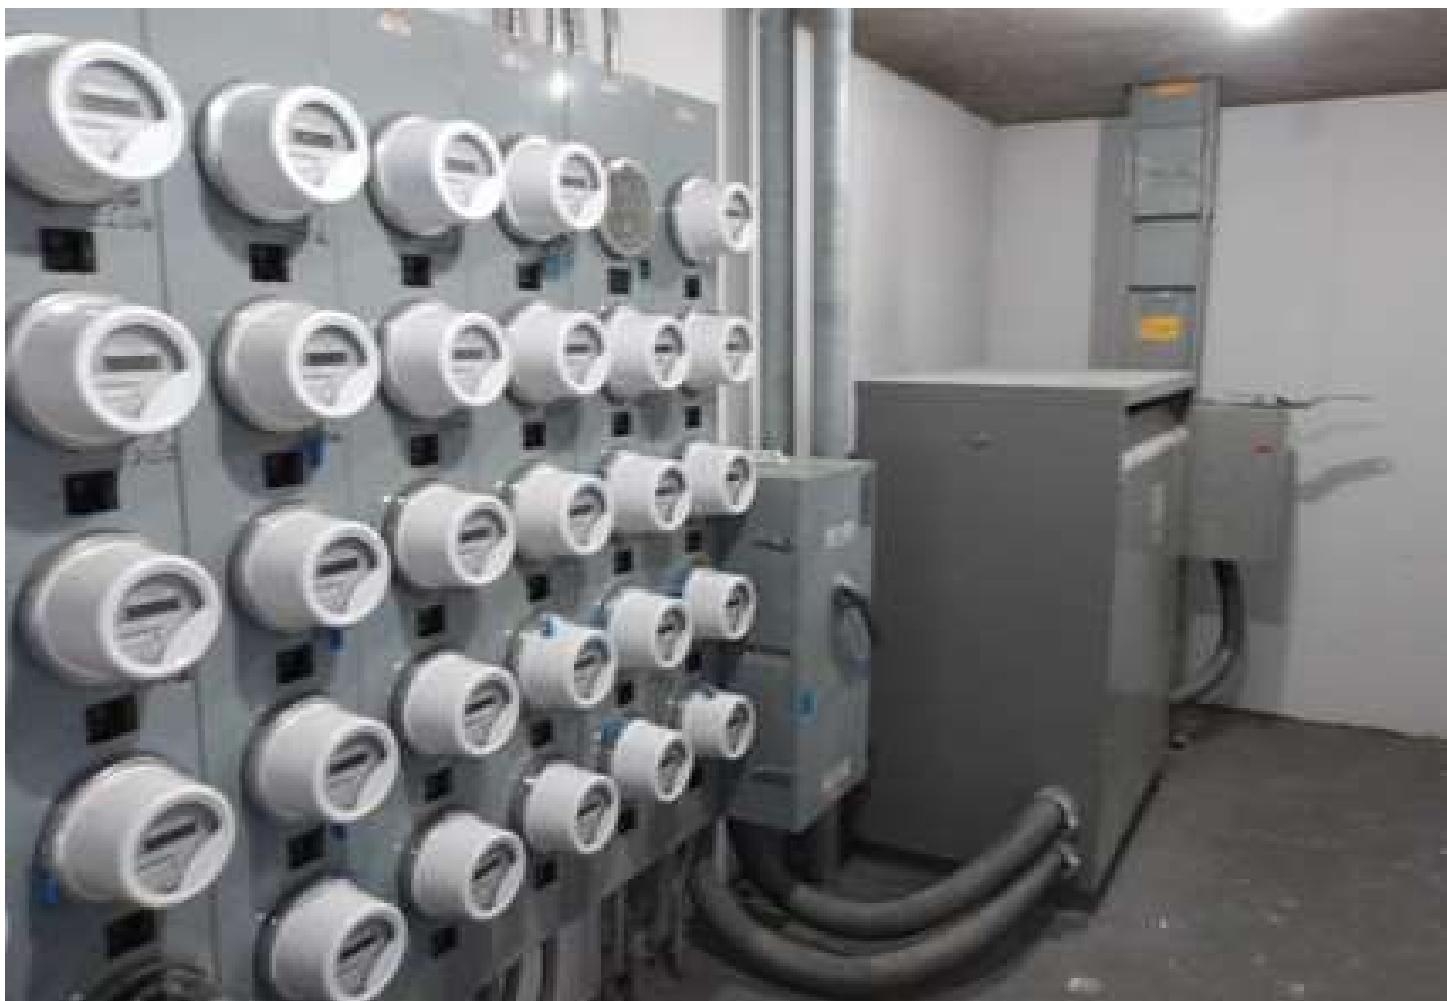
Typical meter room with transformer

Engineering Narrative				
The common electrical system components are primarily original to construction and are reported in satisfactory condition. The client does not report a history of service disruptions or electrical fires. Inspections of the electrical systems are beyond the scope of our non-invasive analysis. We include an allowance to perform infrared thermoscans and repairs to the common electrical components by 2029 and every 12 years after. Updates to this study will consider the findings of any invasive inspection.

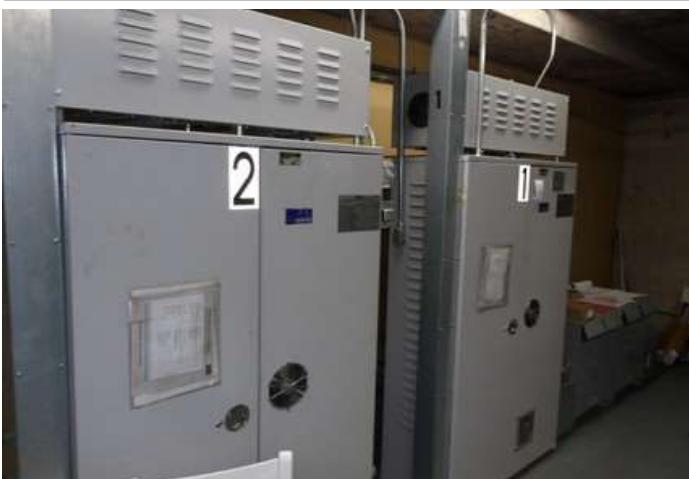
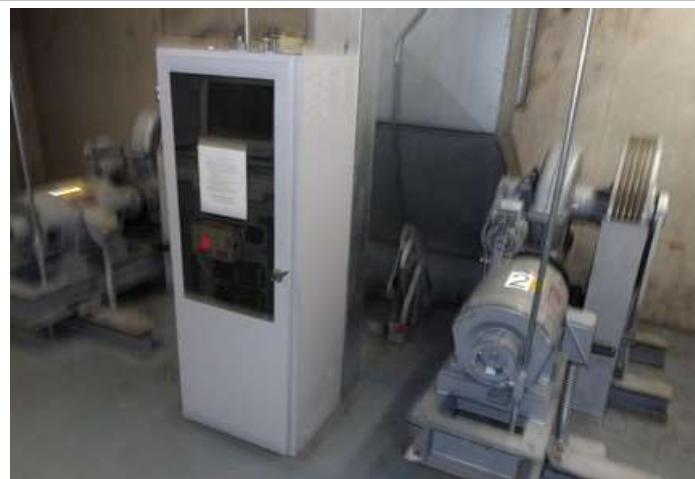
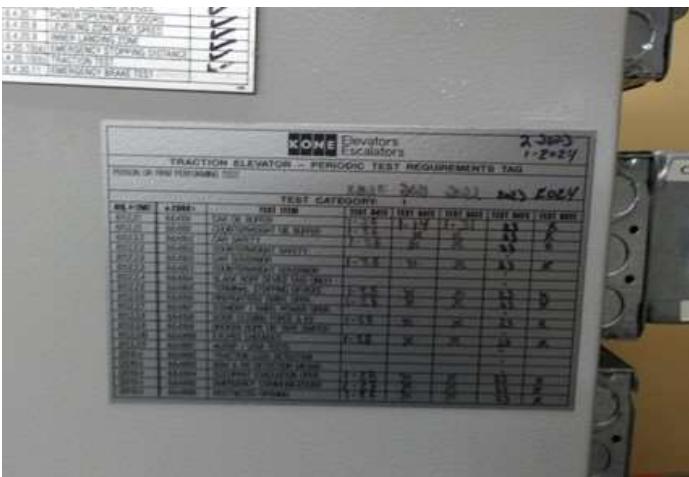
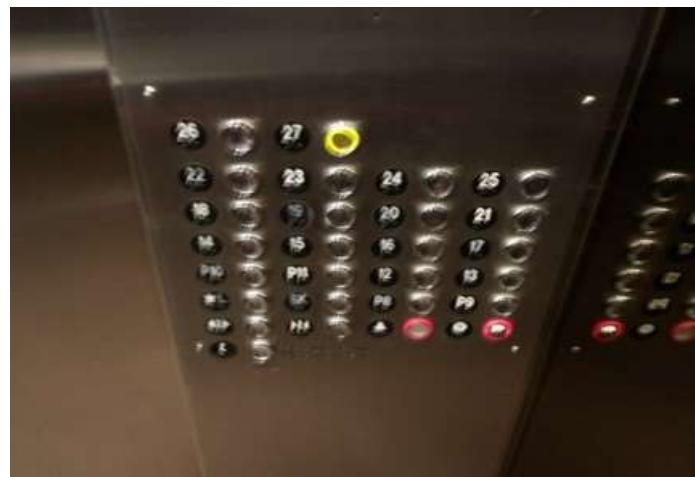
Elevator controls

Elevator hoist and controls

Engineering Narrative	
The elevator controls were reportedly updated in 2006. Modernization cost includes elevator controllers, selector systems, machine encoders, door operators, car operating panels, car governors, fire service/emergency features, and wiring at cars, hoistway, and equipment room. Modernization is recommended by 2040.

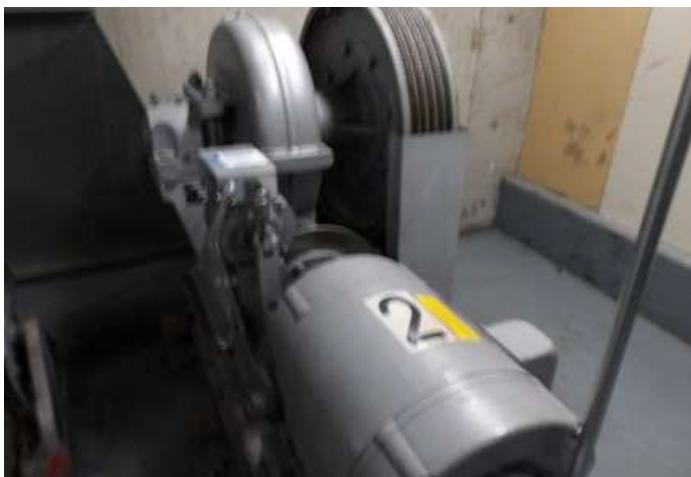
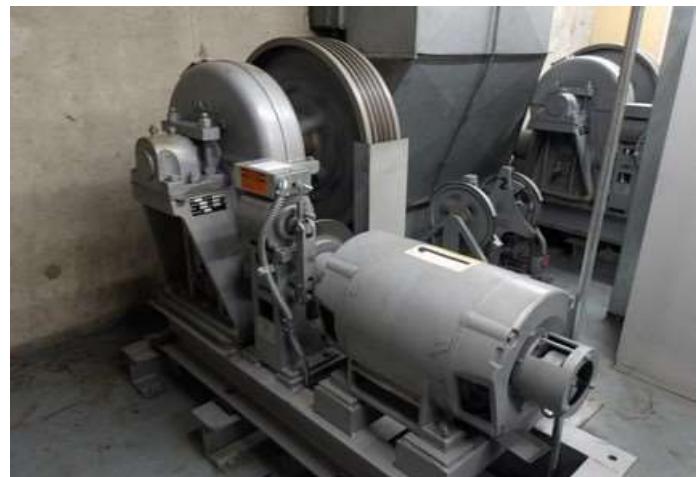
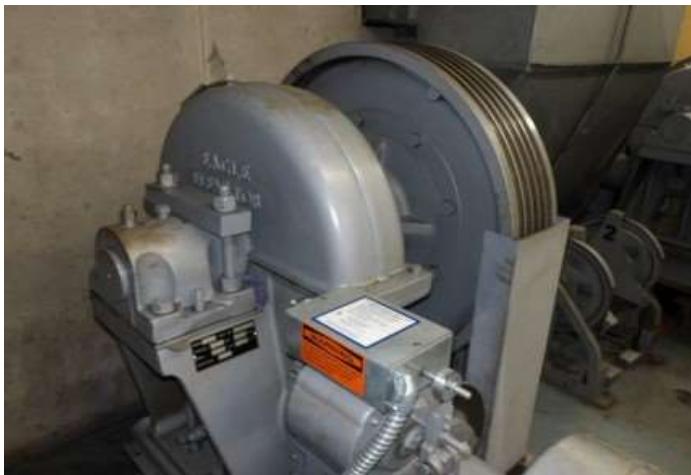
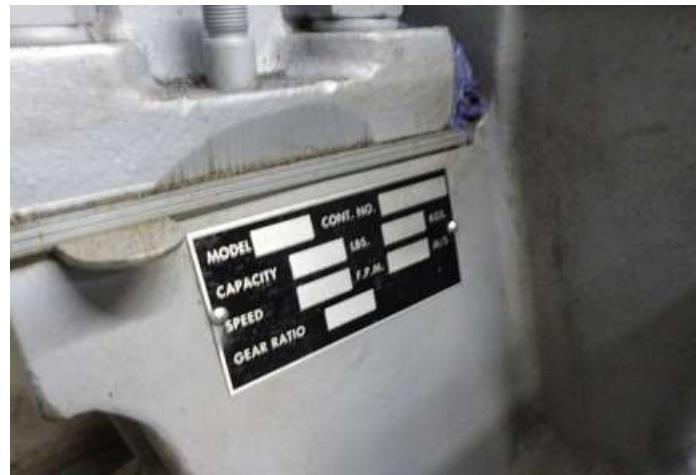
Hoist and motor

Hoist and sheave

The elevator machines (hoists and motors) reportedly date to original construction. Based on age, we include replacement by 2035. This report should be updated with recommendations from qualified elevator contractors and consultants.

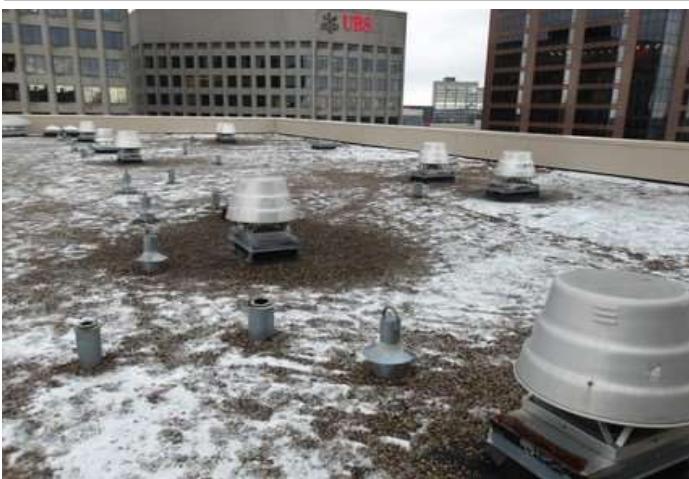
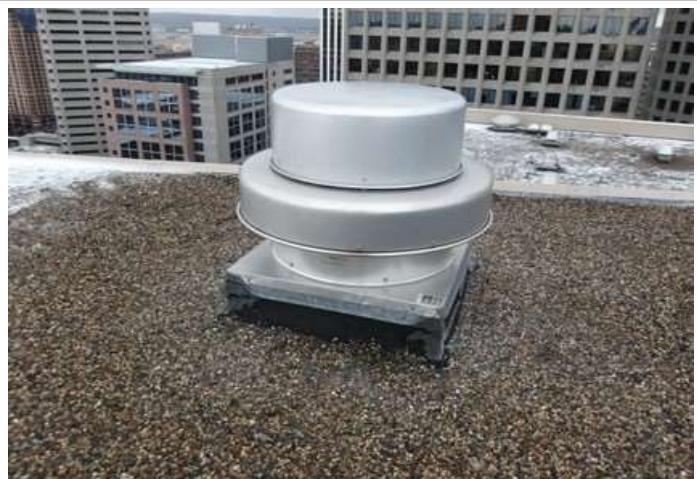
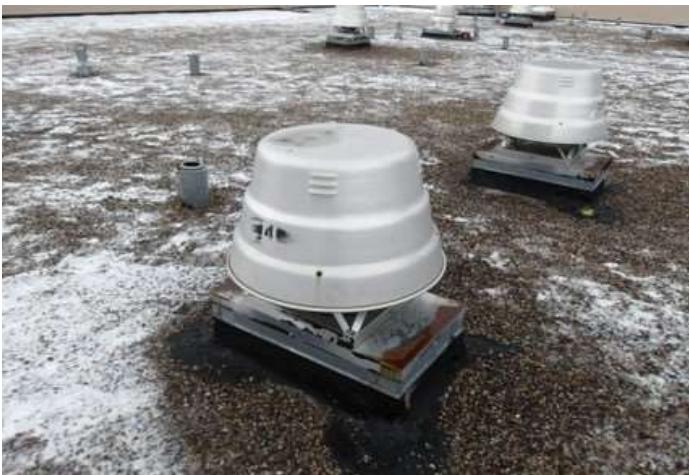
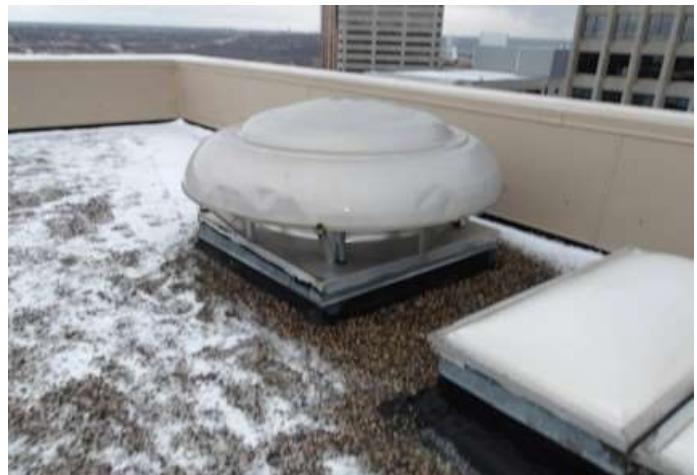
Rooftop exhaust fans

Downblast exhaust fan

Stairwell fan

Exhaust fans serve the kitchens, bathrooms, laundry rooms and stairs. The fans appear to vary in age and style. Based on their varying ages, we recommend the association budget to replace up to 1/6th of the fans by 2027 and every 3 years after. The association should fund interim motor and belt replacements through the operating budget.

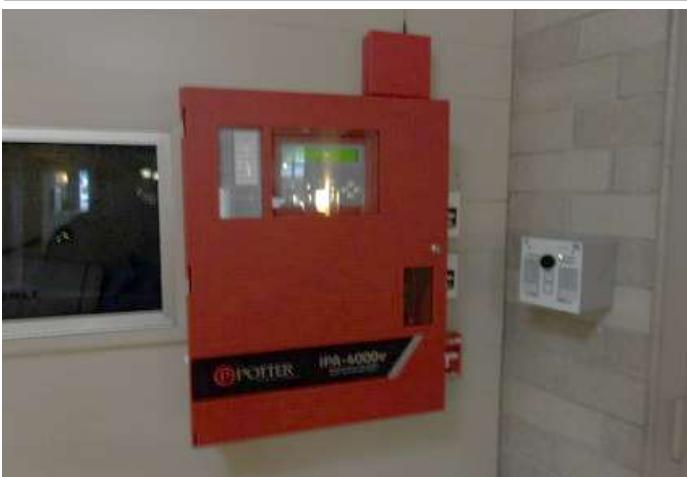
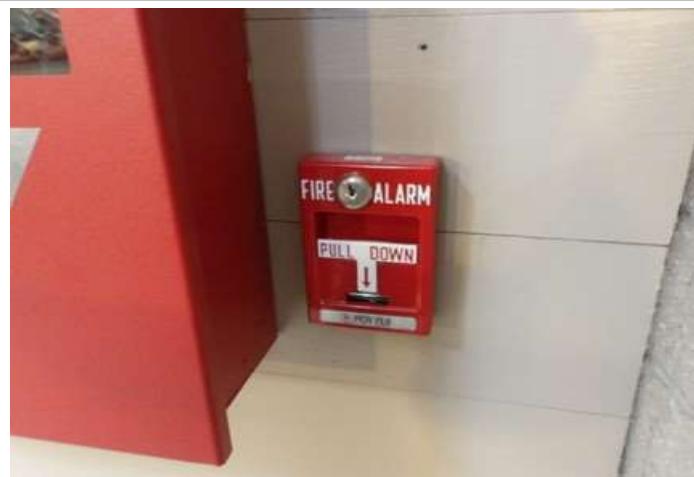
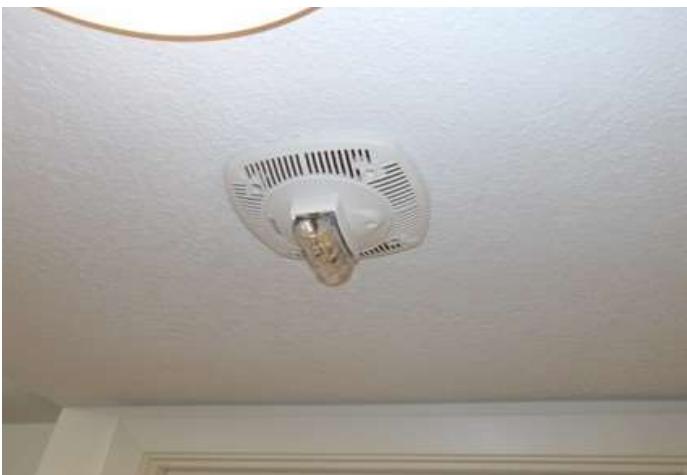
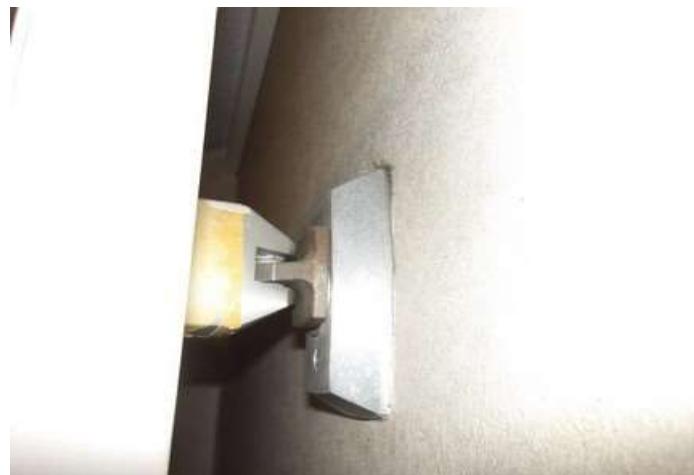
Fire alarm control panel

Manual pull station

Horn / strobe fixture

Door magnet

The fire detection system includes the control panel (located in the lobby), 223 smoke/heat/CO detectors, 1 pull station, 16 magnetic door holders and 509 horn/strobes/speakers. The panels and devices date to 2023 and are in very good condition. The panel can likely be repaired to extend its life. However, sourcing replacement parts will likely become increasingly difficult. Additionally, changes to building codes may prompt the need for replacement. We include an allowance for replacement of the panel and devices by 2047. We partially base our cost on the association's historic cost.

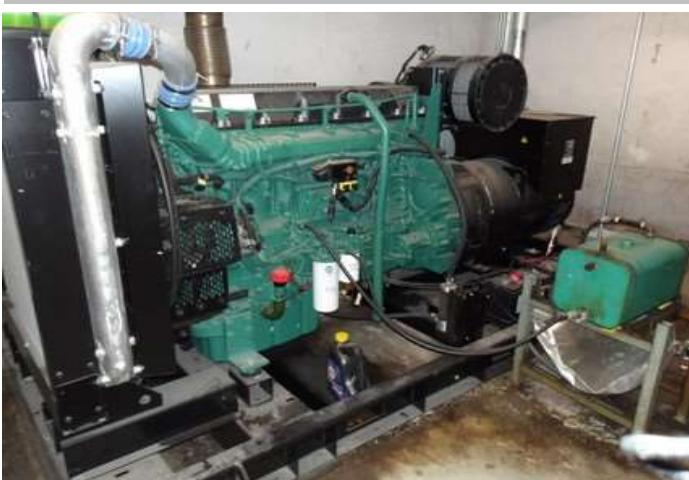
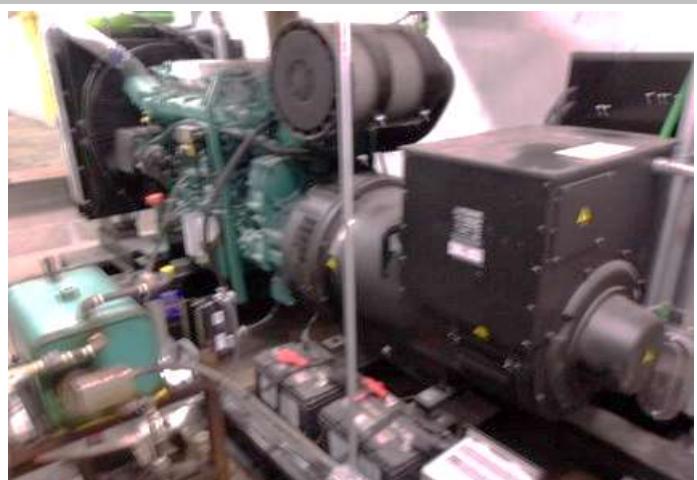
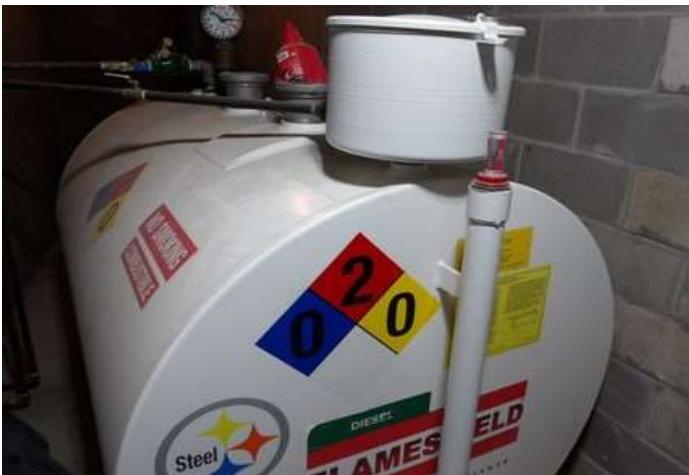
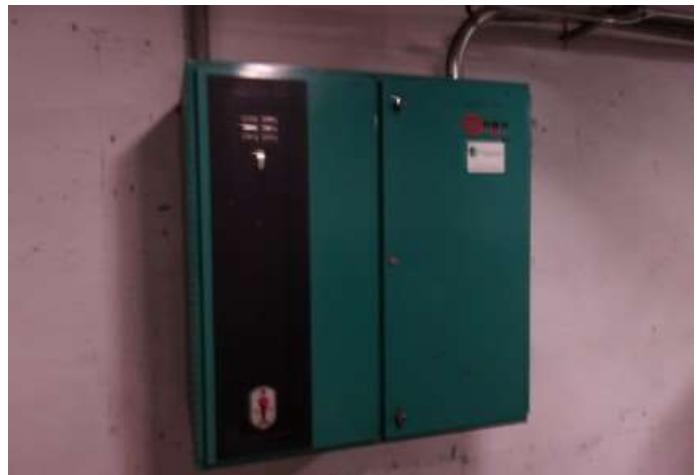
Emergency generator

Fuel storage tank

Transfer switch

Engineering Narrative	
A diesel-fired generator is located in the basement and comes online in the event of a power disruption to power critical building systems. The system has a capacity of 350-kW and dates to 2021. We include an allowance to replace the generator, transfer switch and fuel tank by 2055.

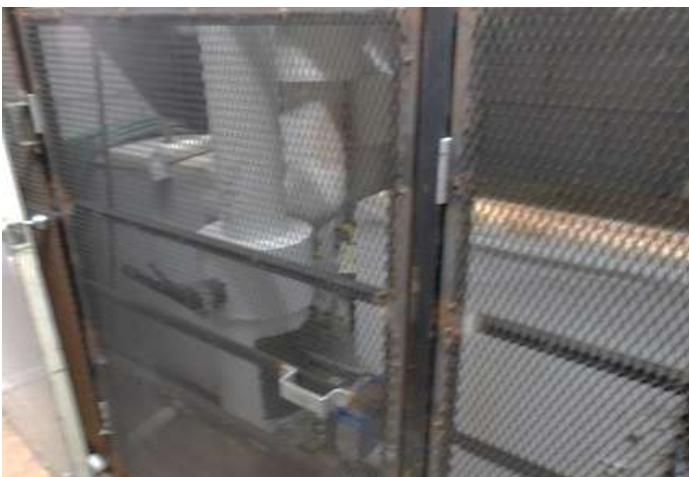
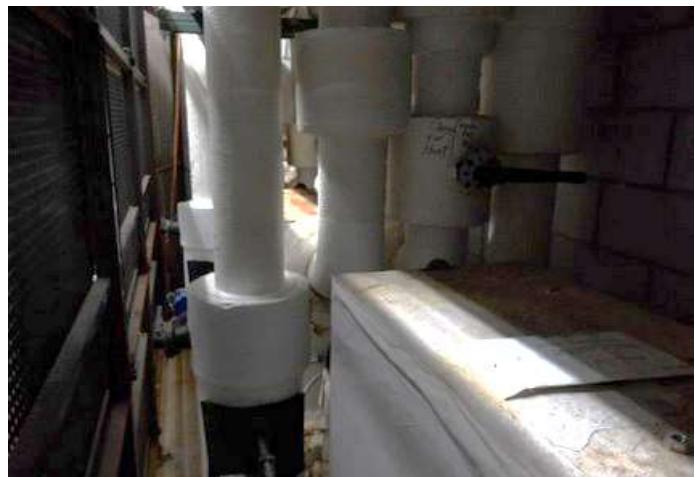
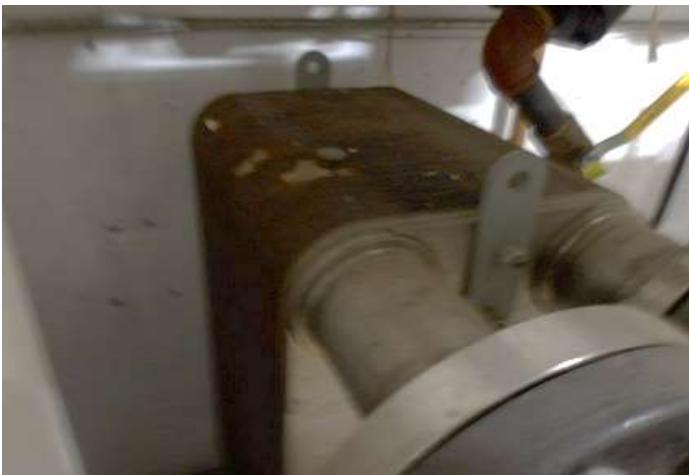
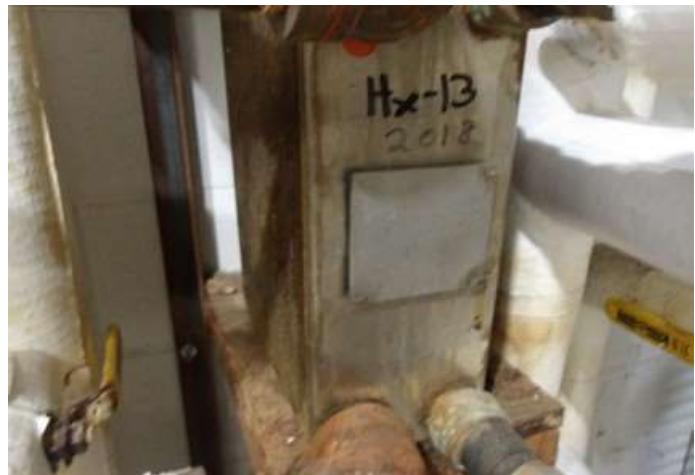
Estimated Current Age in Years:	22	Overall Current Condition:	Good
Remaining Years Until Replacement:	15	Useful Life in St Paul, MN	25 to 35 Years
Estimated First Year of Replacement:	2040	Full or Partial Replacement:	Full 100.0%

Chilled system heat exchangers (HXs)

Chilled system HXs

Building heating plate heat exchanger

Fund replacement of domestic water HXs through operating budget

2 heat exchangers (HXs) serve the building heating system while 3 insulated HXs serve the building cooling system. The heat exchangers allow for transfer of heat between 2 fluids without mixing. The exchanger date to 2003. Based on age, we include an allowance for replacement by 2040. The association should fund replacement of the domestic hot water HXs through the operating budget as needed.

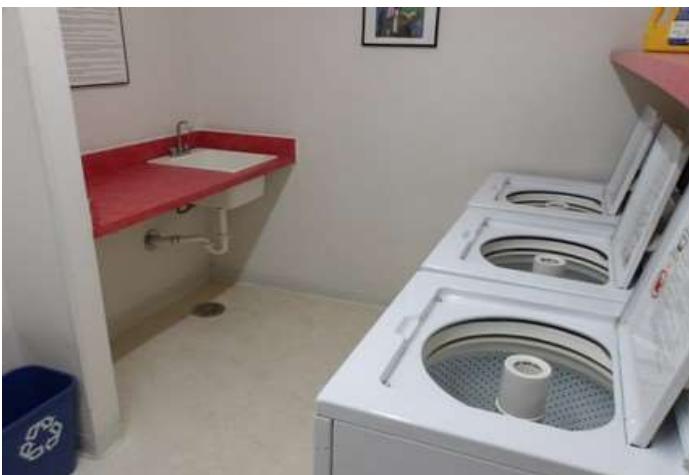
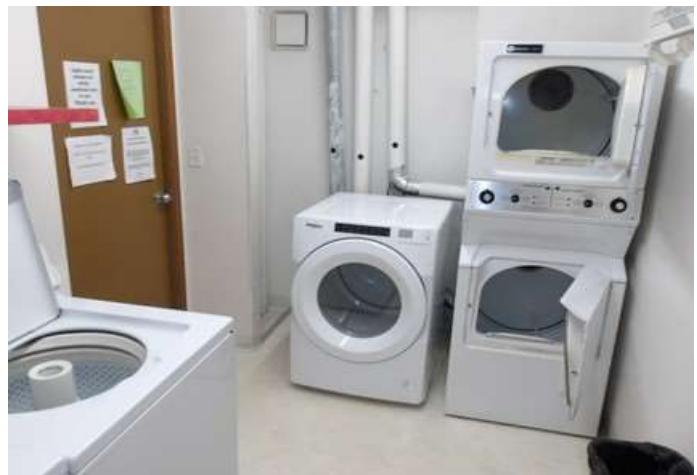
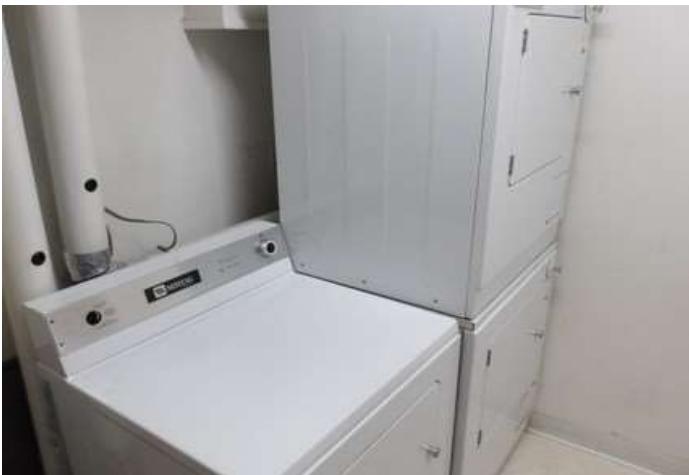
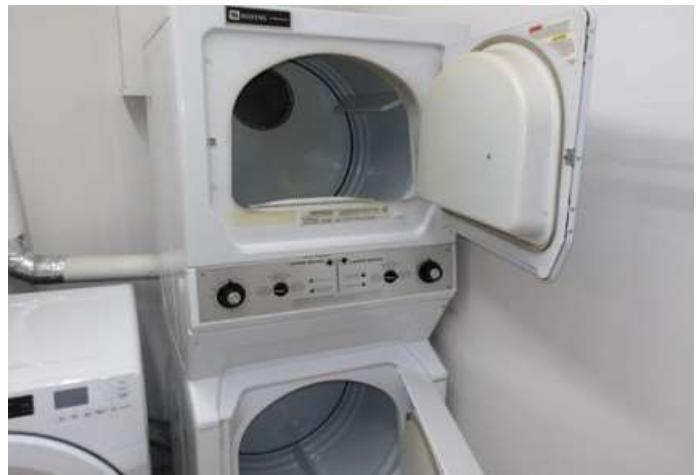
Estimated Current Age in Years:	Varies	Overall Current Condition:	Fair	
Remaining Years Until Replacement:	3	Useful Life in St Paul, MN	10 to 15 Years	
Estimated First Year of Replacement:	2028	Full or Partial Replacement:	Full	250.0%

Laundry washers

Clothes dryers

Common laundry equipment

47 washers and 47 dryers are available to residents. The washers and dryers vary in age, with some dating even to 1982. The association spent \$25,000 on partial replacements in 2025. Based on their varied ages, we include replacement of up to 25% of the equipment every 3 years, beginning by 2028.

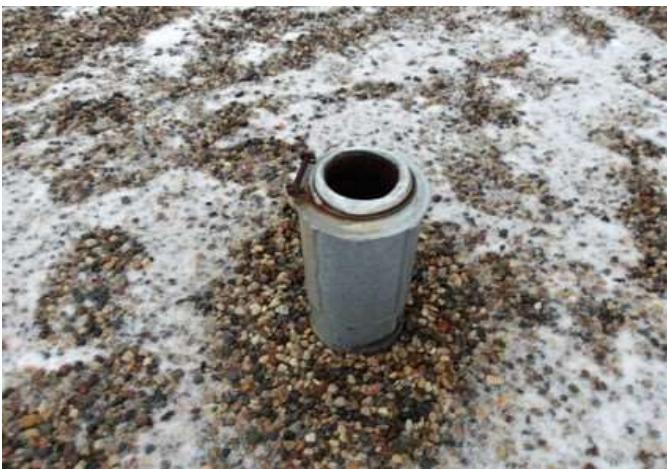
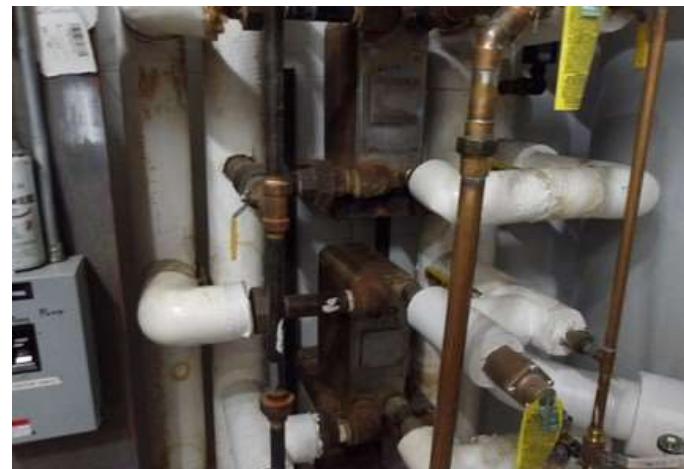
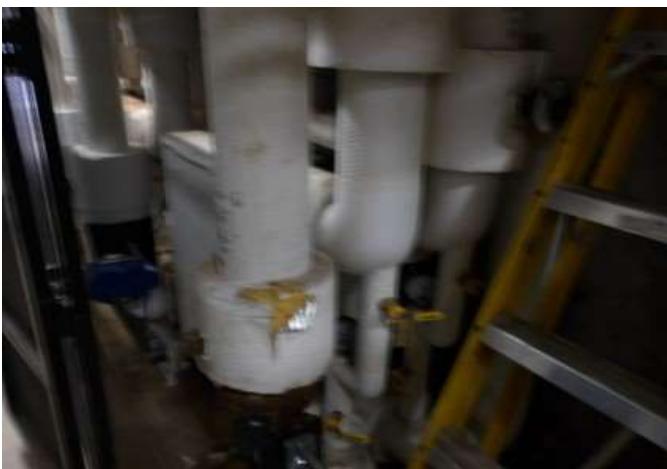
Overall Current Condition:	Fair
Useful Life in St Paul, MN	to 75+ Years
Full or Partial Replacement:	Partial 80.0%

Vent pipe penetration through roof

Insulated piping in mechanical room

Insulated common piping

We estimated 3,250 riser sections serve the building HVAC and domestic water and waste systems of the buildings. A riser section is one section of pipe that is one story in height. The pipes include roof drains, HVAC supply, HVAC return, condensate, cold water supply, hot water supply, hot water return, waste and vent pipes. The HVAC supply and return pipes were reportedly replaced in 2005. The client does not report active leaks, but reports that there have been leaks in the past. The pipes are a combination of materials. Over time, the pipes may increasingly develop pinhole leaks, leaks at joints and accumulate sediment that affects internal pressures. We do not anticipate the need for replacement of all the riser sections during the next 30 years. Instead, we include a budgetary allowance to replace up to 80% of the pipes by 2055.

Due to the limited nature of our non-invasive inspection, we are unable to confirm the layout, quantities and conditions of the pipes. We recommend the association consult with a plumber to determine the condition of the pipes. Updates to this study will consider the findings of any invasive study as well as the timing and scope of pipe replacement projects.
