RESERVE STUDY

**City Walk Condominium Association
66 9th Street East
St Paul, MN**

Date of Inspection: December 3, 2024

Revision #2: September 3, 2025

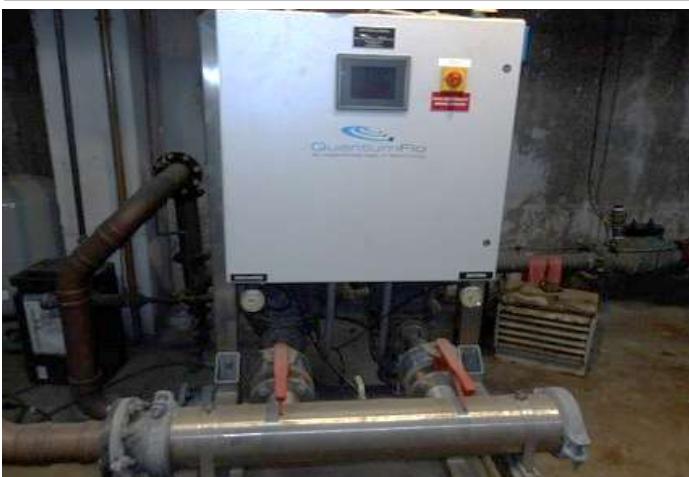
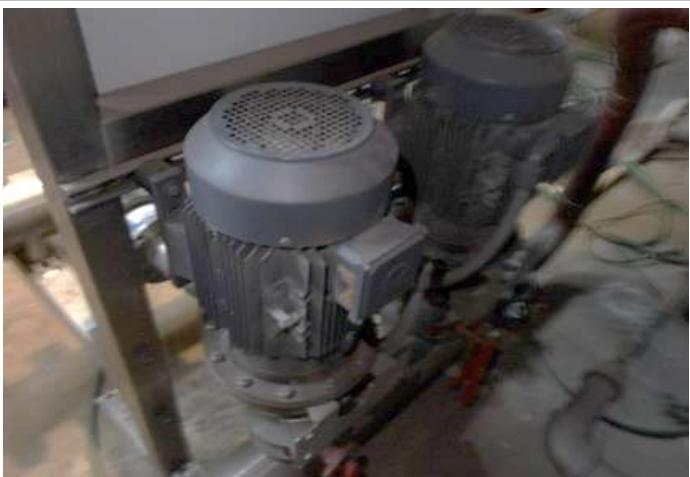
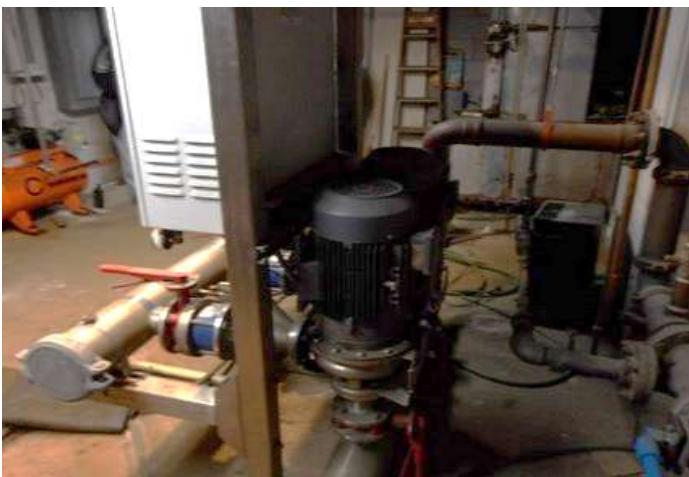
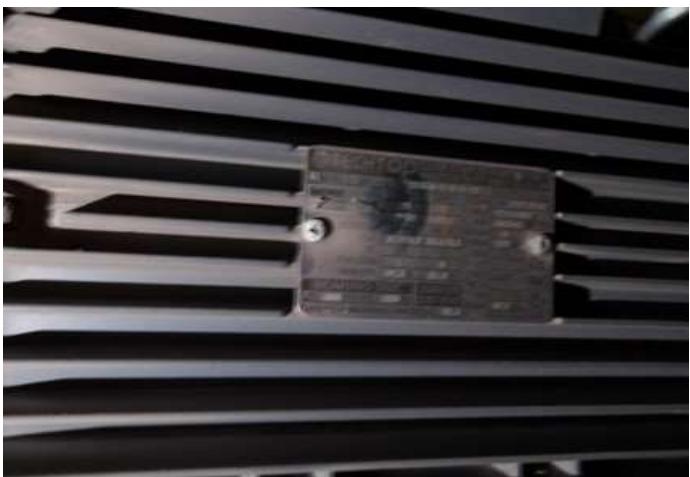
Domestic water pump system

Domestic water pump

Pump and controls assembly

Specification tag

The association maintains 2 pumps with capacities of 15-HP each, and a set of controls to provide domestic cold water throughout the building. The pumps were likely replaced after 2013 and are reported in satisfactory operational condition. We recommend replacement of the pumps and controls by 2038. The association should fund interim motor replacement and pump rebuilding through the operating budget as needed.

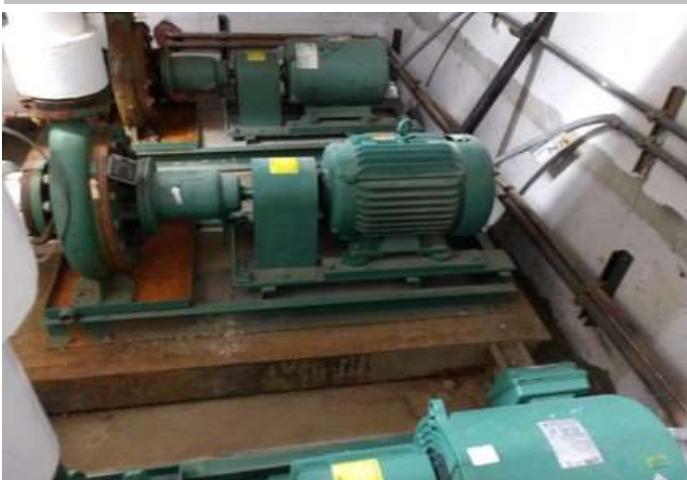
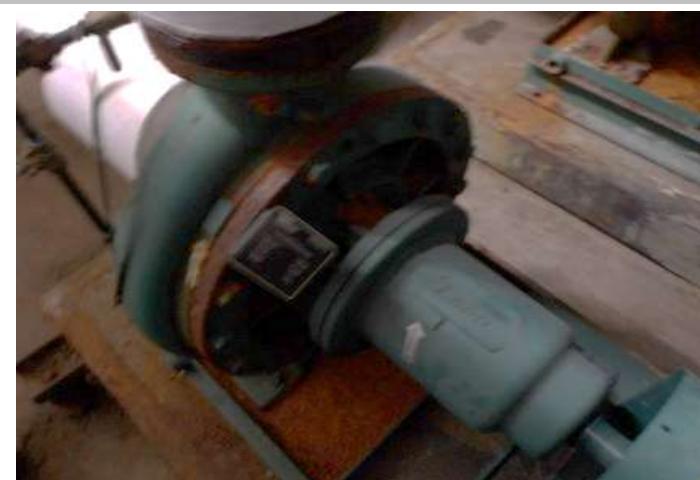
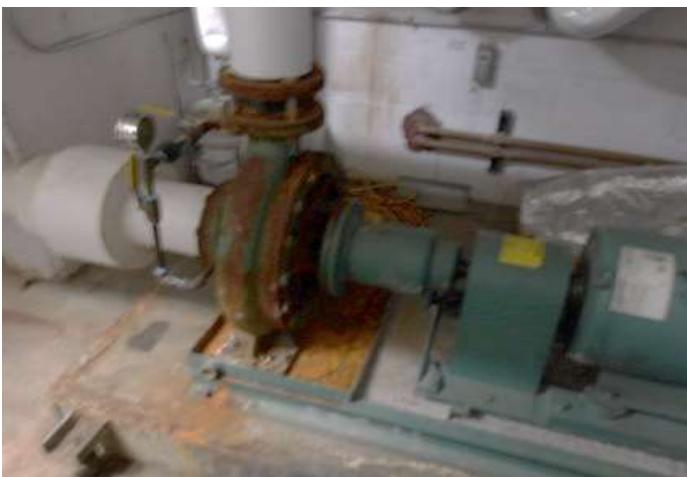
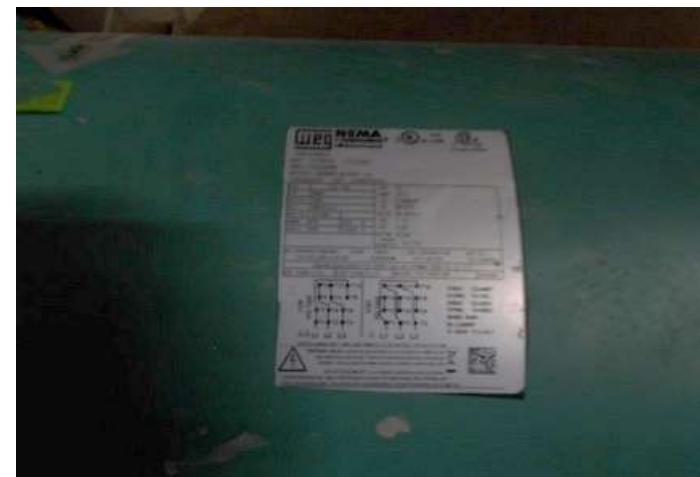
Estimated Current Age in Years:	Varies	Overall Current Condition:	Fair
Remaining Years Until Replacement:	10	Useful Life in St Paul, MN	20 to 30 Years
Estimated First Year of Replacement:	2035	Full or Partial Replacement:	Full 100.0%

HVAC pumps

Pump housing

Specification tag

Engineering Narrative	
<p>The association maintains 3 pumps with capacities of 25-HP each to circulate heated or chilled water to the fan coil units throughout the building. The pumps date to 2010, 2011 and 2024 and are reported in satisfactory condition. We recommend phased replacement between 2035-2050. The association should fund interim motor replacement, pump rebuilding and replacement of pumps with capacities less than 5-HP through the operating budget as needed. We partially base our cost of replacement on the association's historic cost.</p>

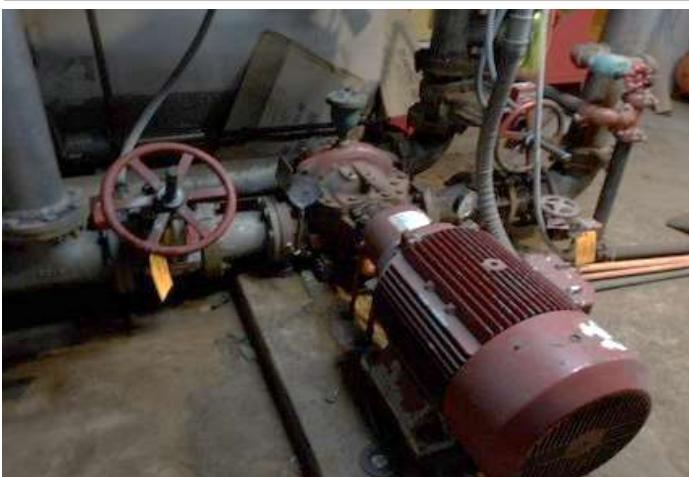
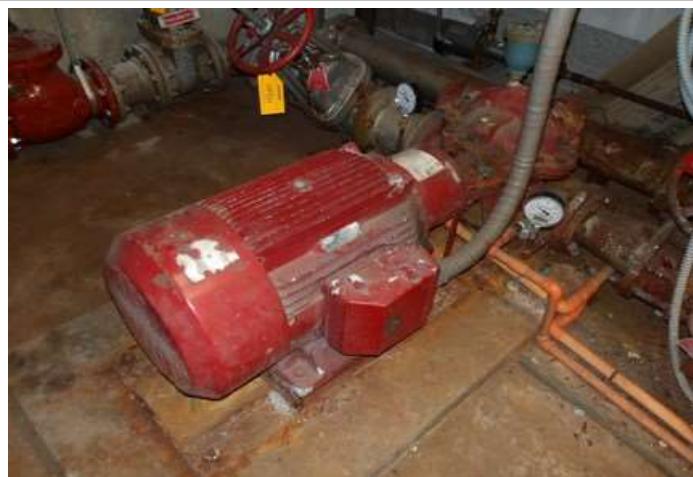
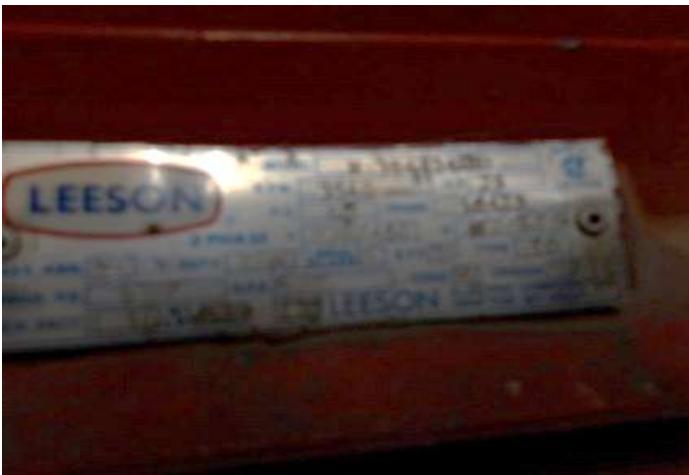
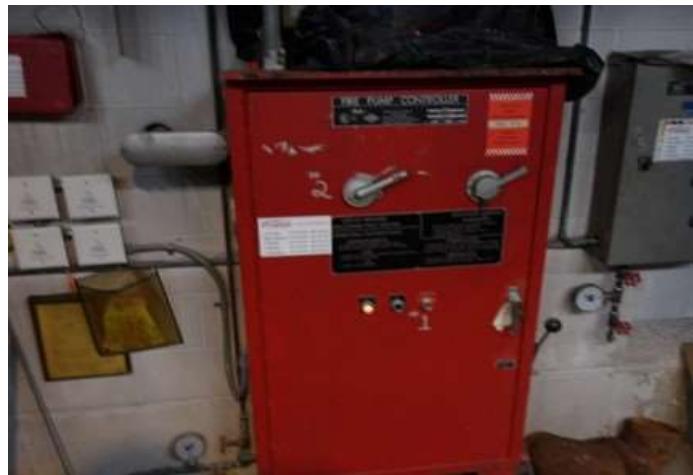
Estimated Current Age in Years:	43	Overall Current Condition:	Fair
Remaining Years Until Replacement:	6	Useful Life in St Paul, MN	to 50 Years
Estimated First Year of Replacement:	2031	Full or Partial Replacement:	Full 100.0%

Fire suppression pump

Pump motor

Specification tag

Fire pump controller

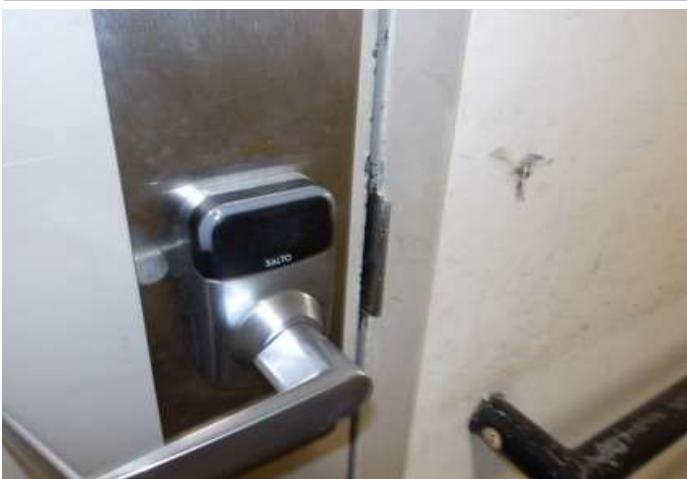
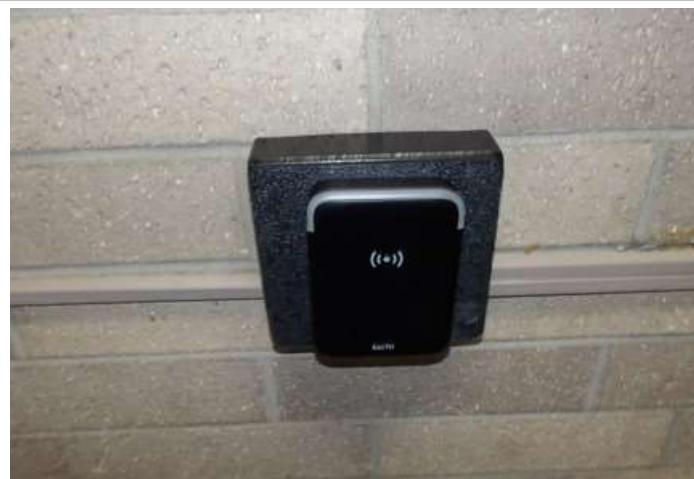
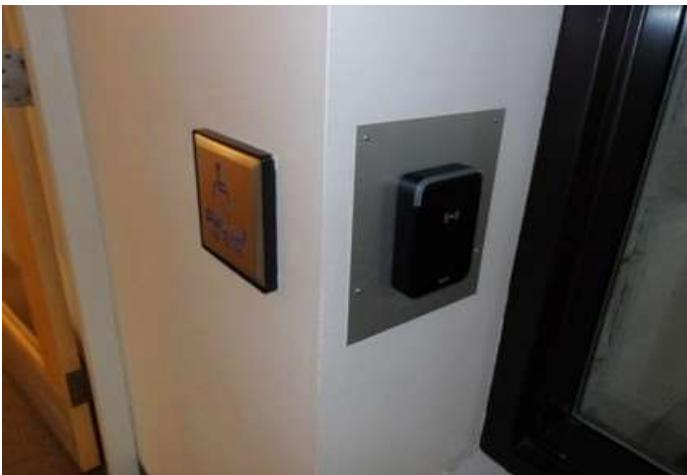
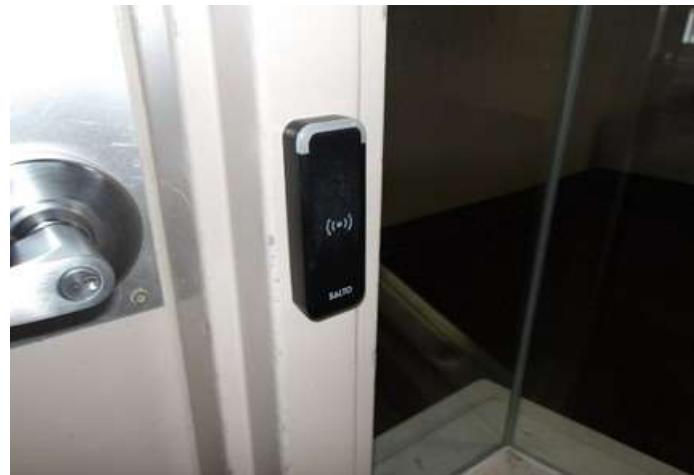
FOB access reader

Proximity reader

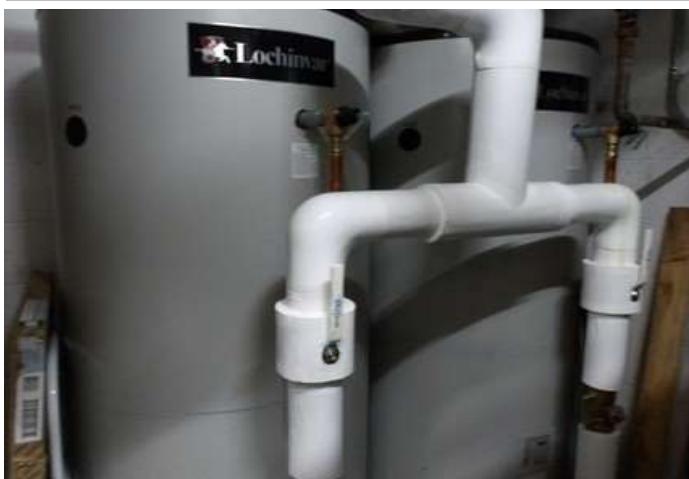
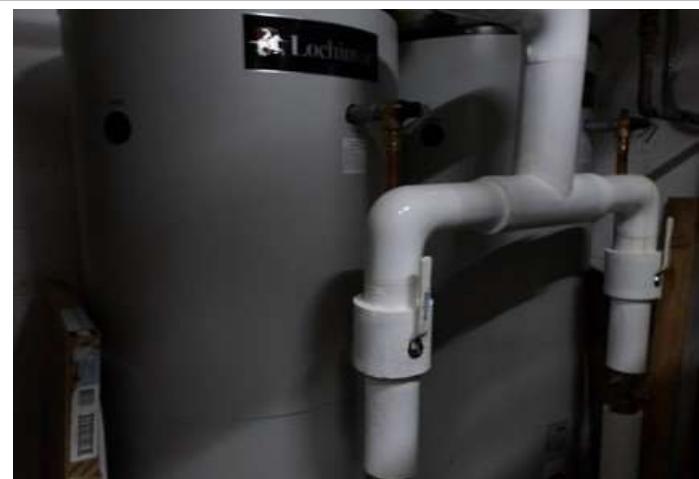
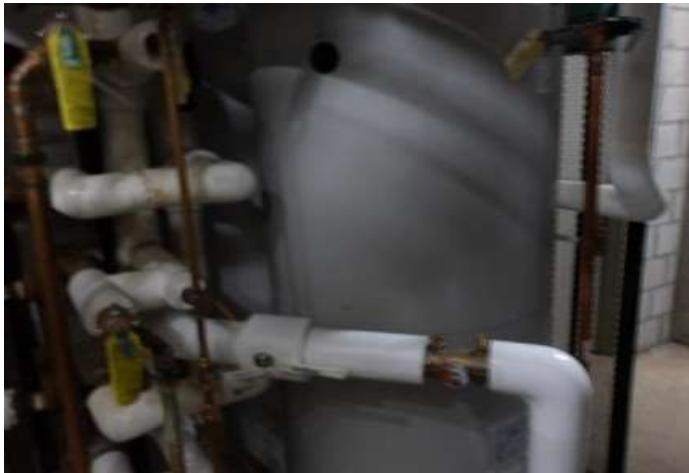
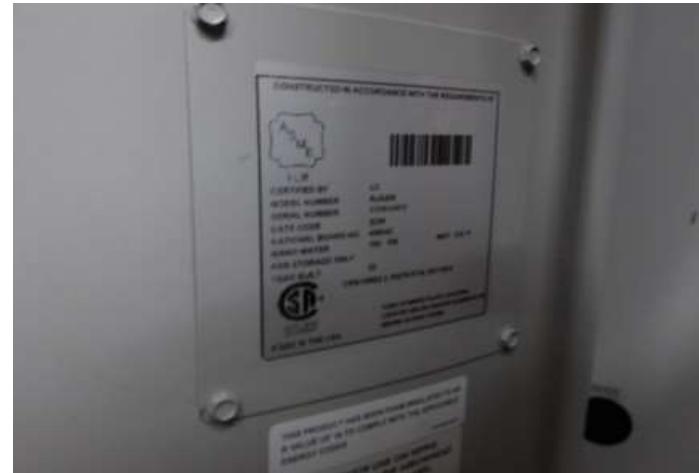
Line Item: 51

Water storage tanks

Domestic hot water tanks

Insulated storage tank

Specification tag

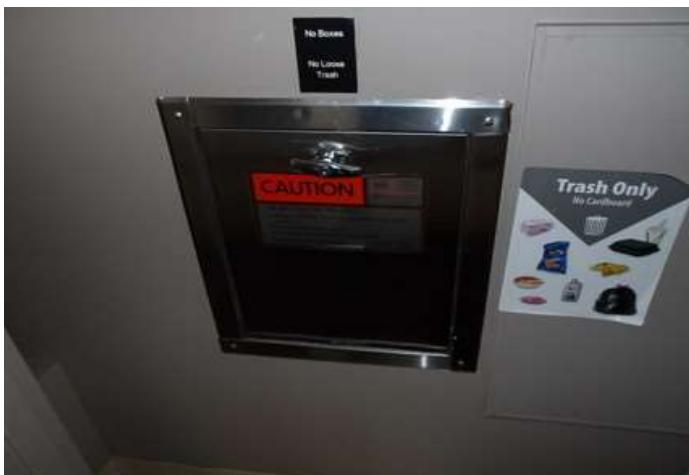
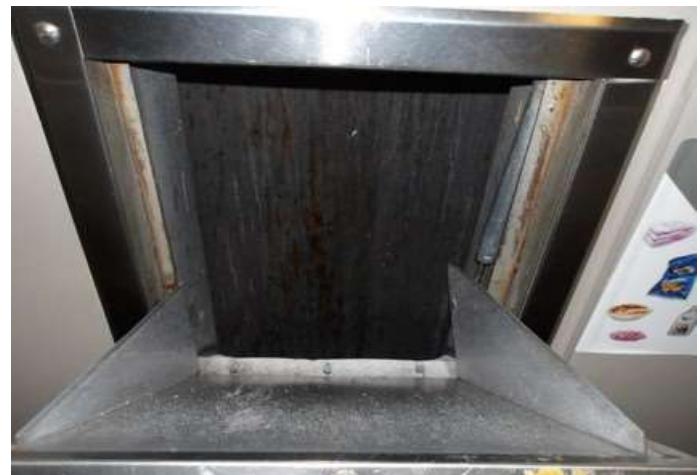
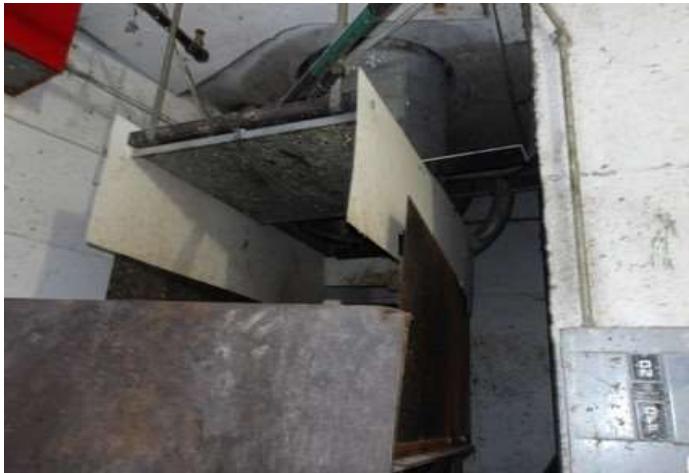
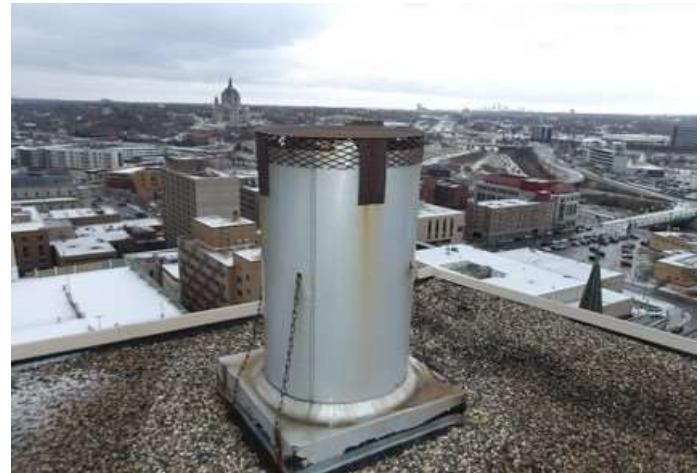
Line Item: 52

Trash chute door

Trash chute liner

Trash chute discharge

Trash chute vent

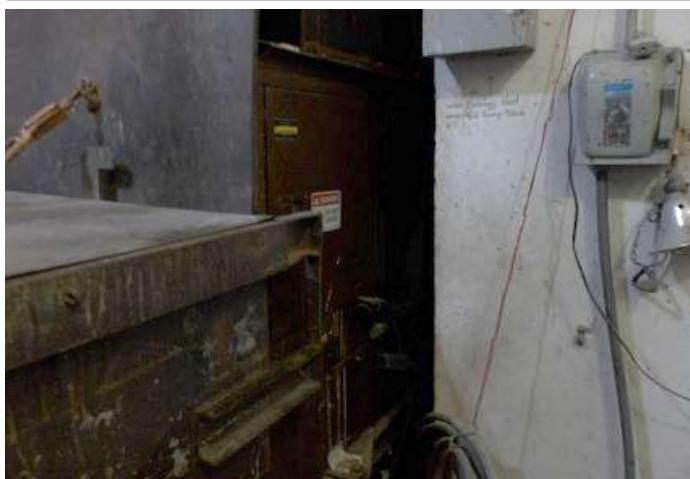
Trash compactor

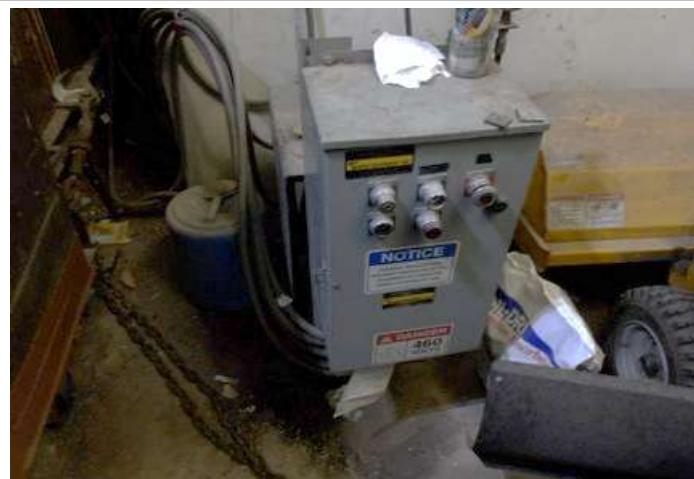
A trash compactor is located at the base of the trash chute. The compactor reportedly dates to 2003. Based on age, we include an allowance for replacement by 2028 and again by 2053.

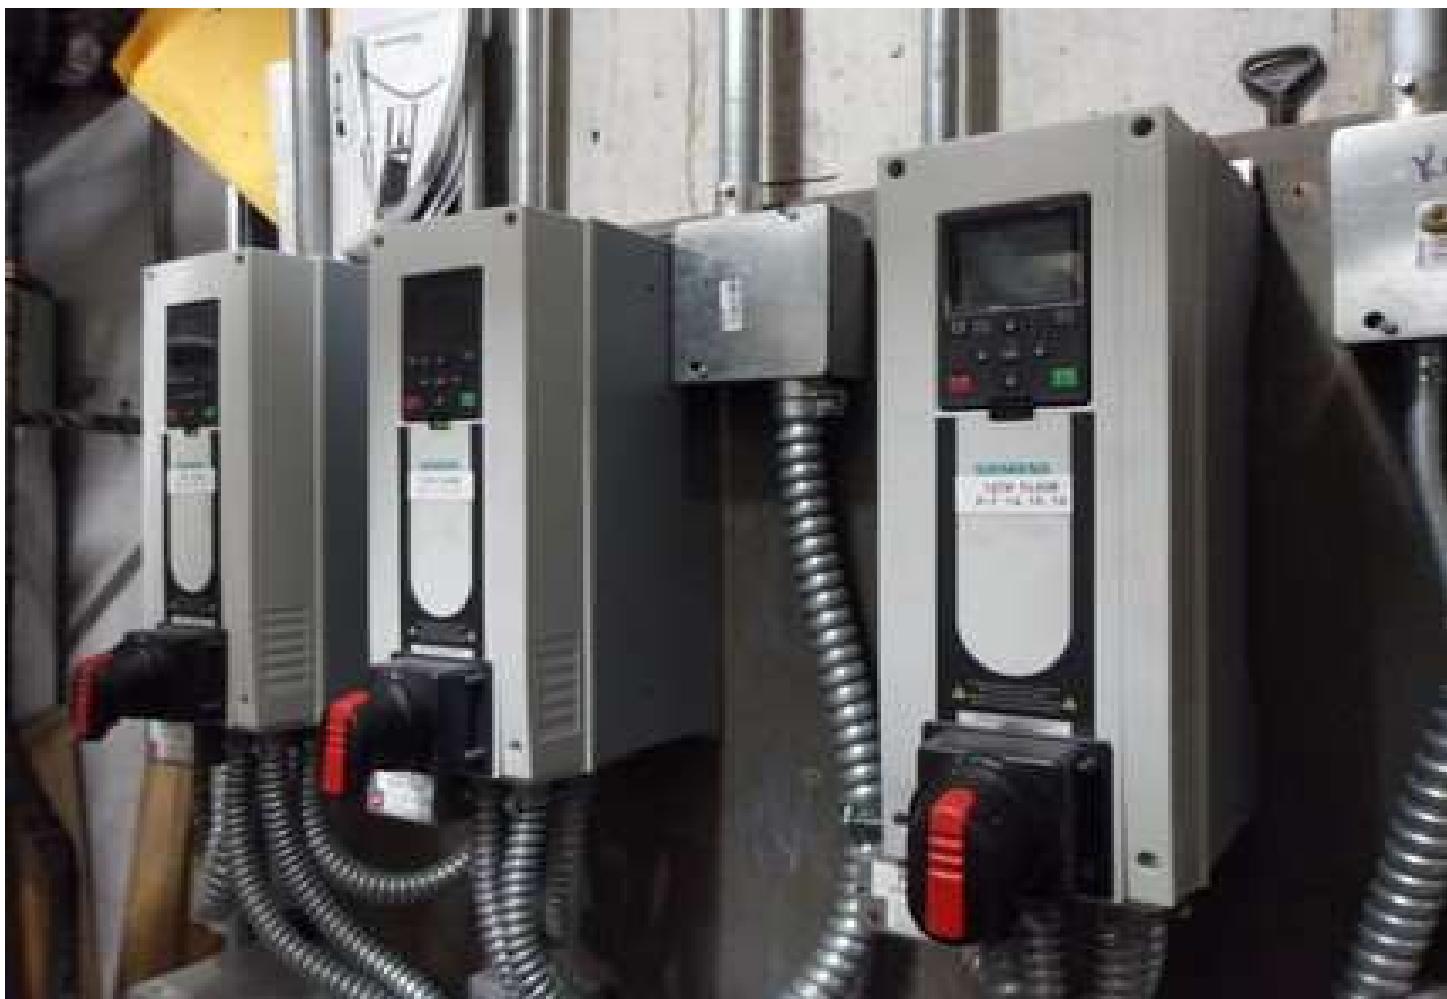
Variable frequency drives

Engineering Narrative				
The 3 core loop HVAC pumps are each served by a variable frequency drive (VFD). These drives work with motors to allow for incremental operation to better modulate system pressure and energy use. Additionally, VFDs will reduce the wear and tear of motors that is normally experienced when motors are powered on. We recommend replacement of the VFDs by 2036 and again by 2054.

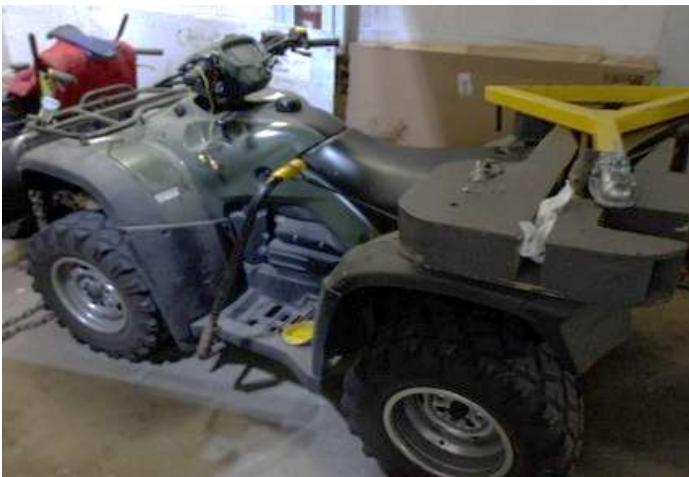
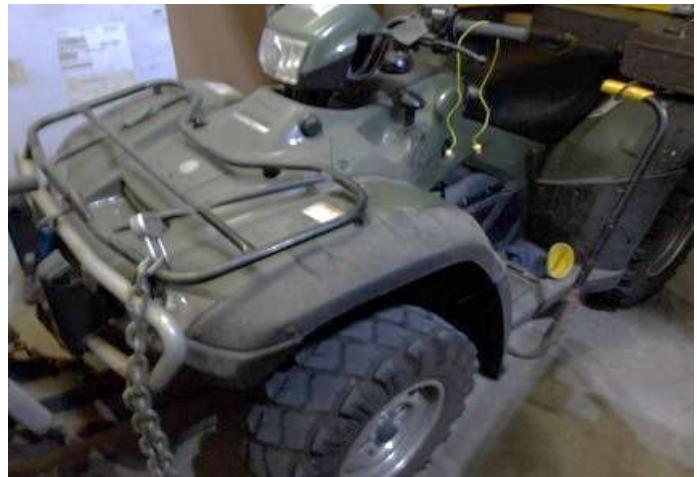
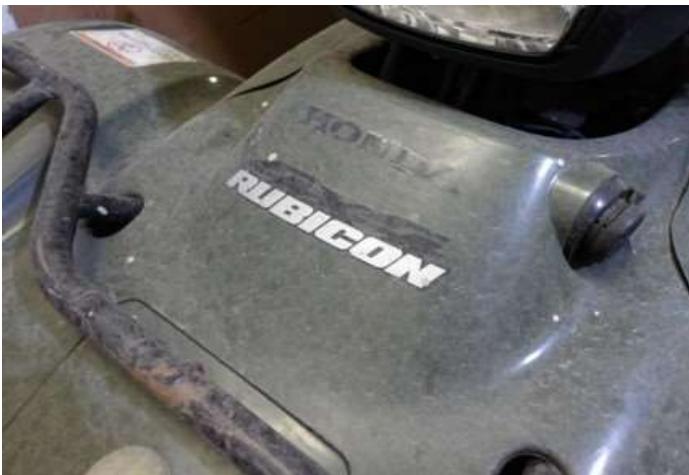
Honda Rubicon

Common utility vehicle

Utility vehicle model

The association owns a utility vehicle to move dumpsters through the parking ramp. The age of the vehicle was not available at the time of inspection, but it was reportedly overhauled in 2023 and is in fair condition. The client reports that the plow needs replacement near term. Based on its operational condition, we include replacement by 2030 and again by 2050.

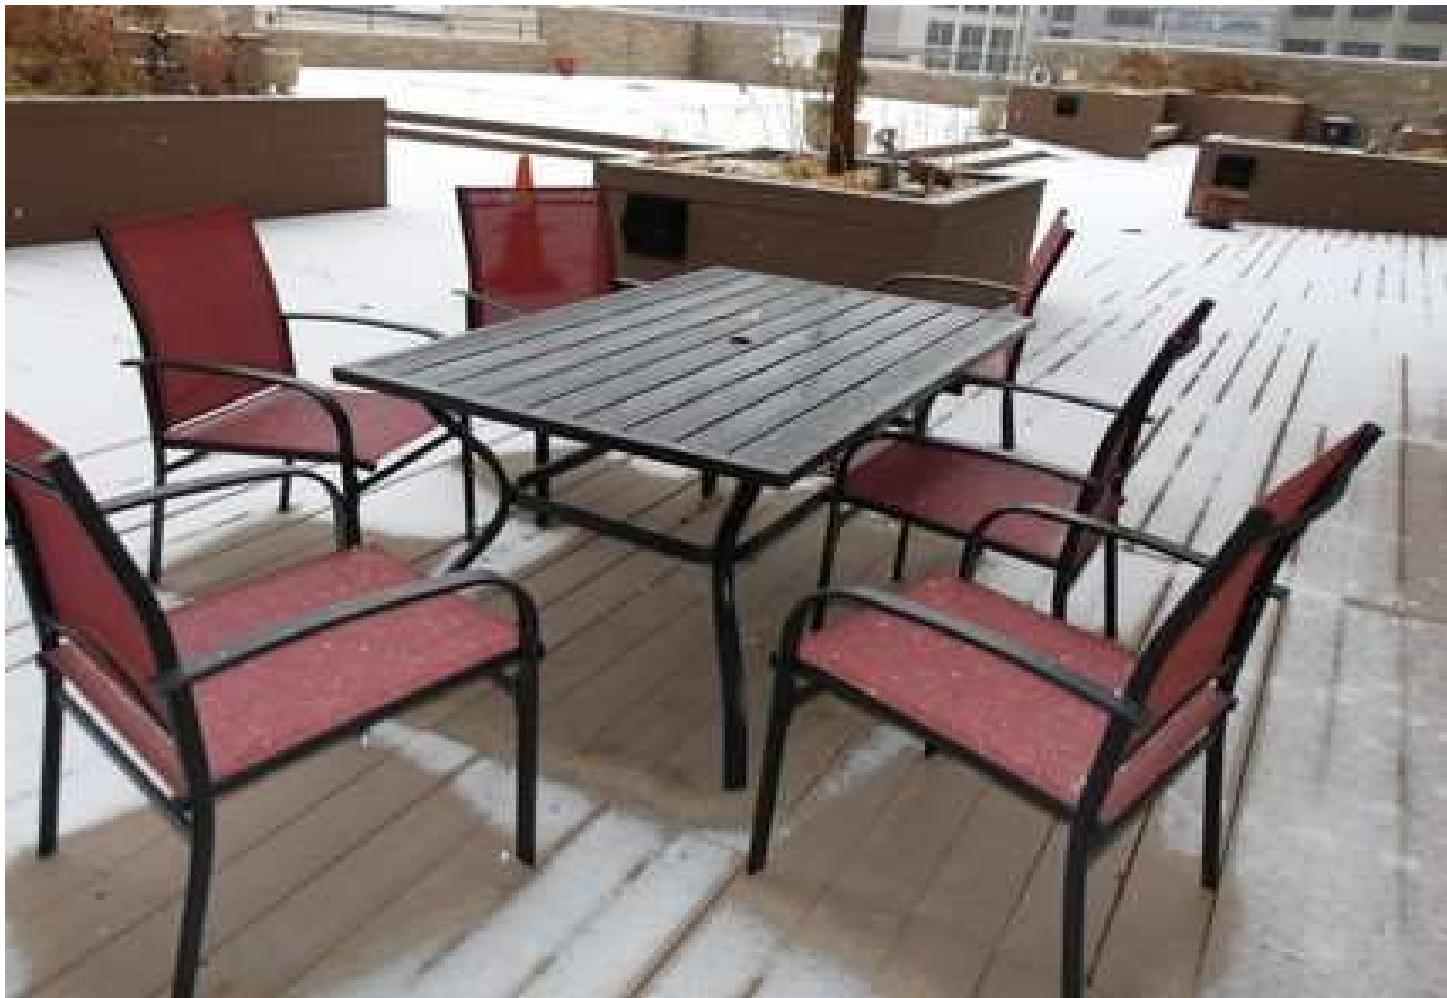
Common furniture

Engineering Narrative				
The association replaced the pool furniture in 2022 and it is reported in good condition. The majority of the furniture was in storage at the time of our inspection. Based on age, we include future replacement by 2032 and every 10 years after.

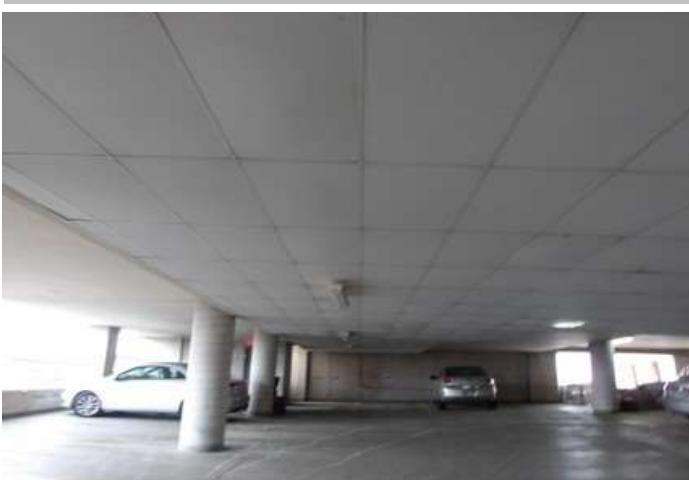
Dropped ceiling tile and grid system

A dropped grid and tile system is located at P11, under the building superstructure. This system is critical to insulate piping serving the condominium. The age of the system was not available at the time of inspection, but may be original. We recommend the association continue to fund interim repairs through operating budget. We include full replacement by 2034, in coordination with other garage renovation projects.

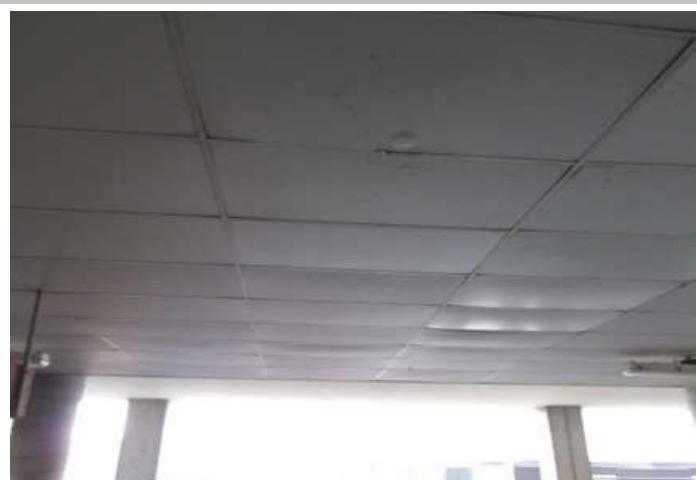
Sagging tiles

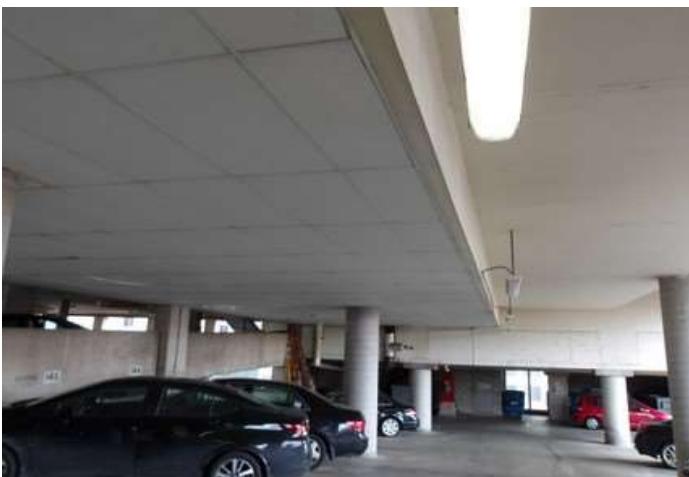
Garage dropped ceiling

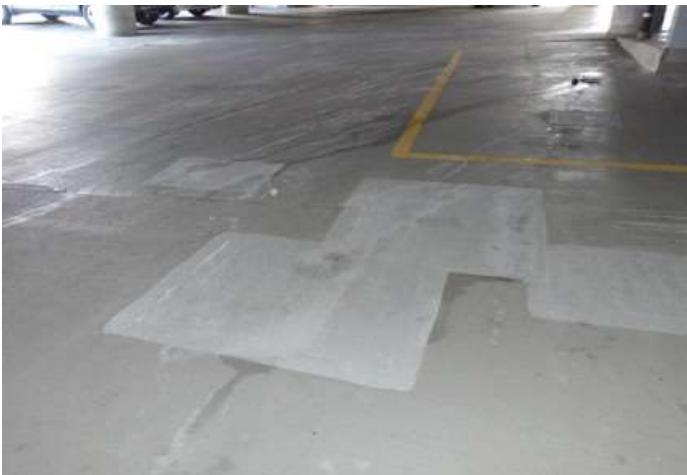
Previous concrete patches

The elevated concrete floors in the private garage (floor P8 through P11) appear in fair overall condition. The concrete uses a traffic membrane and the client reports they did major repairs in 2020 and are doing additional repairs between 2024-2025. It is imperative to conduct inspections and timely repairs to prevent water infiltration into the structures, where moisture can cause rusting of the structural steel. At this time, we include an allowance for comprehensive inspection, repairs and traffic membrane installation by 2034 and every 10 years after.

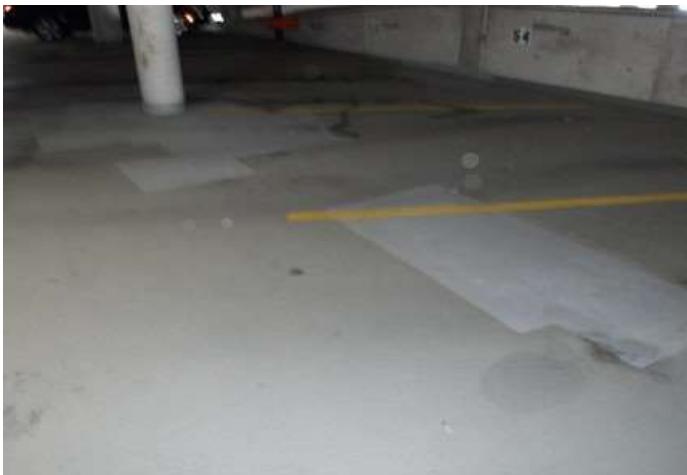
Elevated concrete floor

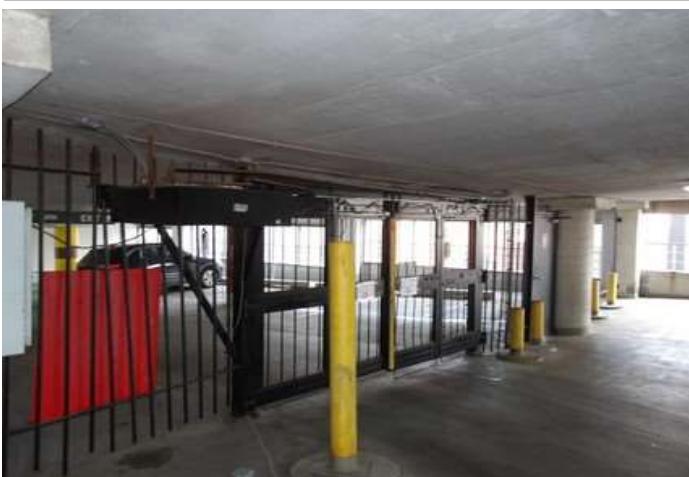
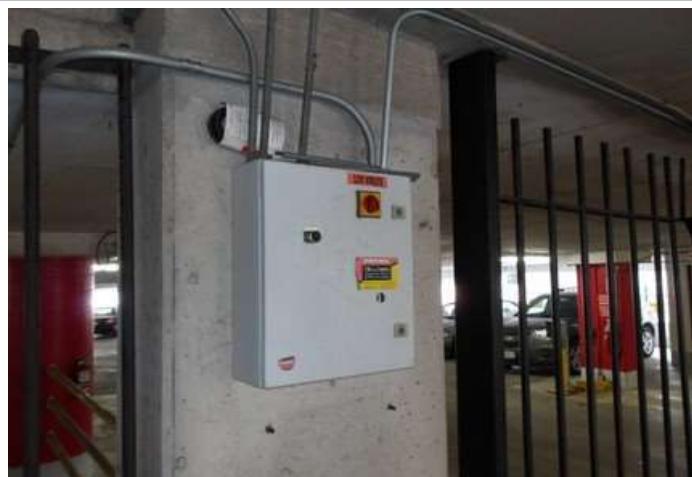
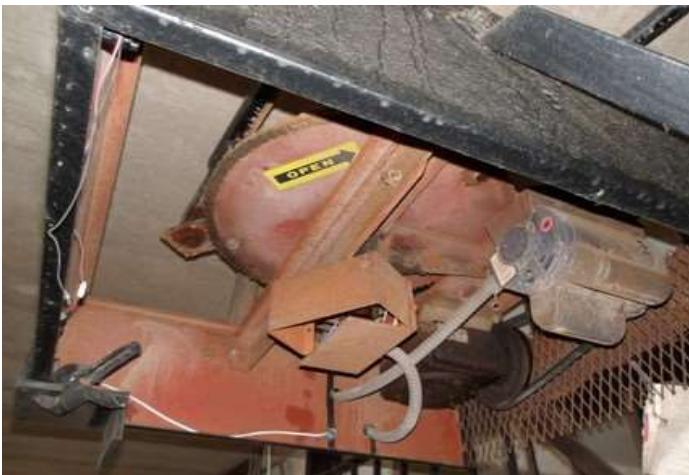
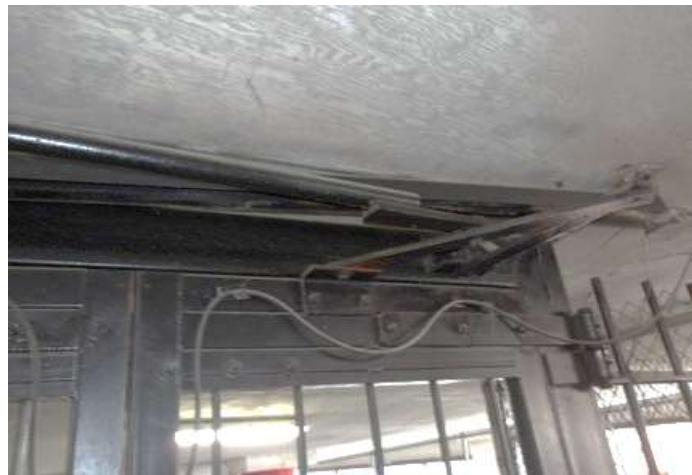
Common garage gates

Gate operator controls

Garage gate operator

Gate arm

Two sets of gates limit access into the condominium garage, beginning at level P8. The ages of the gates is approximately 30 years and they are reported in satisfactory operational condition. Based on condition, we recommend the association defer replacement until 2030. We include subsequent replacement by 2055.

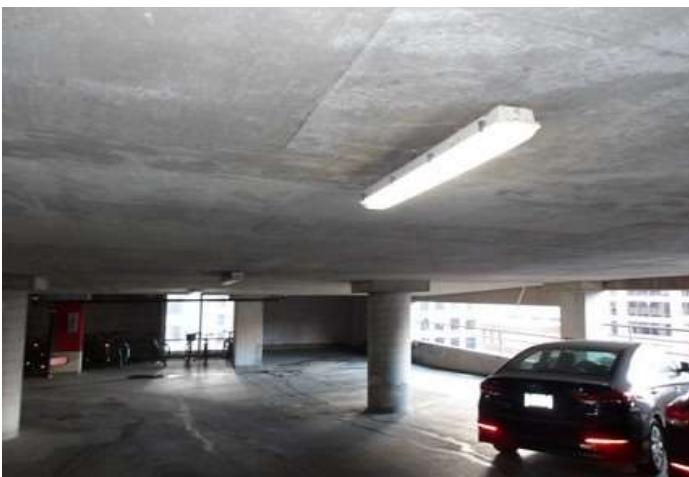
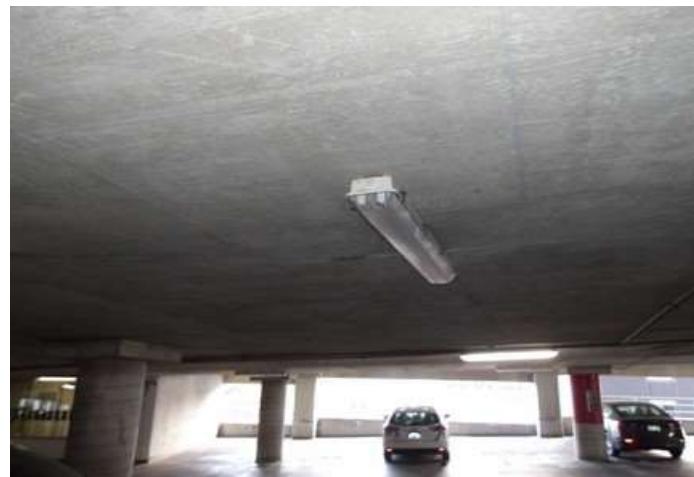
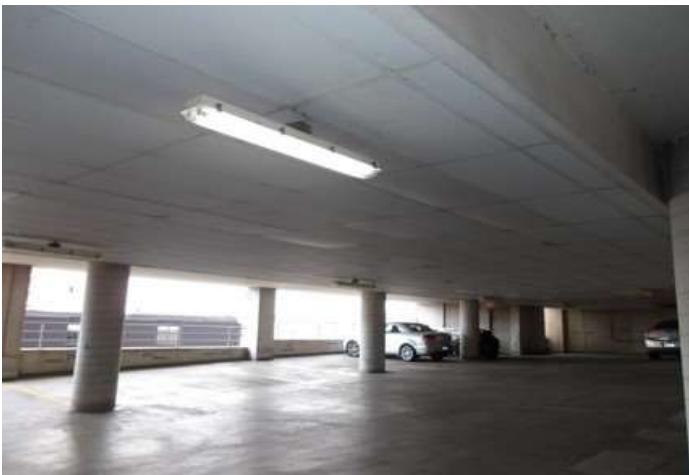
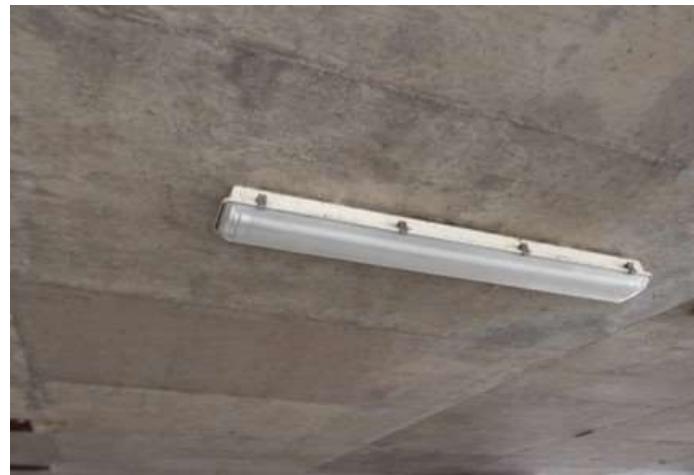
Garage lighting

Garage light fixture

Strip garage fixture

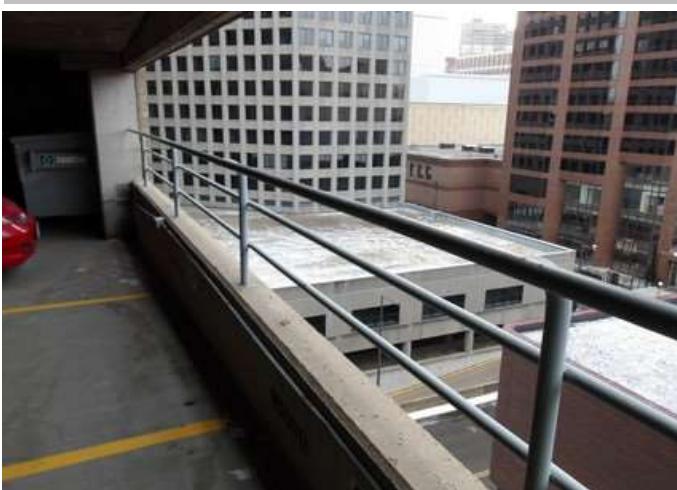
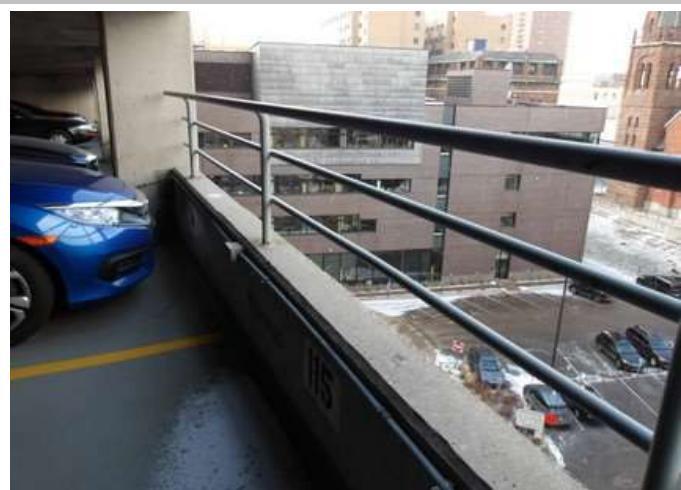
Garage railings

Metal railings

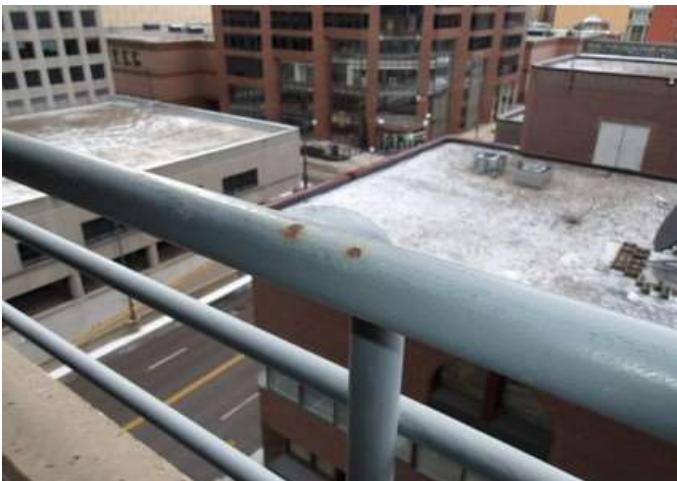
Rust at metal railing

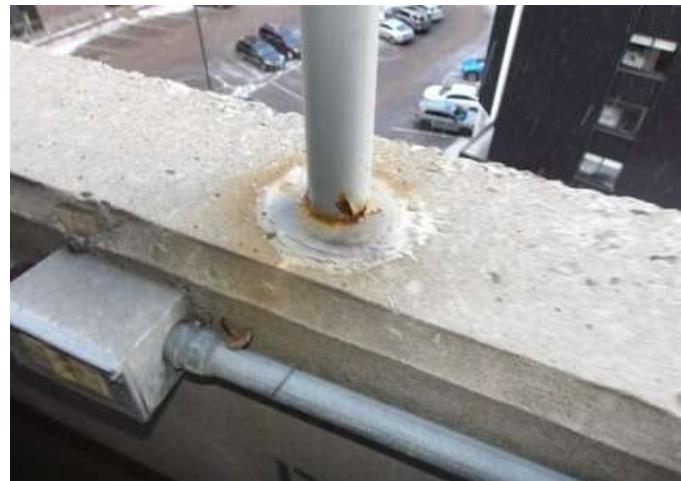
Rust at post

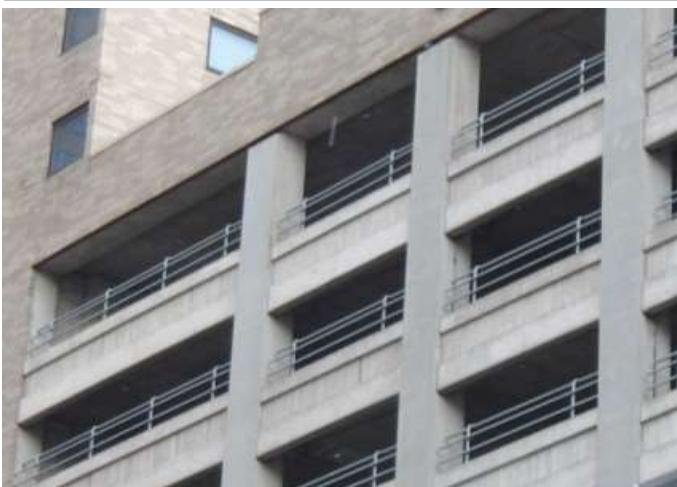
Garage railings as viewed from street level

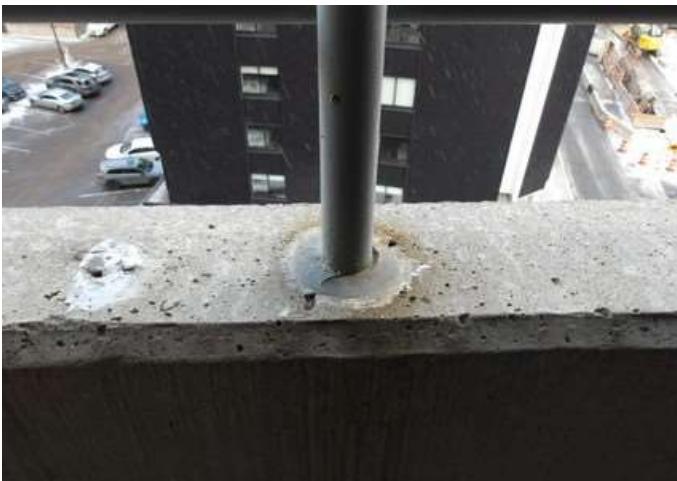
Post pocket detail

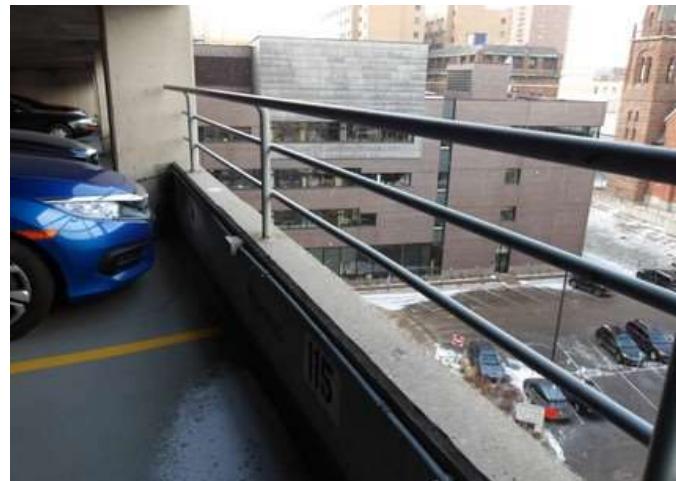
Horizontal garage railings
