# FULL RESERVE STUDY

## City Walk, A Condominium

St. Paul, Minnesota

August 13, 2014

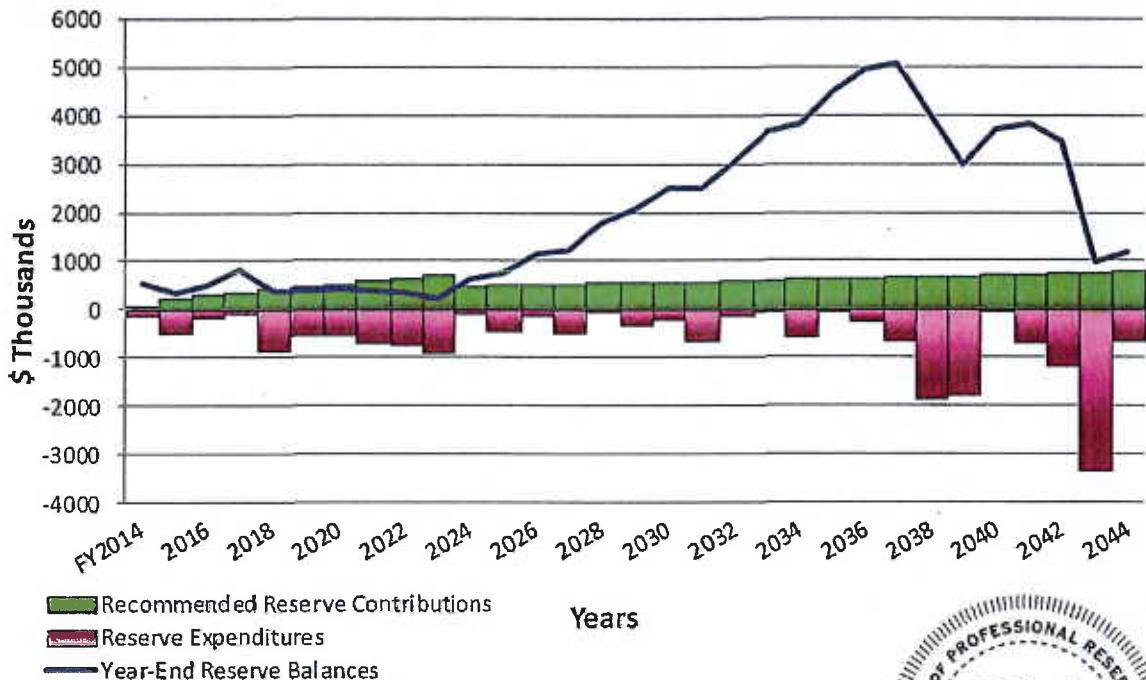
City Walk  
 Recommended Reserve Funding Table and Graph

Year	Reserve Contributions (\$)	Reserve Balances (\$)	Year	Reserve Contributions (\$)	Reserve Balances (\$)	Year	Reserve Contributions (\$)	Reserve Balances (\$)
2015	258,500	341,233	2025	516,600	747,112	2035	648,500	4,488,807
2016	317,000	496,311	2026	528,500	1,158,604	2036	663,400	4,956,432
2017	375,500	803,660	2027	540,700	1,230,568	2037	678,700	5,048,924
2018	434,000	397,420	2028	553,100	1,784,625	2038	694,300	3,968,434
2019	492,500	366,878	2029	565,800	2,076,725	2039	710,300	2,983,521
2020	551,000	408,515	2030	578,800	2,501,868	2040	726,600	3,716,698
2021	609,500	365,507	2031	592,100	2,505,830	2041	743,300	3,817,359
2022	668,000	334,854	2032	605,700	3,050,522	2042	760,400	3,471,194
2023	726,500	210,988	2033	619,600	3,680,909	2043	777,900	967,137
2024	505,000	635,760	2034	633,900	3,813,594	2044	795,800	1,162,383

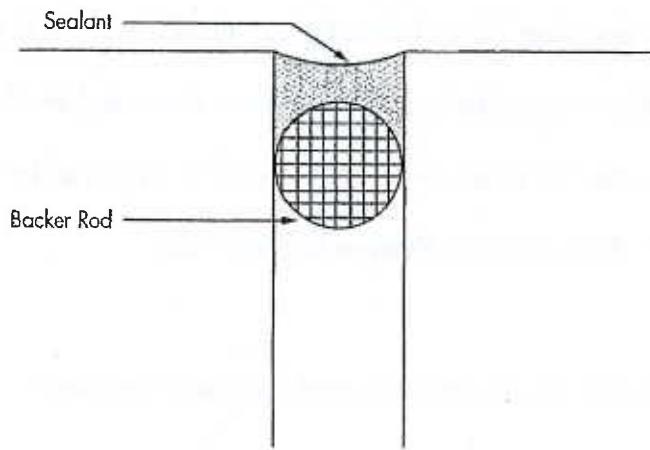
## SEALANT AT CONTROL JOINT DETAIL

cohesion failure. The following detail depicts a control joint with sealant and a flexible backer rod. Sealant installation at window perimeters comprises a similar detail:

Several types of caulk are available with significantly different weathering and elongation properties. We recommend a silicone-based or polyurethane-based caulk. The major advantage of polyurethane-based caulk is their ability to bond to most construction surfaces without special preparation, such as primer application, as is required for alternate materials like silicone caulk. With proper surface preparation, i.e., removing surface contaminants, silicone-based caulk performs better than most other caulk materials. The weathering and elongation properties of silicone-based caulk give it a much longer useful life than other caulk materials.

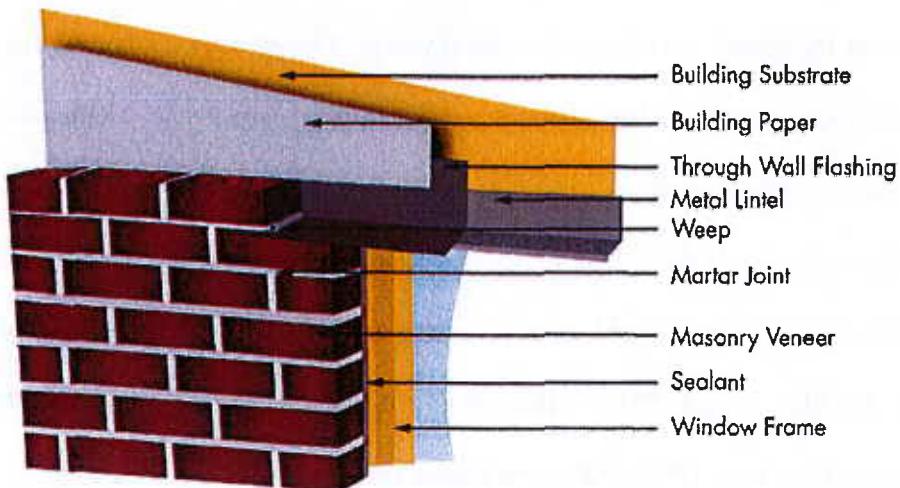
## MASONRY WALL, METAL LINTEL AND WEEP SYSTEM DETAIL

We also recommend inspection and repairs of the steel shelf angles. Shelf angles are steel angles which support the weight of masonry veneer between floors and transfers that weight onto the main structural system. Shelf angles require through the wall flashing and weeps to ensure proper elimination of water from the masonry system. The contractor should remove any areas of rust, prime and paint exposed shelf angles at windows. The following diagram details a metal lintel and weep system. However, this detail is similar to construction at shelf angles:

In consideration of the conditions, a portion of the shelf angles will require flashing installation during the next 30 years. This project includes the following activities:
